Prepared by:
Mitch Johnson, PE and Kevin Biehn of Emmons & Olivier Resources, Inc.
for the Soil and Water Conservation District of Scott County

Crosby Farm Park: Bluff Stabilization / Restoration Feasibility Study - St. Paul, MN

Feasibility Report 08/07/2007

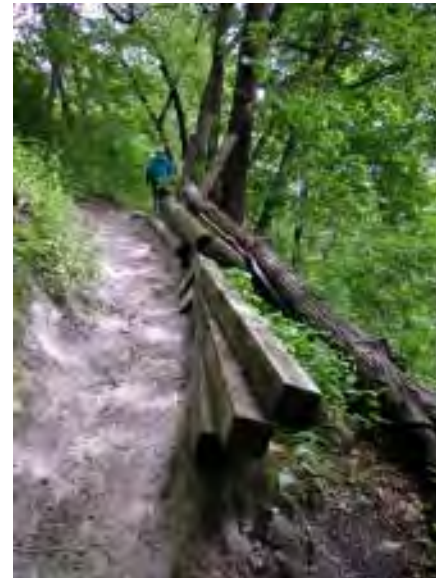
Start of segment, stairs recommended.

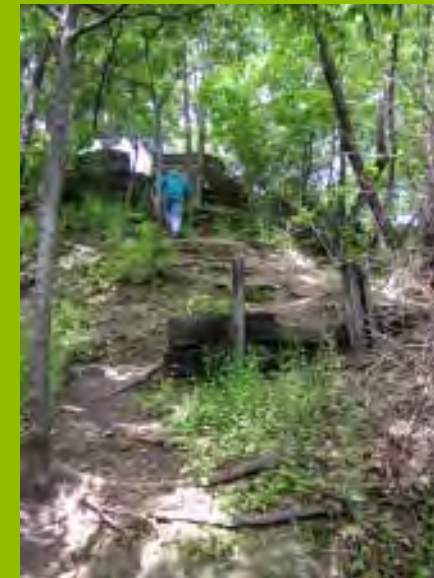
Abandoned trail to old overlook.

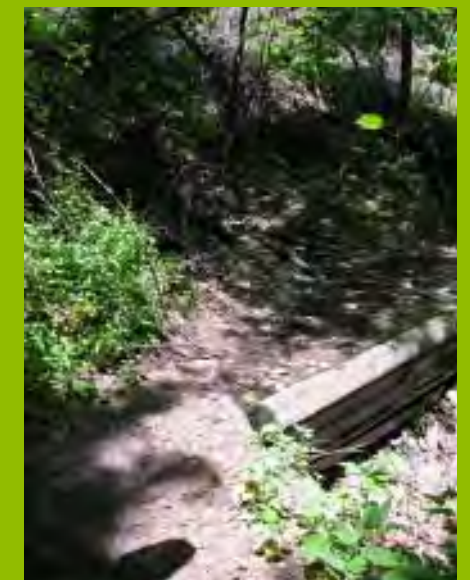
Water on trail, gabion's recommended.

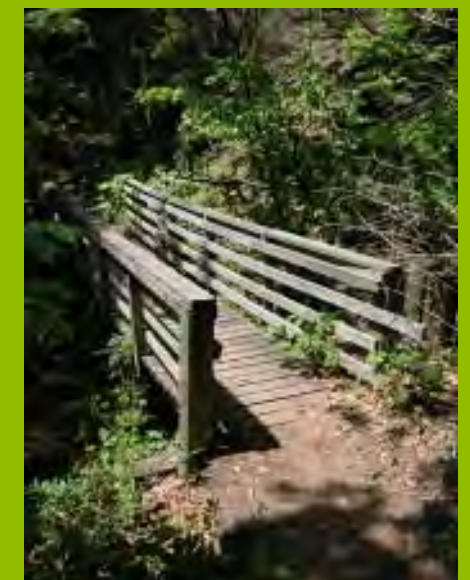
Boardwalk with eroded condition on uphill side.

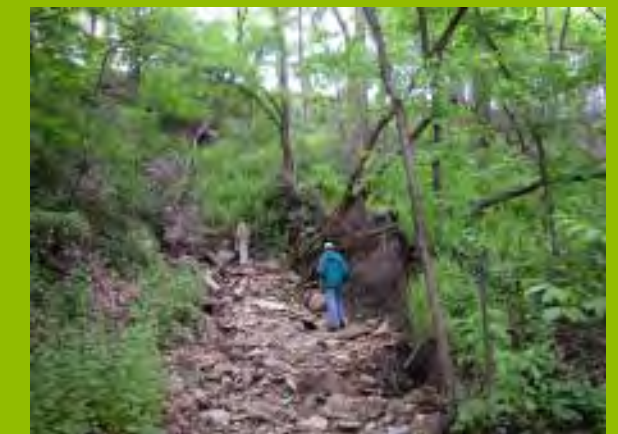
Another severely eroded gorge, above, with the cause of its erosion, a storm water pipe, below.

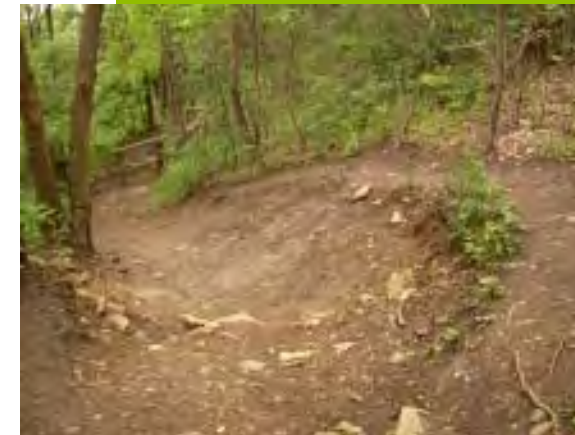
Sloped and eroded trail, where wide stairs are recommended.

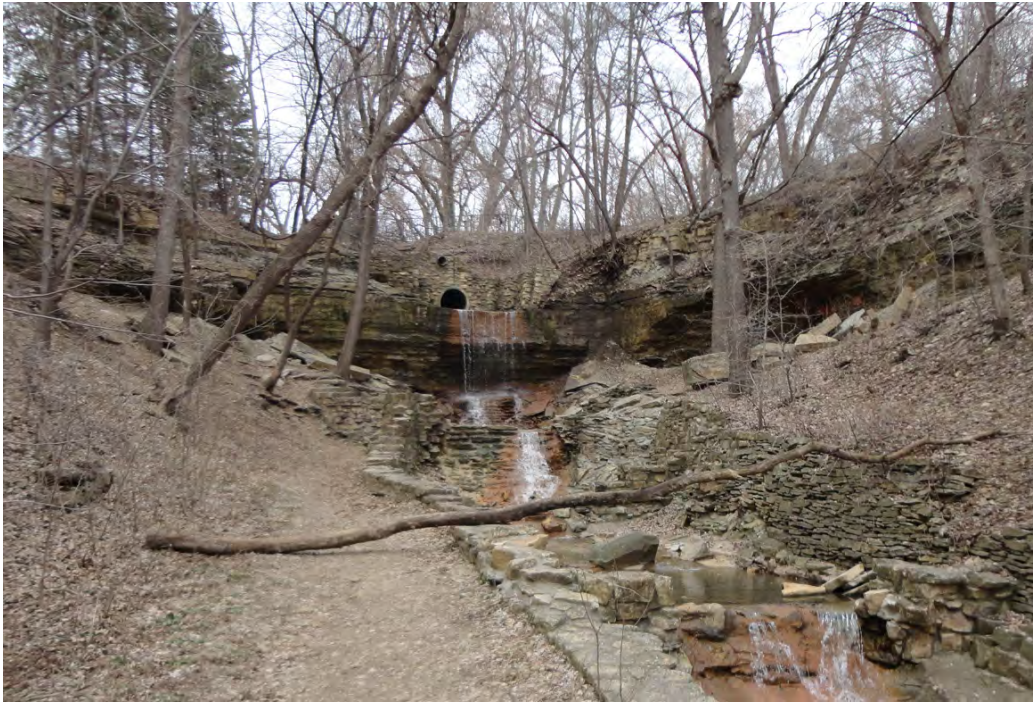
Figure 6: View of Hidden Falls showing the worn and undercut Platteville Limestone caprock, fallen limestone blocks and existing pools and cascades of upper falls

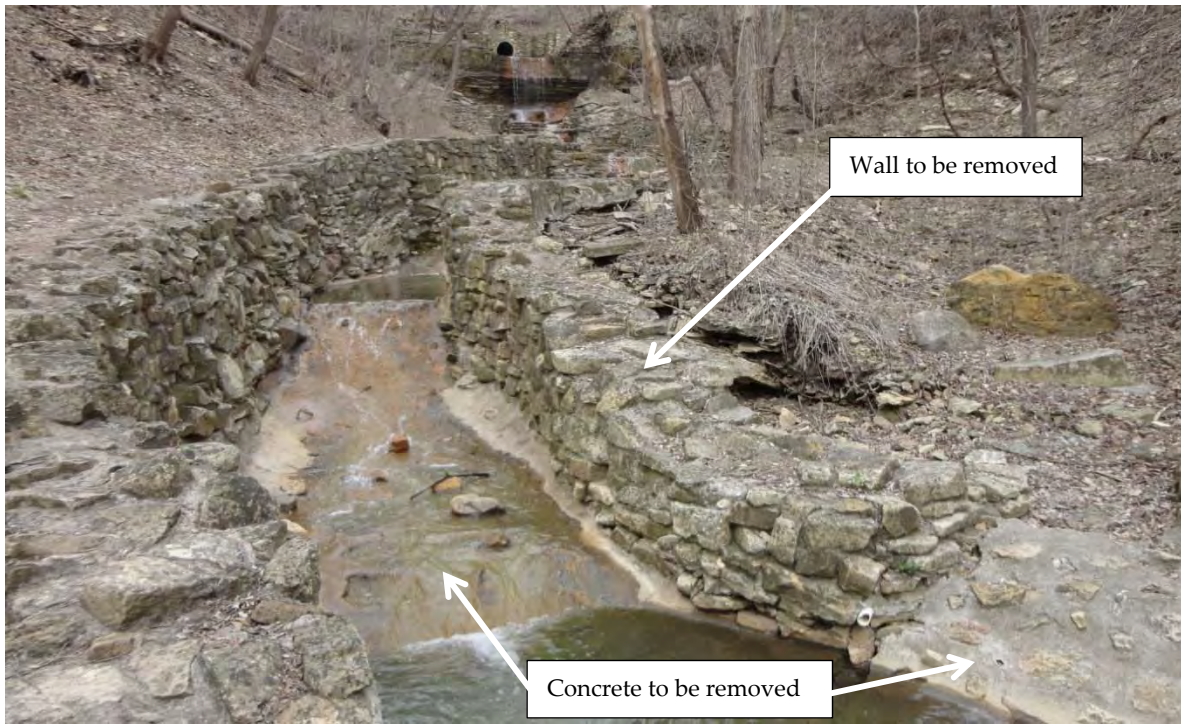
Figure 33 – East wall and concrete lining should be removed in the upper step pool reach.

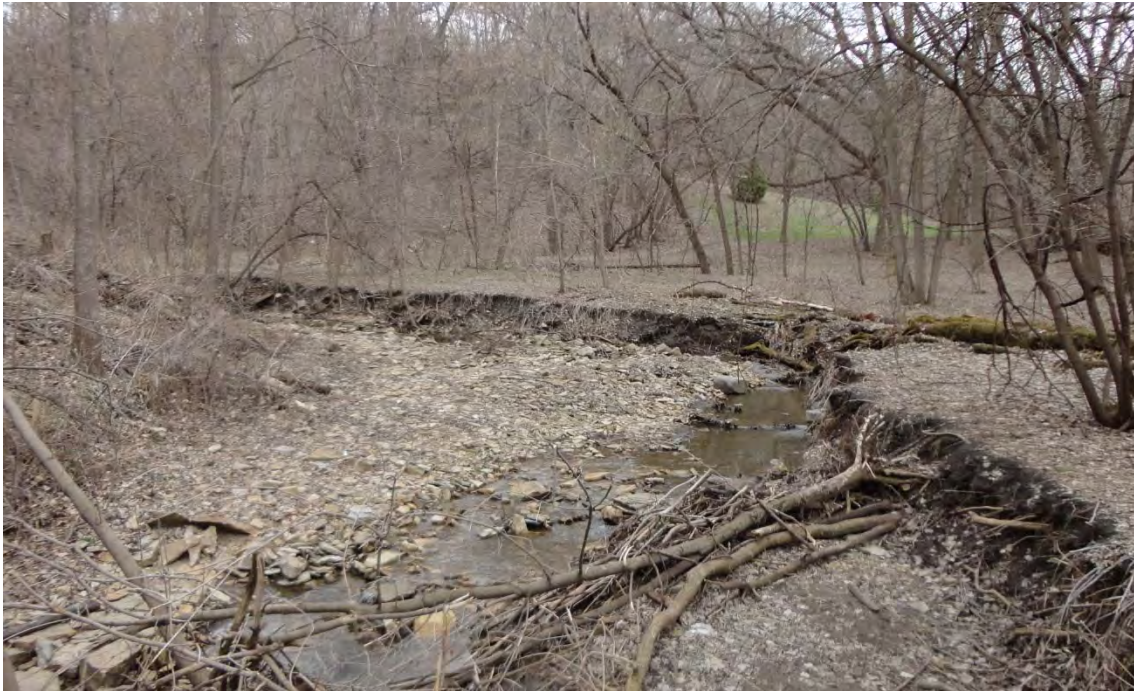
Figure 37: This bend in the stream should be designed as the final drop from the step pool reach into a large pool that is accessible to park users.

The entire concrete chute should be removed and replaced with the same natural step pool form. We propose ending the step pool reach just upstream of the existing bend in the stream, near Station 10+00 (see Concept Drawings, Appendix B and Figure 1). A final step should be designed with a larger drop that creates a small water fall into a pool. This location can be an attractive stream access feature that is visible and audible from the pavilion and can draw people to the creek.

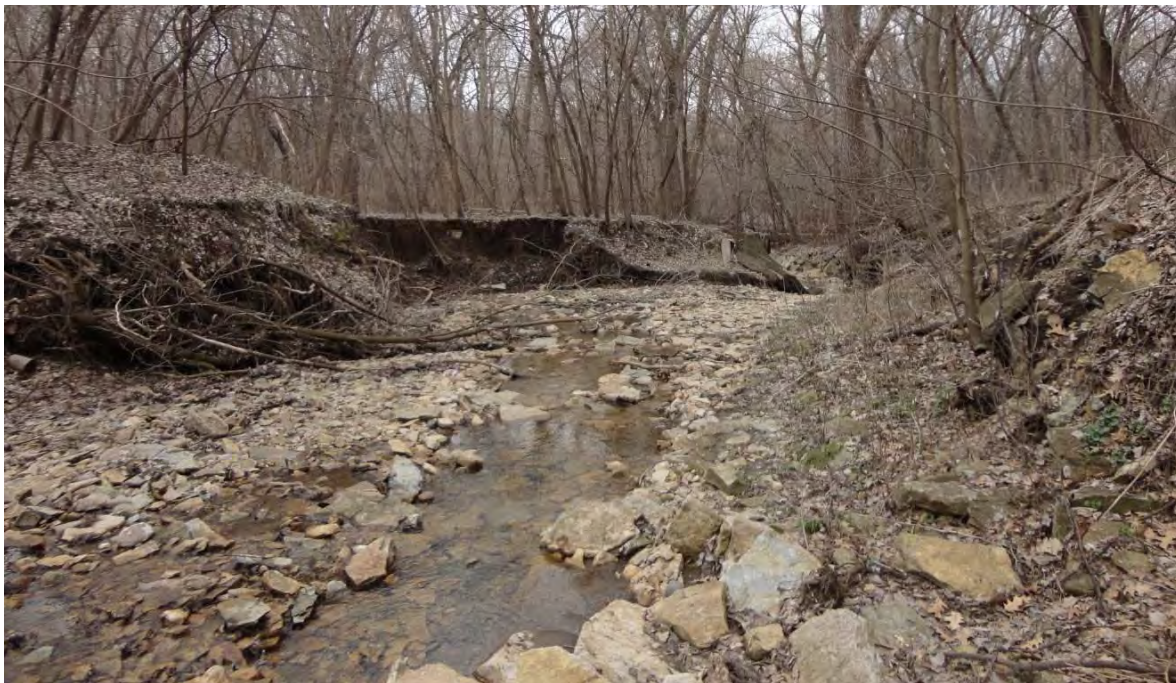
Figure 39: Stable right bank and steep, eroding left bank. Left bank should be graded and stabilized. Channel bed should be reshaped to include a low flow channel and floodplain bench.

To maximize long term sustainability of the stream, we propose leaving the stream in its current alignment through the lower reaches. From the end of the step pool reach to the middle pedestrian bridge, the stream cross section should be modified to improve channel stability and aesthetics. The valley wall on the right side of the stream (looking downstream) contains large quantities of fractured rock that provides adequate stability on that side. Additionally, there are currently no trails on that side of the stream and there is not room for future trails that could be subject to damage by erosion. Therefore, the right bank can remain unchanged. The left bank is very high and steep, and it appears to be actively eroding. The channel is wide. We propose reshaping the stream bed, supplementing with additional stone as necessary to create a low flow channel and floodplain bench. The left bank should be graded back to achieve a maximum slope of 3:1. It should be covered with temporary erosion control fabrics to provide short term stability and planted with native vegetation along the entire slope to provide long term stability.

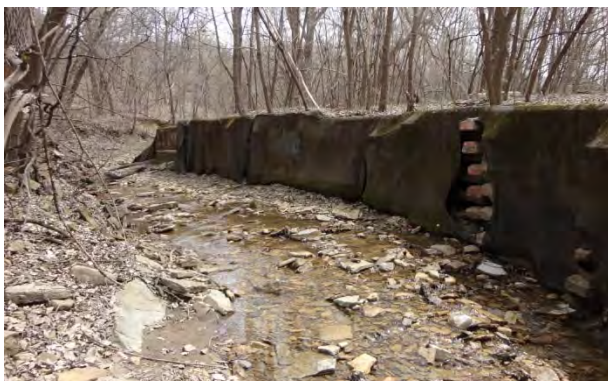
Figure 41: Existing bank armor to be removed.

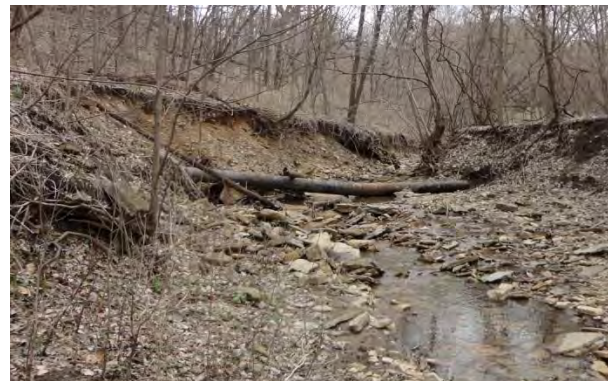
Figure 42: Pipe to be removed.
