### Structural Analysis and Mold Evaluation of 208 Bates

**RE: Executive Summary of Structural Assessment, 208 Bates Avenue**

Re: **208 Bates - Structural Assessment**  
St. Paul, MN  
ERA Commission Number: 2010-096

**Report of:** Phase I Environmental Site Assessment  
208 and 210 Bates Ave., St. Paul, MN 55106  
**Reported to:** City of St. Paul  
Planning & Economic Development, St. Paul, MN 55102

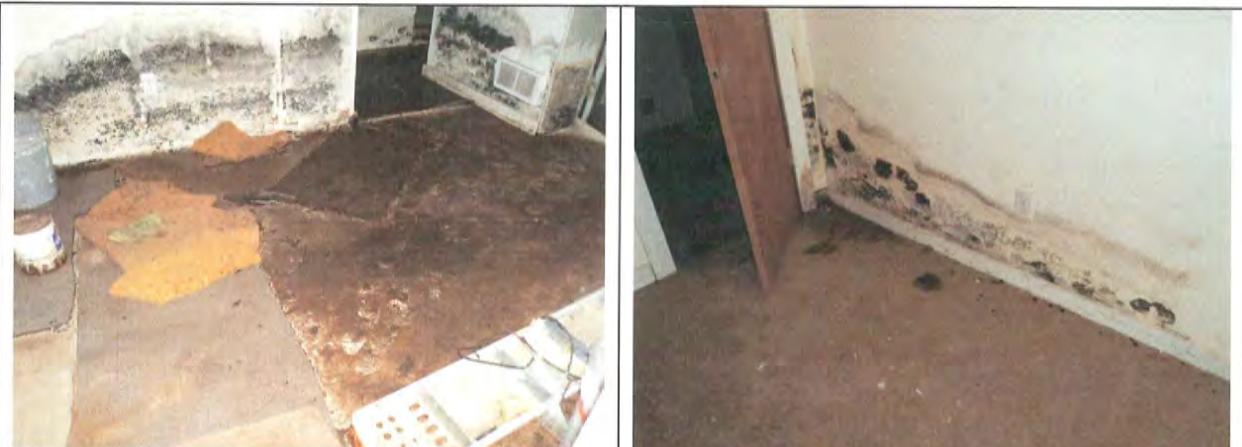
208 First Floor—kitchen: standing water on floors and saturated carpet plus mold were present on the kitchen floor and walls.

208 First Floor—SE-central room: saturated carpet and wet floors were present with mold located on the lower portion of the walls.

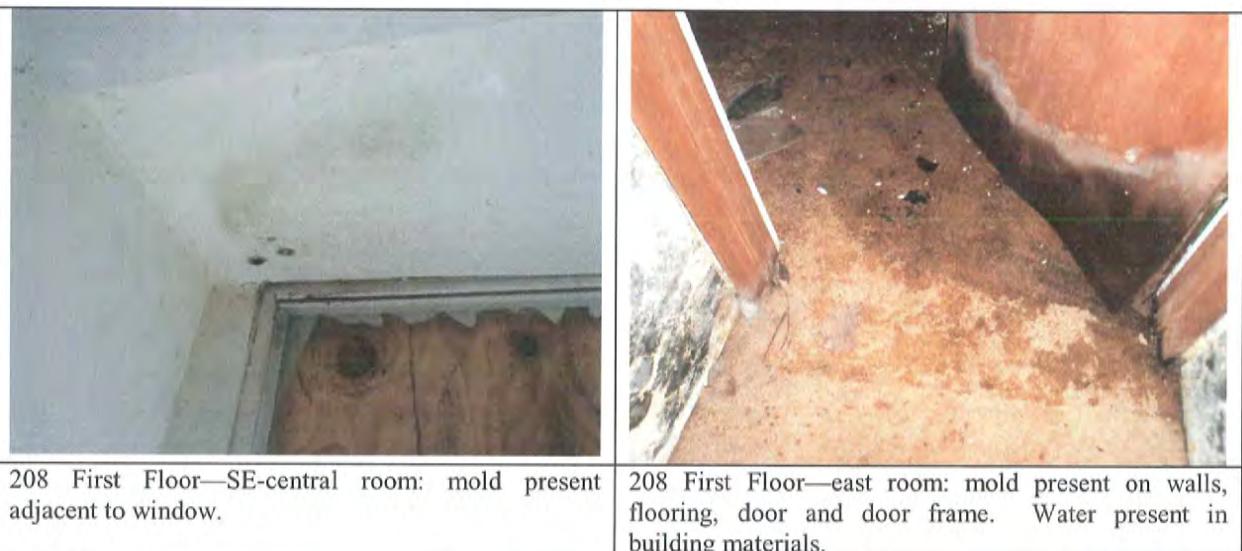
208 First Floor—SE-central room: mold present adjacent to window.

208 First Floor—east room: mold present on walls, flooring, door and door frame. Water present in building materials.

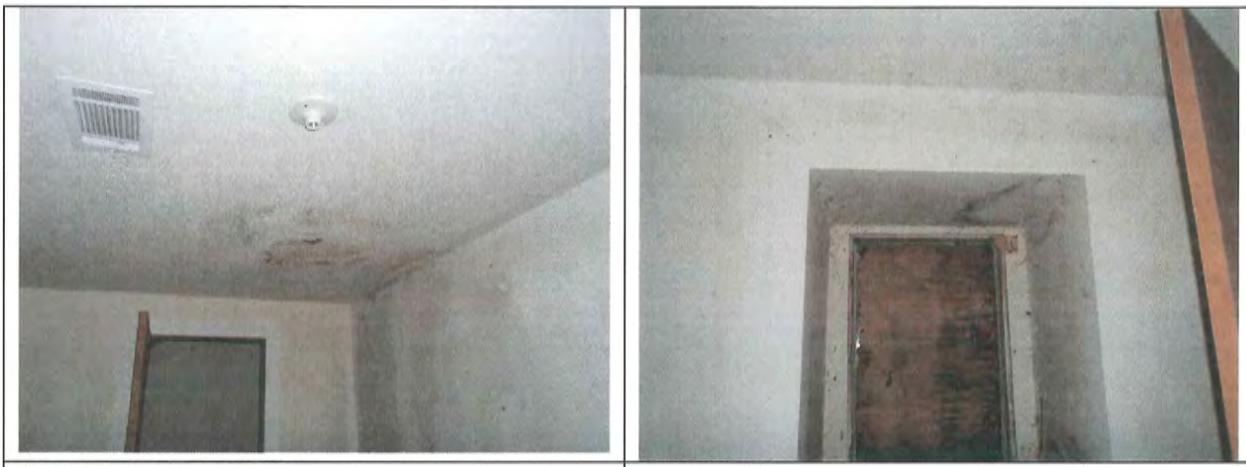
208 First Floor—east room: ceiling and wall mold.

208 First Floor—east room: mold around window area.

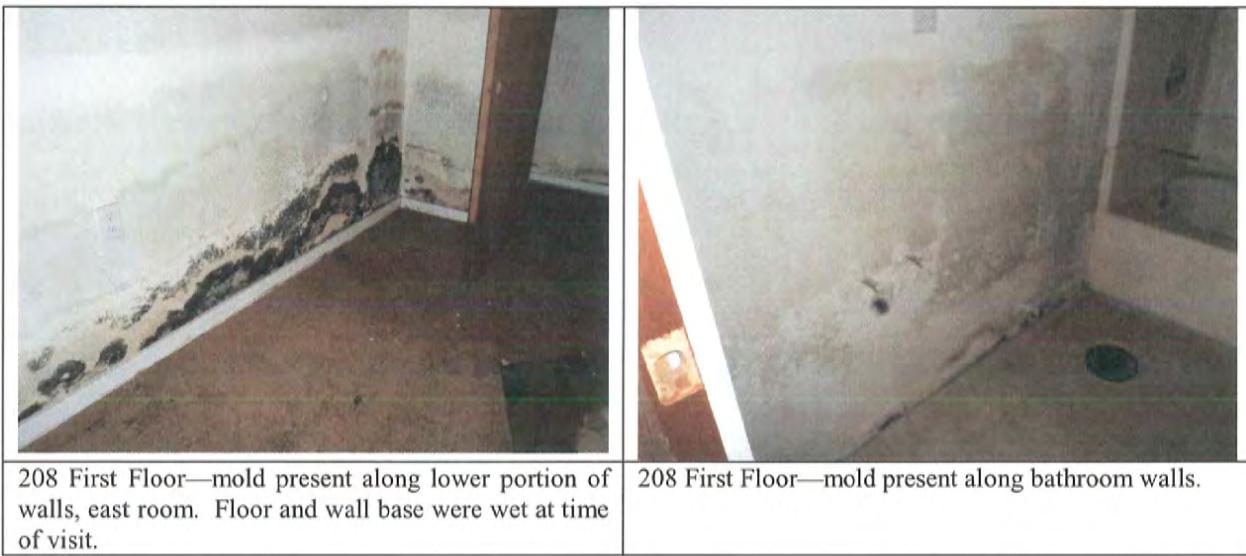
208 First Floor—mold present along lower portion of walls, east room. Floor and wall base were wet at time of visit.

208 First Floor—mold present along bathroom walls.

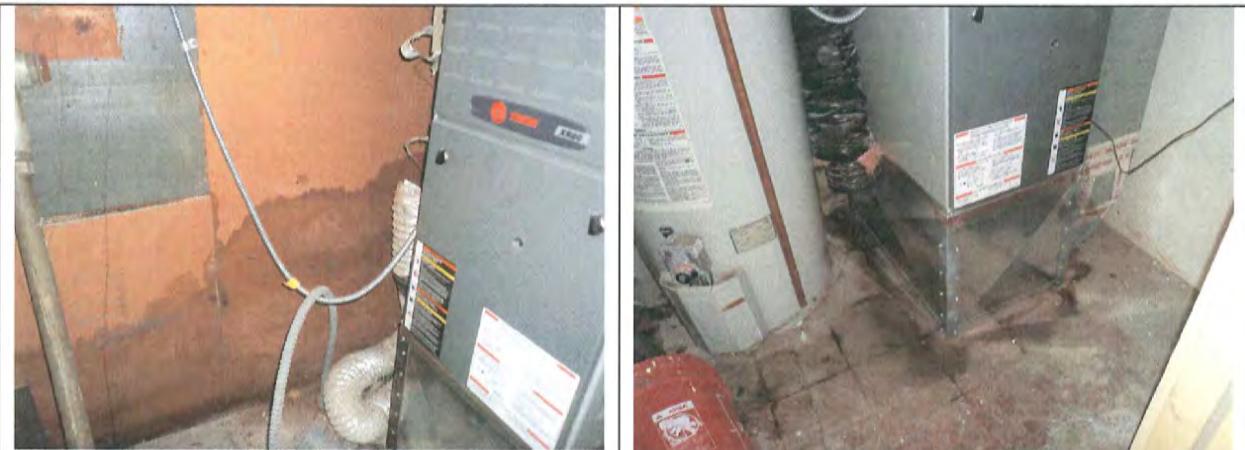
208 First Floor—saturated sheetrock present near furnace in utility room. It was wet at time of visit.

210 First Floor—floor in utility room wet at time of visit.

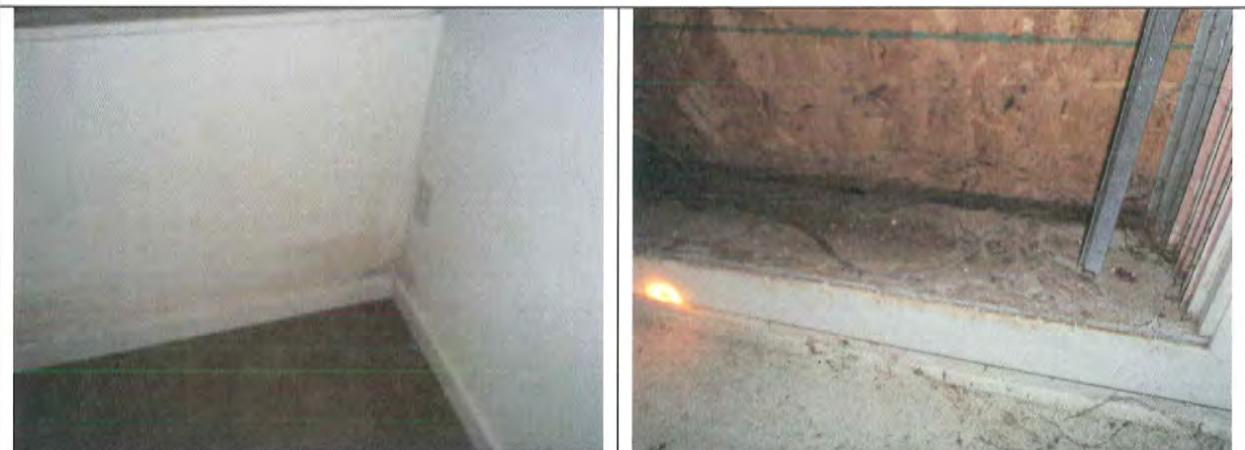
210 First Floor—mold present on the lower portion of the walls in NW-central room.

210 First Floor—NW-central room window well: mold

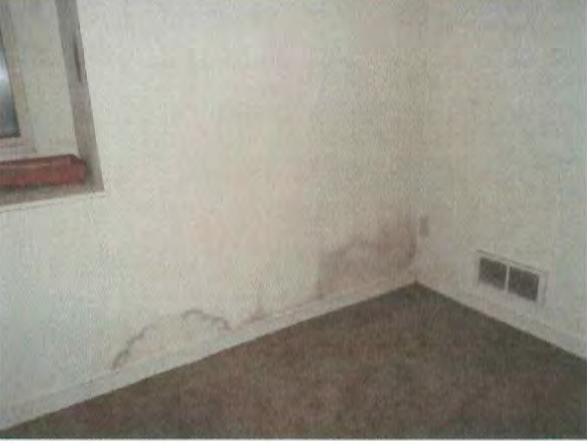
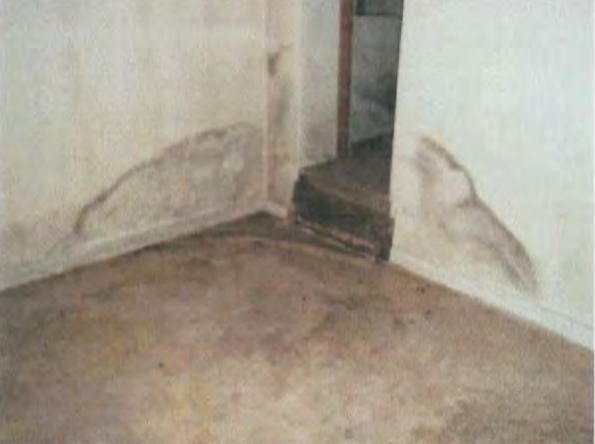
210 First Floor—mold present on the lower portion of the wall NE-central room.	210 First Floor—mold present on the lower and mid portions of the walls in the room off kitchen. Floor was wet at time of visit.

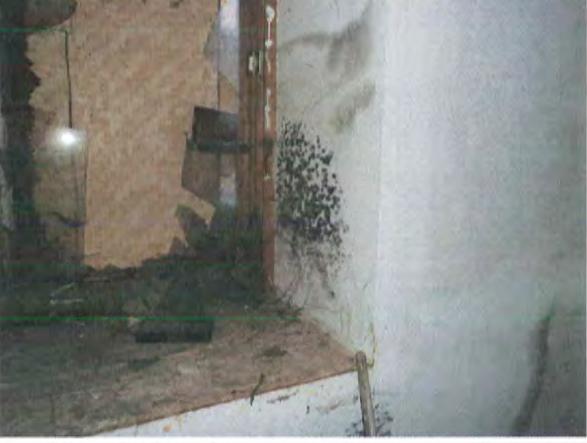
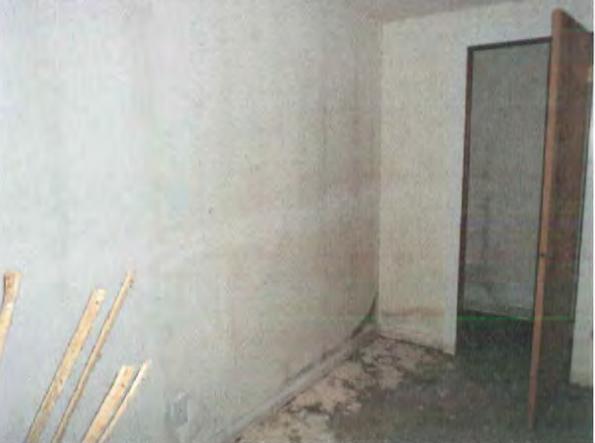
210 First Floor—East room mold present around window.	210 First Floor—East room: mold on walls. Note evidence on walls of wet studs. Floor was wet at time of visit.

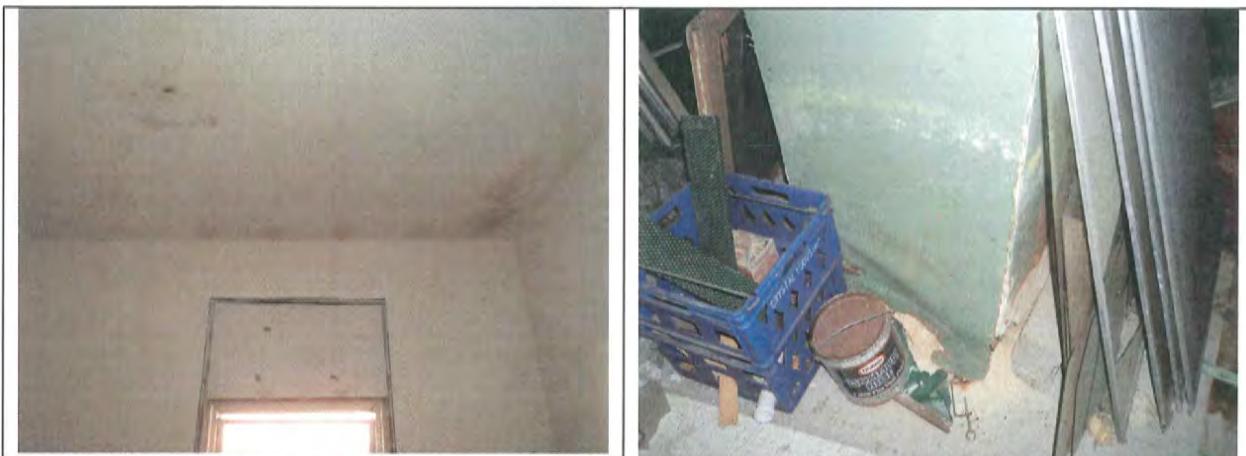
210 2<sup>nd</sup> Floor—NE-central room. Staining and mold present on ceiling.

Basement south side—SW area: water damage to sheetrock.

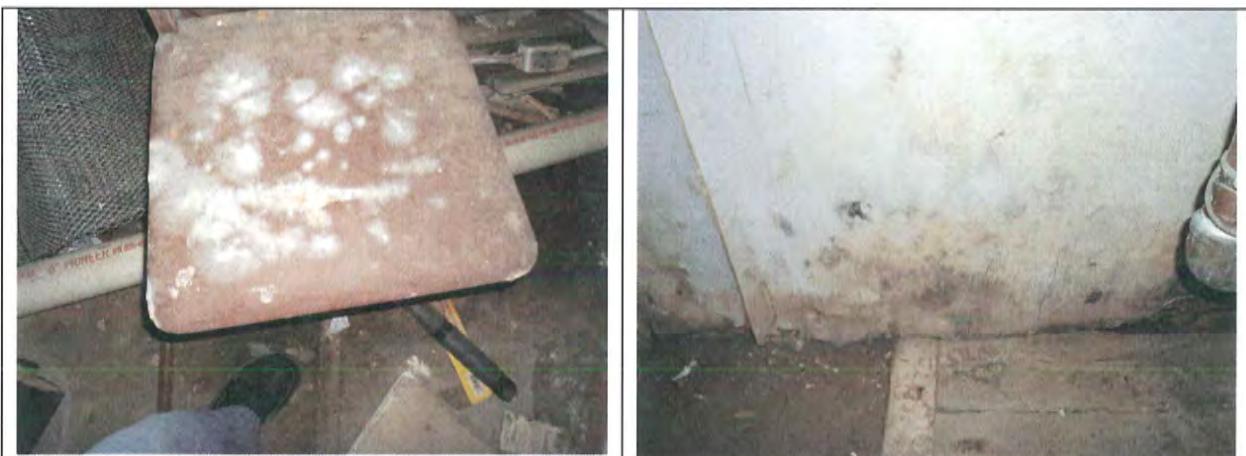
Basement south side—Mold present on table and other materials.

Basement north side—Mold present on the lower and mid portion of the wall as well as water damage to sheetrock.

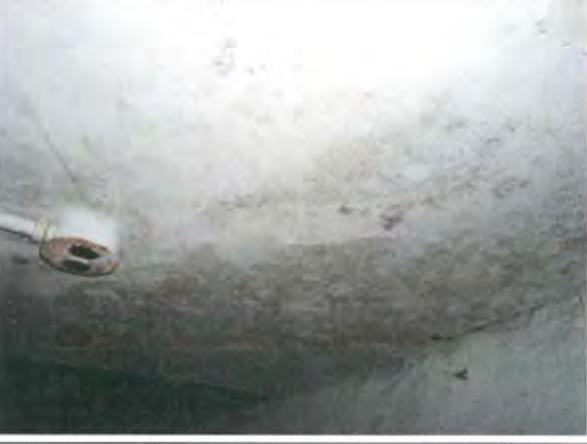
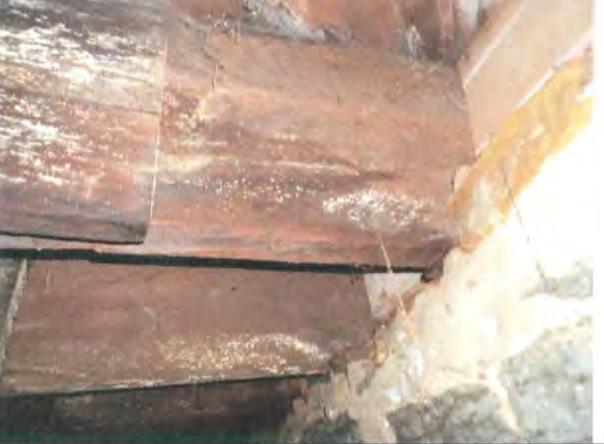
Basement north side—Mold and water damage present on the ceiling sheetrock.	Basement central corridor—mold present on floor joist.

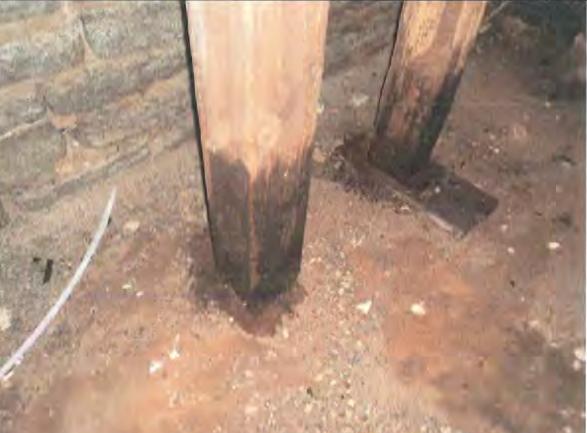
Basement central corridor—water saturated on support beams

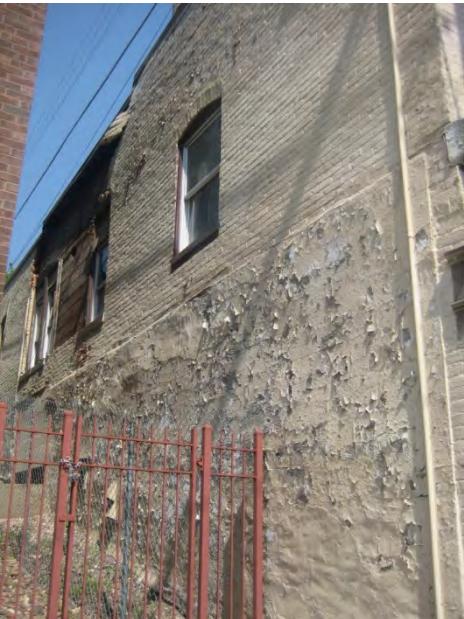
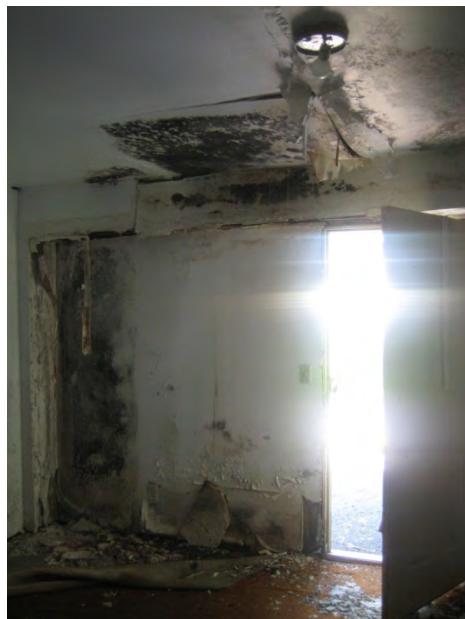
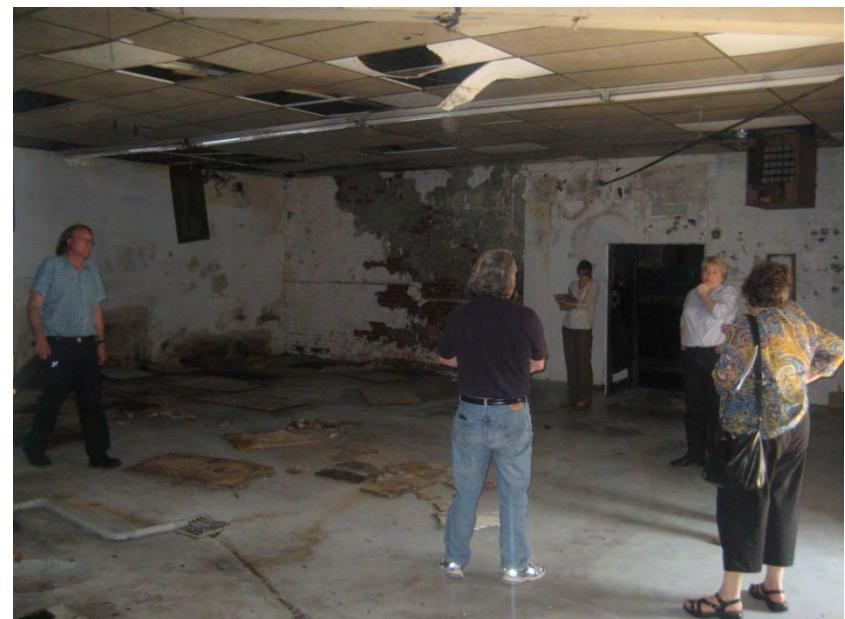
208 Bates East elevation

216 Bates water damage

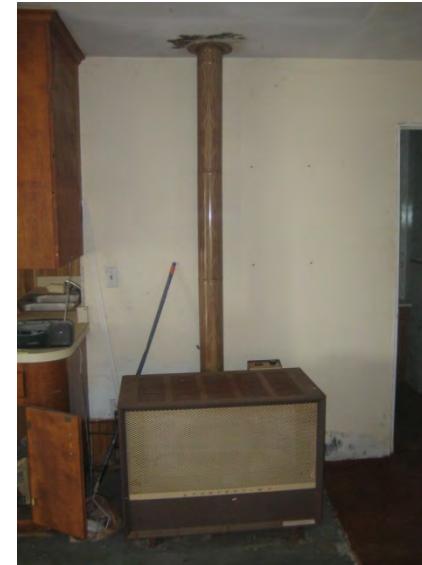
**216 Bates:** current heat pictured to left

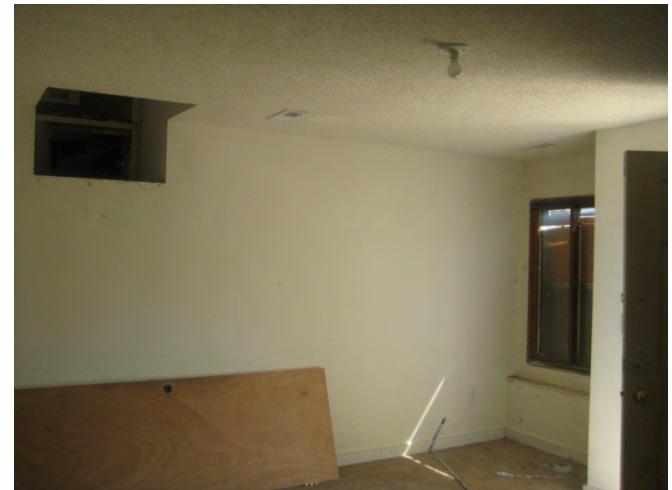
**208 Bates:** interior condition pictured below
