Structural Analysis and Mold Evaluation of 208 Bates

RE: Executive Summary of Structural Assessment, 208 Bates Avenue

Re: 208 Bates – Structural Assessment
St. Paul, MN
ERA Commission Number: 2010-096

**Quadruplex
208 and 210 Bates Avenue
St. Paul, MN 55108**

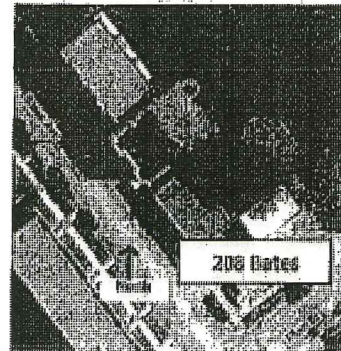
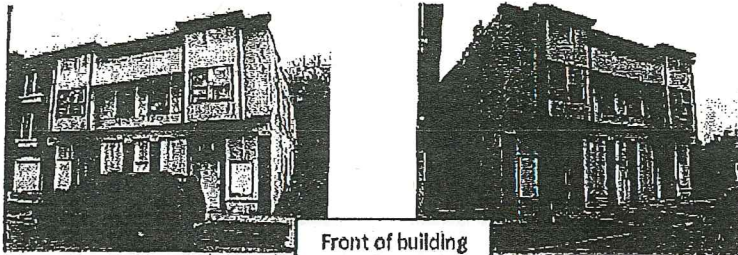
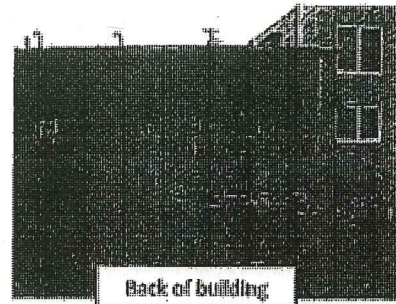
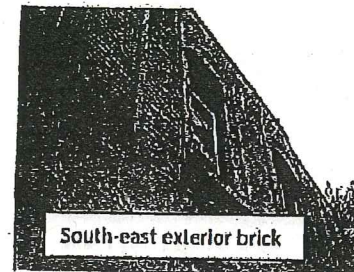
- 1) A large portion of the brick along the north-west wall has fallen off from the wall. The exterior wood sheathing was still in place.
- 2) The south-east wall brick has been secured with wood planks securing the brick from falling off the building.
- 3) Wall sheathing boards were pulled away from the 2x4 wall studs in one location observed.

The existing brick was originally secured to the sheathing with box nails working as ties. Over the years these nails have deteriorated and vanished, thus leaving the brick with no lateral support. Without lateral support, the brick is susceptible to falling from the building, creating a hazardous situation for anyone in the vicinity.

- 1) The brick should be completely removed from the building and a new brick wall should be built with galvanized ties for lateral support to the building structure. Prior to installation of new brick veneer, the exterior wall sheathing boards should be securely fastened to the wall studs.
- 2) Alternatively, a post installed re-securing system for the brick could be used; however, the existing wall sheathing boards would have to be fastened to the existing wall studs from the inside. This would require all interior sheathing on the exterior walls to be completely removed.

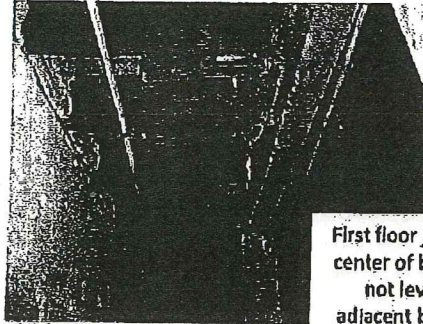
- 1) The floors in each unit are visibly not level. Generally the floors slope down towards the centerline of the building. Upon observation of the basement, it appears that this is due to settlement of the interior bearing walls.

- 2) Interior stairs are sloping from side to side indicating differential settlement at the center bearing walls.
- 3) First floor joists at the centerline of the building are not level due to the settlement of the interior bearing walls.
- 4) Existing floor joists observed in the basement appeared to be in good condition.

First floor joists at center of building not level – adjacent bearing walls have settled

- 1) Improvements to the foundations at the interior walls along with jacking and leveling of the floor and roof structure will be necessary in order to achieve levelness of the floors. The wall sheathing on all walls within the interior of the building will need to be removed in order to do this, otherwise they will crack and work against the jacking effort.
- 2) Without improving the foundations there is no indication that the settlement will stop.

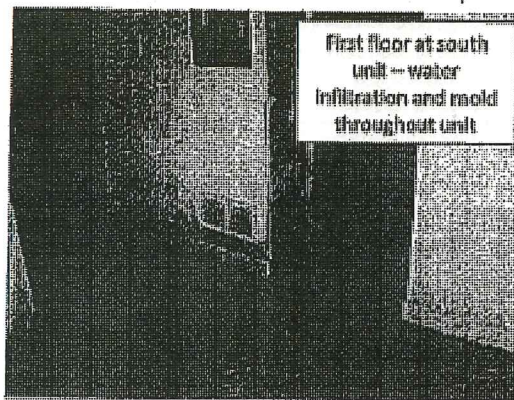
- 1) The walls and ceilings were covered with drywall and painted white, so the structure was not observable. However, it was apparent that there has been moisture in the walls and ceilings. Interior finishes have been damaged by water and mold.
- 2) Most of the windows appeared to have mold around the base of the window.
- 3) The first floor units in the back of the building had large amounts of water damage and mold growing on the walls, ceilings, and floors. Since the back of the building at first floor is below grade, it is likely that ground water is seeping through the wall.
- 4) Some walls are noticeably out of plumb and slightly sagging.

First floor at south unit – water infiltration and mold throughout unit

- 1) If water proofing is applied to the exterior face of the below grade walls, the existing wall may not be adequate to support the additional hydrostatic lateral pressures.
- 2) In order to assess the condition of the bearing walls and the damage that the moisture infiltration has done to the structure, it will be necessary to remove the interior sheathing on the ceilings and walls throughout the building.
- 3) Remove or reinforce any structural framing that has deteriorated due to water damage.

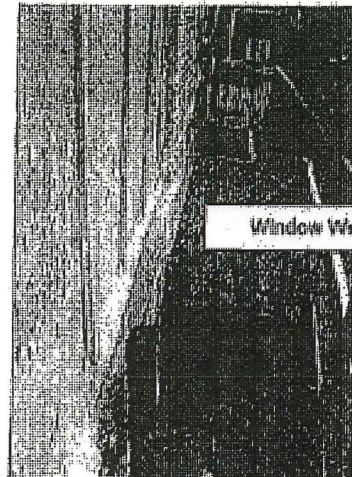
Window Wells

- 1) Window wells have been constructed with plywood and 2x wood framing retaining the earth pressures. This construction is not code compliant.

- 1) Remove and replace non-compliant construction.

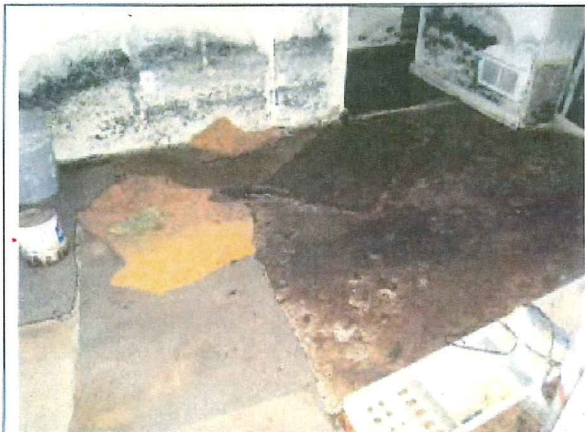
208 First Floor—kitchen: standing water on floors and saturated carpet plus mold were present on the kitchen floor and walls.

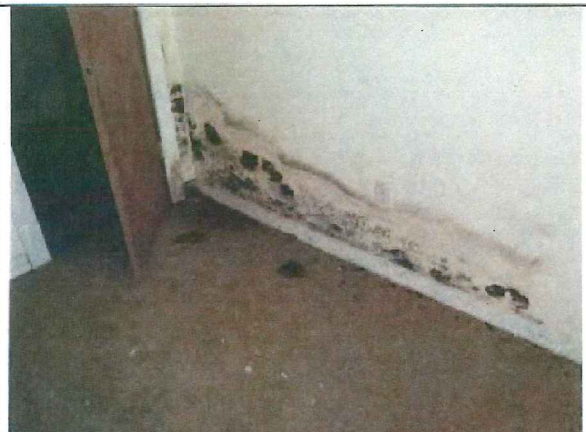
208 First Floor—SE-central room: saturated carpet and wet floors were present with mold located on the lower portion of the walls.

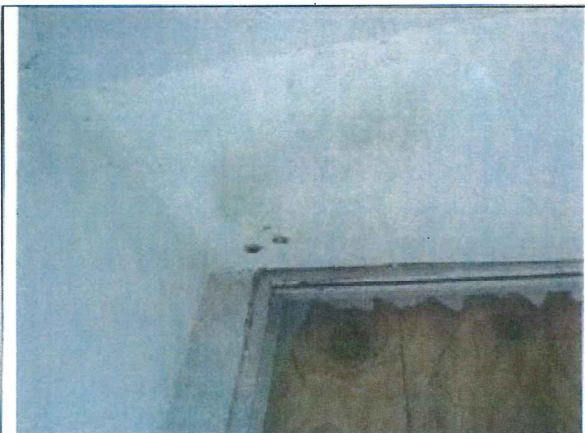
208 First Floor—SE-central room: mold present adjacent to window.

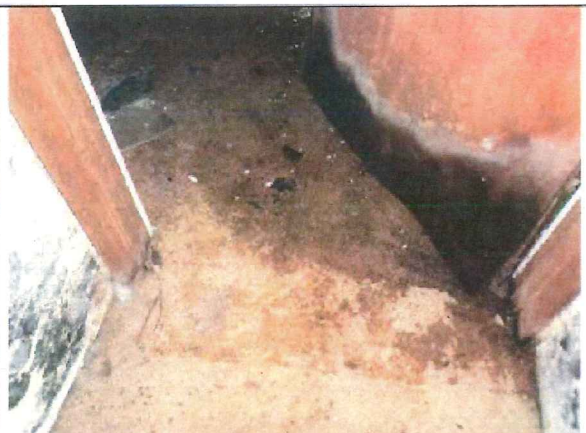
208 First Floor—east room: mold present on walls, flooring, door and door frame. Water present in building materials.

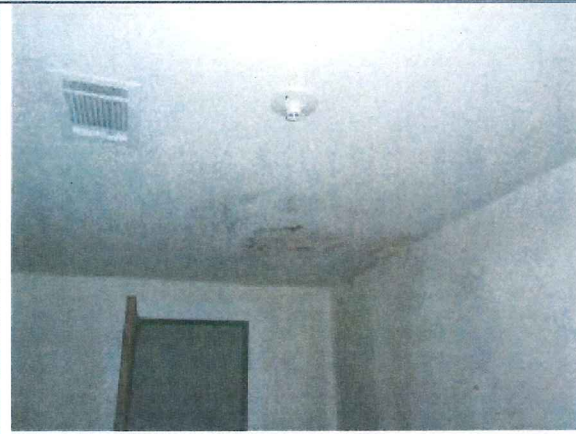
208 First Floor—east room: ceiling and wall mold.

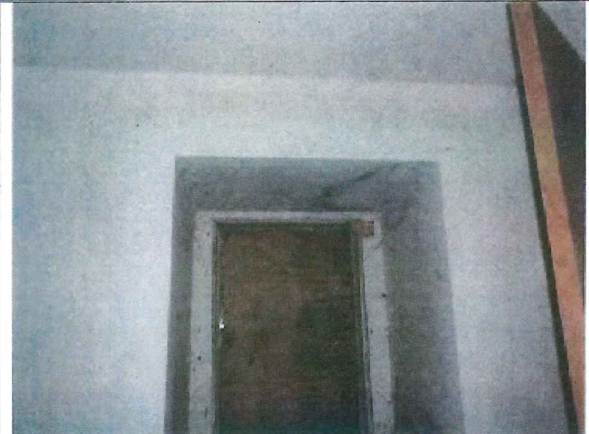
208 First Floor—east room: mold around window area.

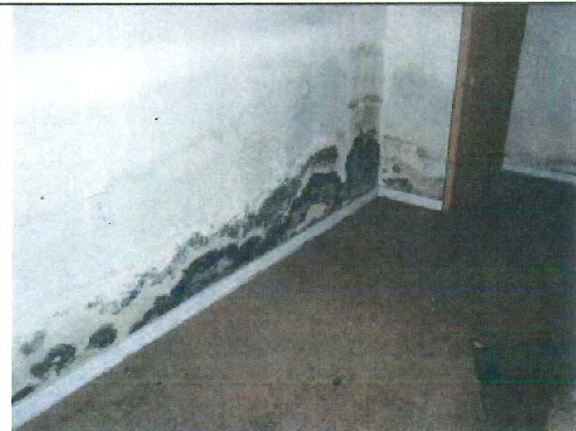
208 First Floor—mold present along lower portion of walls, east room. Floor and wall base were wet at time of visit.

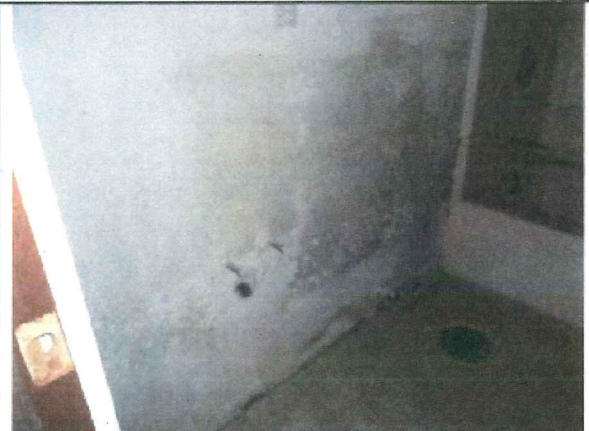
208 First Floor—mold present along bathroom walls.

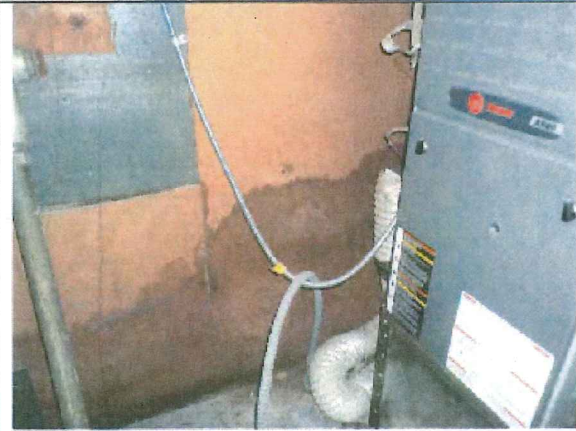
208 First Floor—saturated sheetrock present near furnace in utility room. It was wet at time of visit.

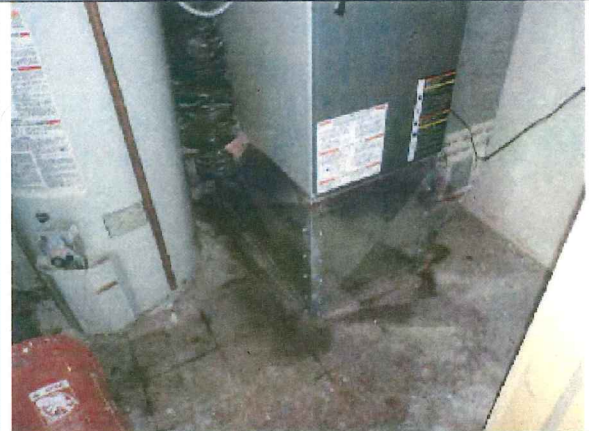
210 First Floor—floor in utility room wet at time of visit.

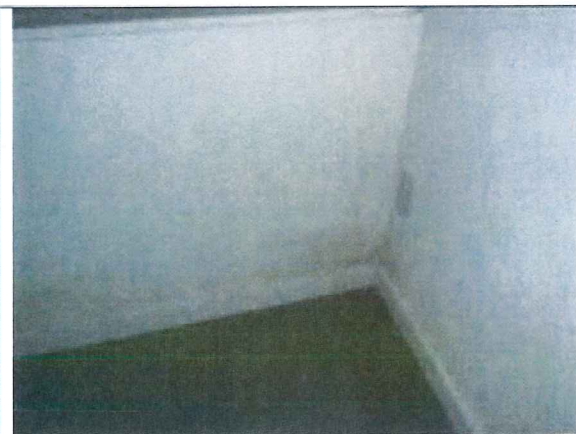
210 First Floor—mold present on the lower portion of the walls in NW-central room.

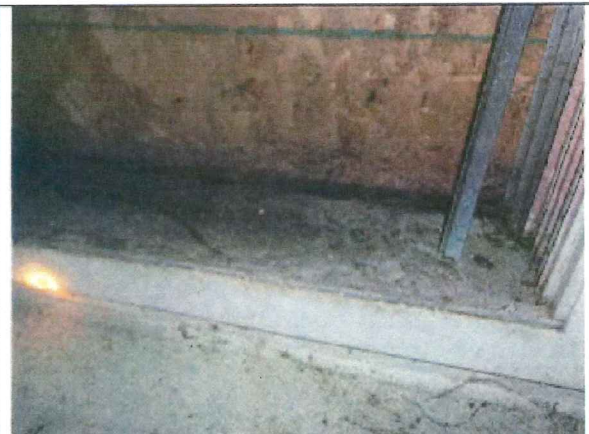
210 First Floor—NW-central room window well: mold

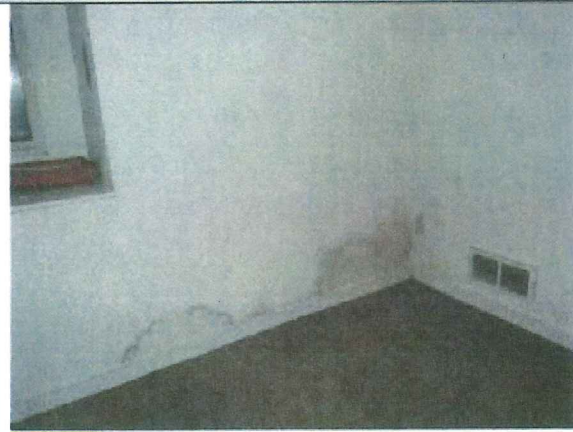
210 First Floor—mold present on the lower portion of the wall NE-central room.

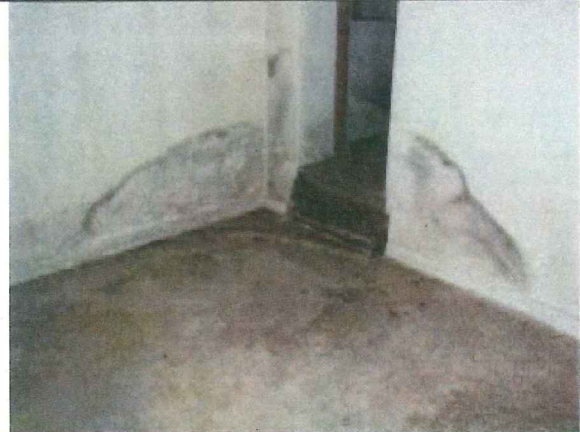
210 First Floor—mold present on the lower and mid portions of the walls in the room off kitchen. Floor was wet at time of visit.

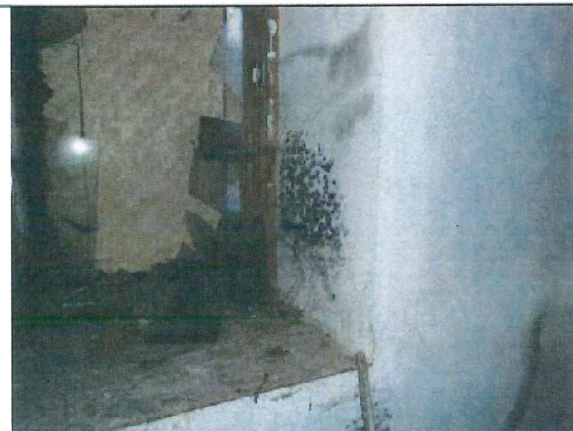
210 First Floor—East room mold present around window.

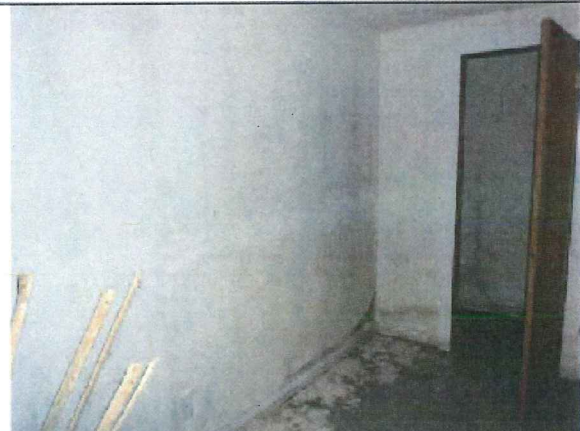
210 First Floor—East room: mold on walls. Note evidence on walls of wet studs. Floor was wet at time of visit.

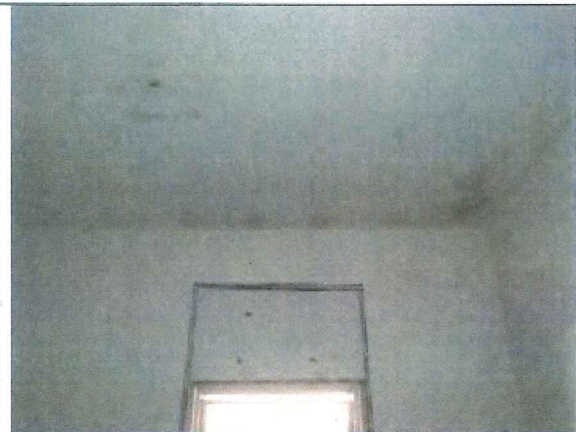
210 2nd Floor—NE-central room. Staining and mold present on ceiling.

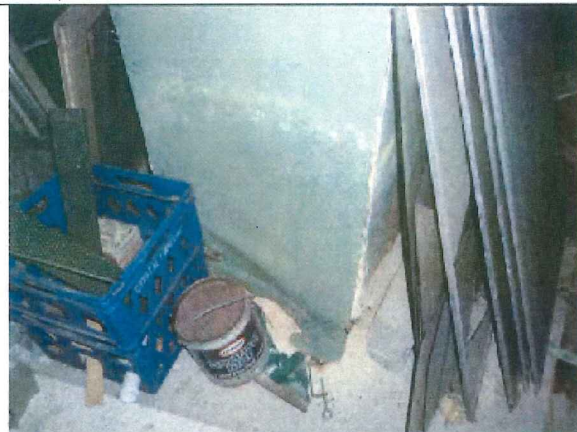
Basement south side—SW area: water damage to sheetrock.

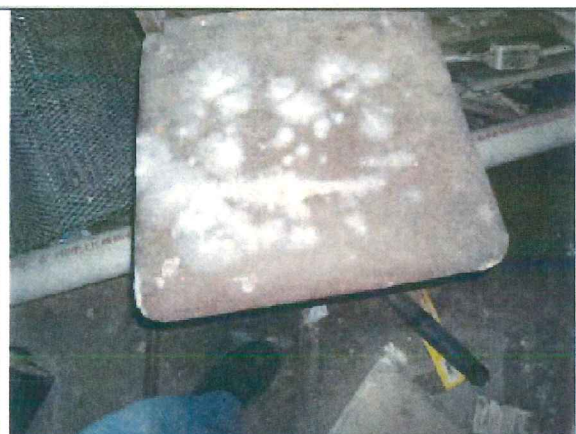
Basement south side—Mold present on table and other materials.

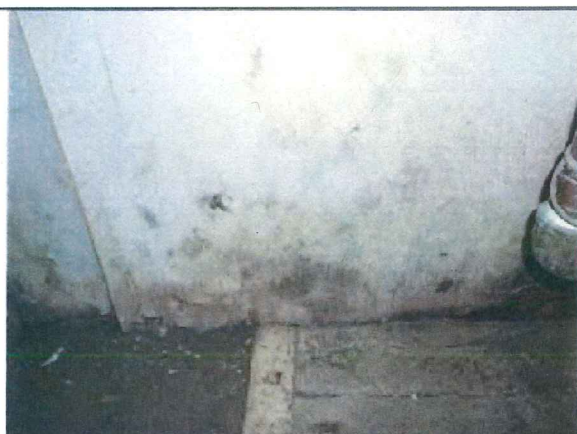
Basement north side—Mold present on the lower and mid portion of the wall as well as water damage to sheetrock.

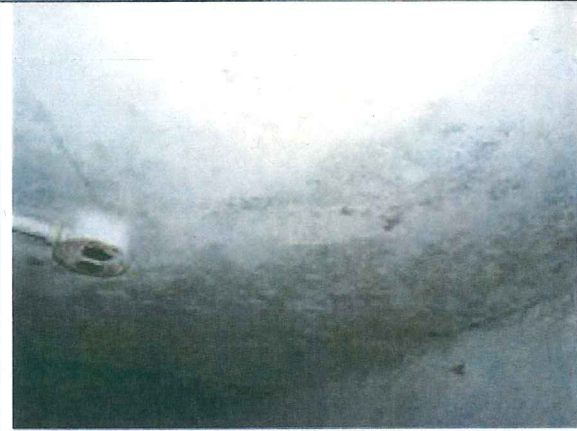
Basement north side—Mold and water damage present on the ceiling sheetrock.

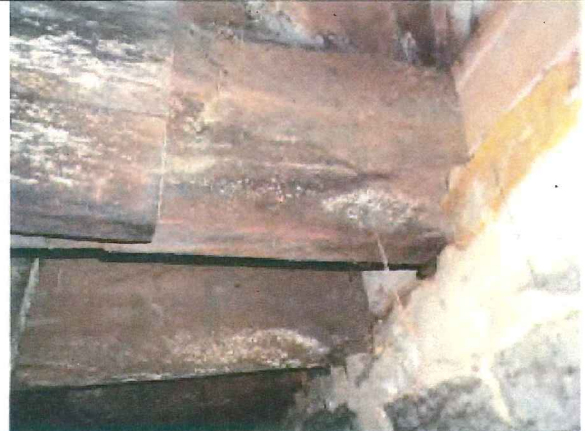
Basement central corridor—mold present on floor joist.

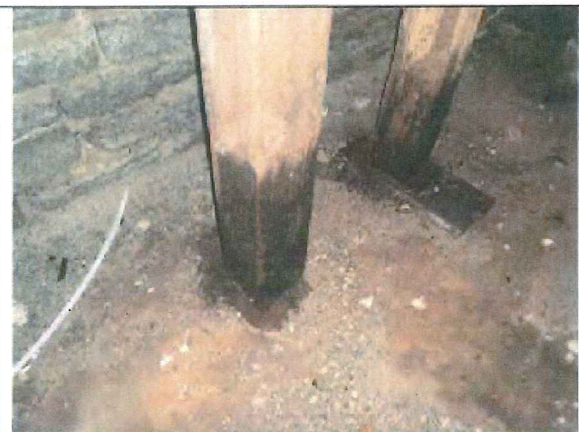
Basement central corridor—water saturated on support beams
