CITY OF SAINT PAUL HERITAGE PRESERVATION COMMISSION STAFF REPORT

FILE NAME: 1082 Summit Avenue

HPC SITE/DISTRICT: Summit Avenue West Heritage Preservation District

CLASSIFICATION: Demolition & building permit

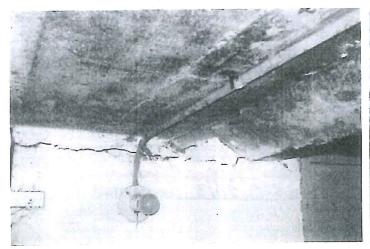
The concrete slab has experienced considerable spalling and deterioration. (See Pictures # 3, 4 & 6) The reinforcing has corroded badly in several locations. (See Picture # 3) The two steel beams have corroded badly also. (See Picture # 4) The steel posts also have extensive corrosion.

(3) CORRODED REBAR

(4) CORPORED STEEL BEAM
