**CITY OF SAINT PAUL
HERITAGE PRESERVATION COMMISSION STAFF REPORT**

FILE NAME: 275 Bates Avenue – Louis Hansen House and Bakery

CLASSIFICATION: Demolition Permit

Project No.: 15536.00
Re: Structural Condition Review of the building at 275 Bates Ave.

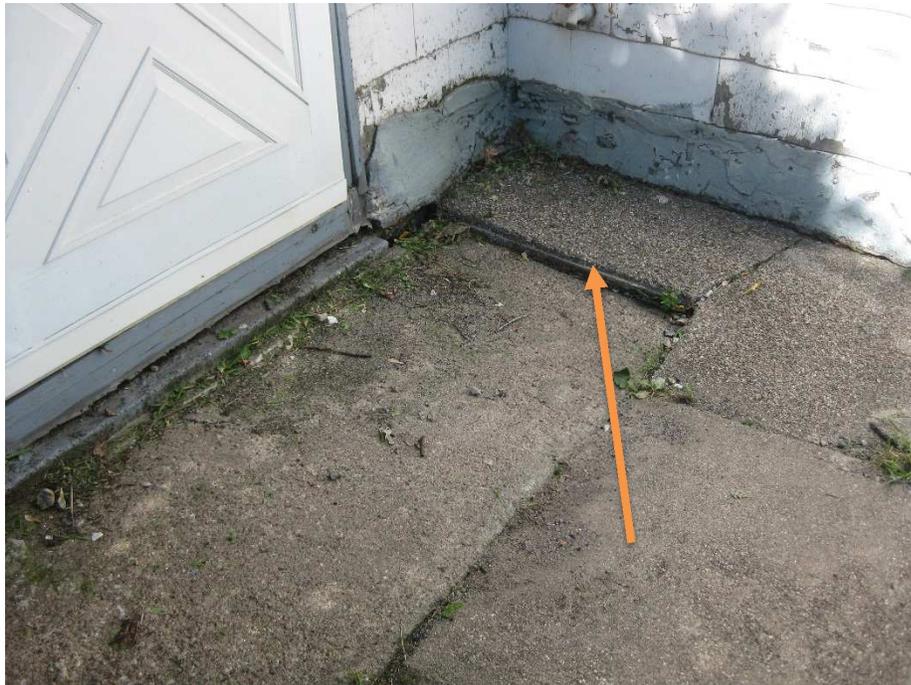
The front porch slab that is assumed to rest directly on grade has settled approximately 1". Picture 1 shows the displacement of a slab joint. The most likely cause of this settlement is water intrusion of the soil below the slab. Picture 2 shows the same slab from a different angle. Runoff along the foundation walls will continue to cause deterioration and may result in freeze thaw damage.

Picture 1 – Front Slab Settlement

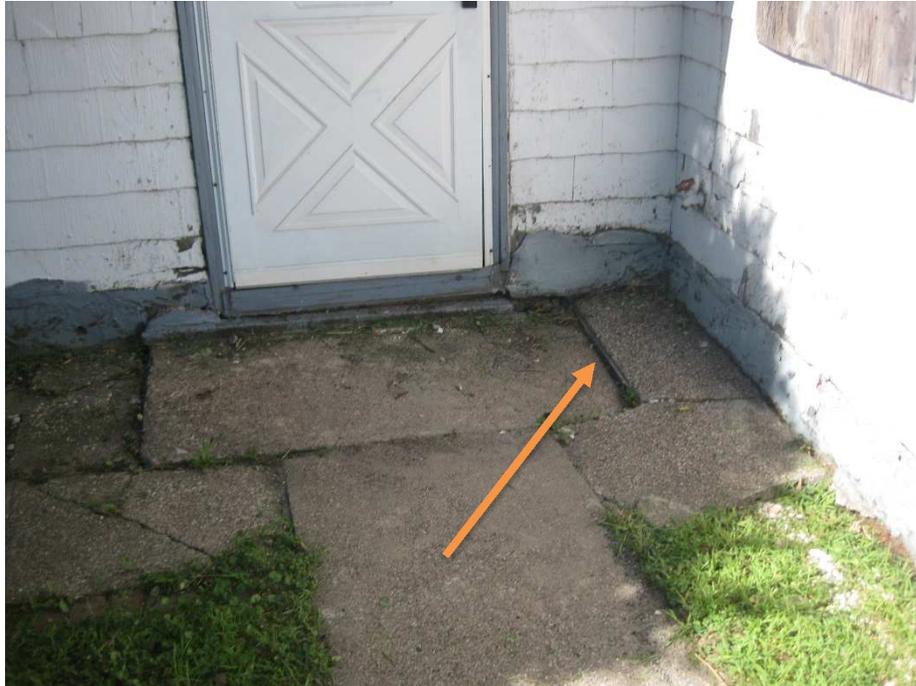
Picture 2 – Front Slab Settlement

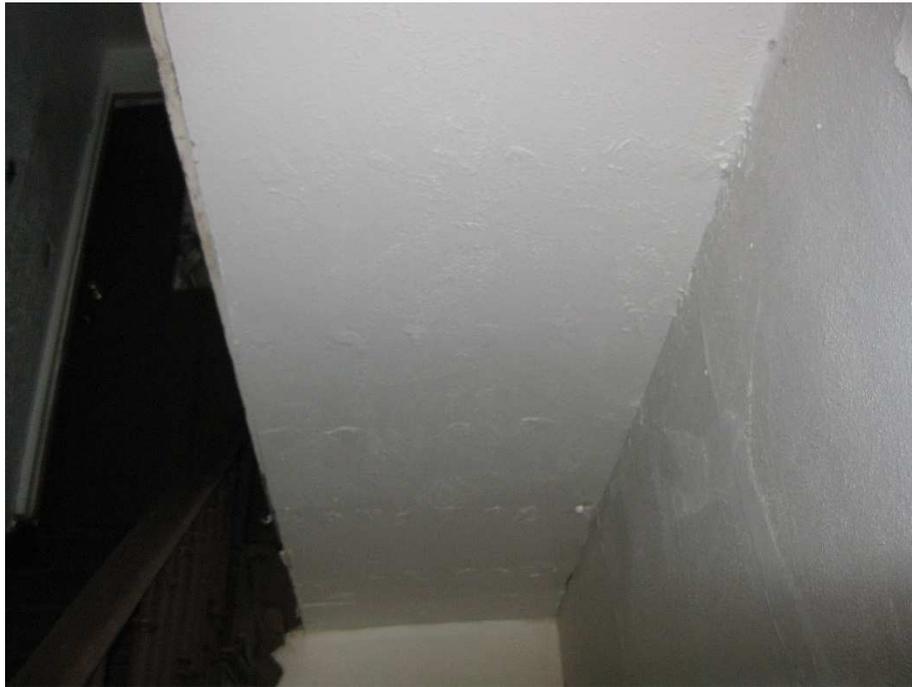
Some of the floors of the building were observed to slope. Picture 3 shows the underside of a floor that has sloped and Picture 4 shows a gap that was created from the movement that caused the floor to slope.

Picture 3 – Underside of Uneven Floor

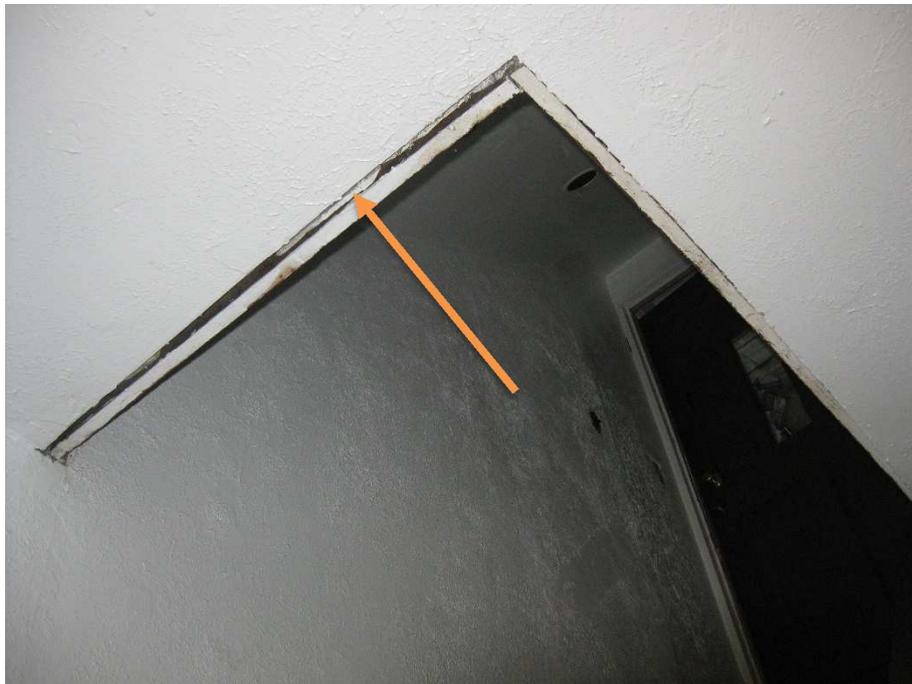
Picture 4 – Gap Due to Sloping

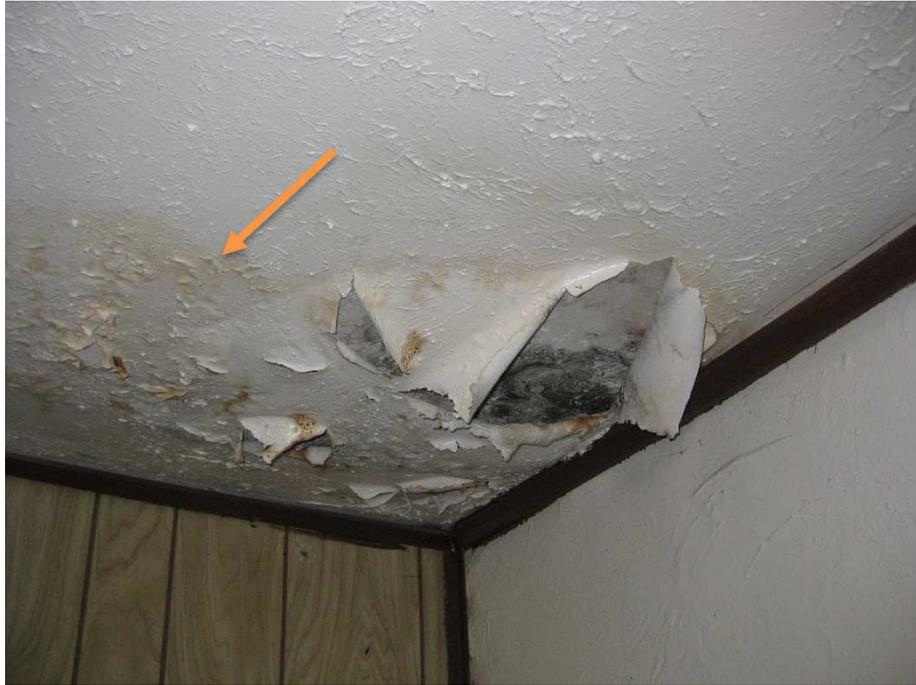
Water damage was observed throughout the building. The ceiling of the second floor was observed to have water stains along with mold and peeling paint. Picture 5 shows the damage of the water to the ceiling of the second floor. Directly above the damaged area is the roof. It is likely that there is damage to the roof which is allowing water to enter the home. We were unable to observe the roof in its entirety. Picture 6 shows the underside of a ceiling system that is rotting. This is likely due to water infiltration and can be assumed to be found throughout the house. Wood rot was also found in the basement. Many of the joists had rot at each of its ends, where it connected to the foundation walls and where it connected to the center beam.

Picture 5 – Water Damage on Second Floor Ceiling

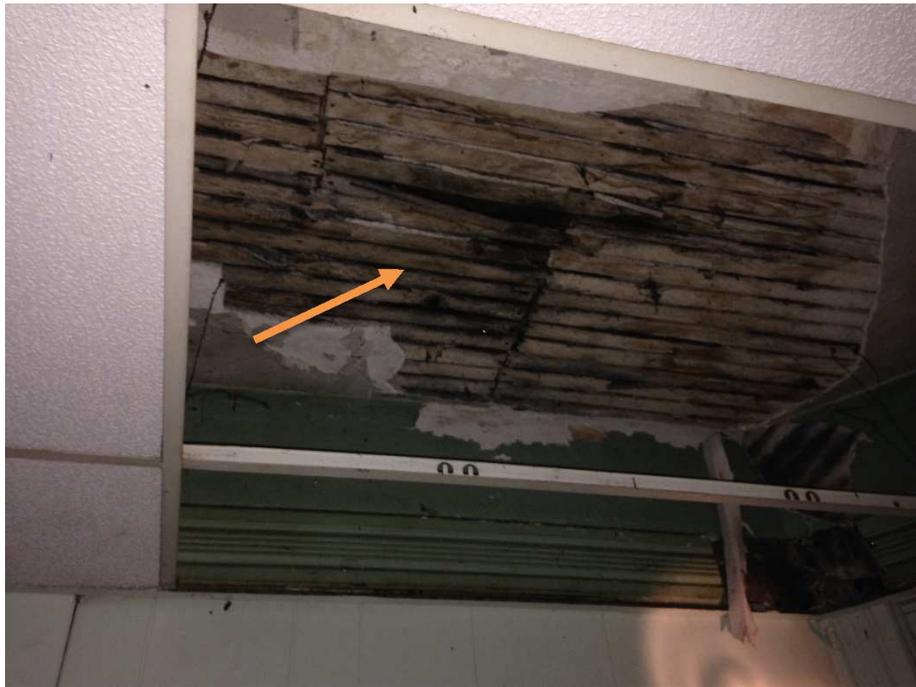
Picture 6 – Deterioration of Ceiling System

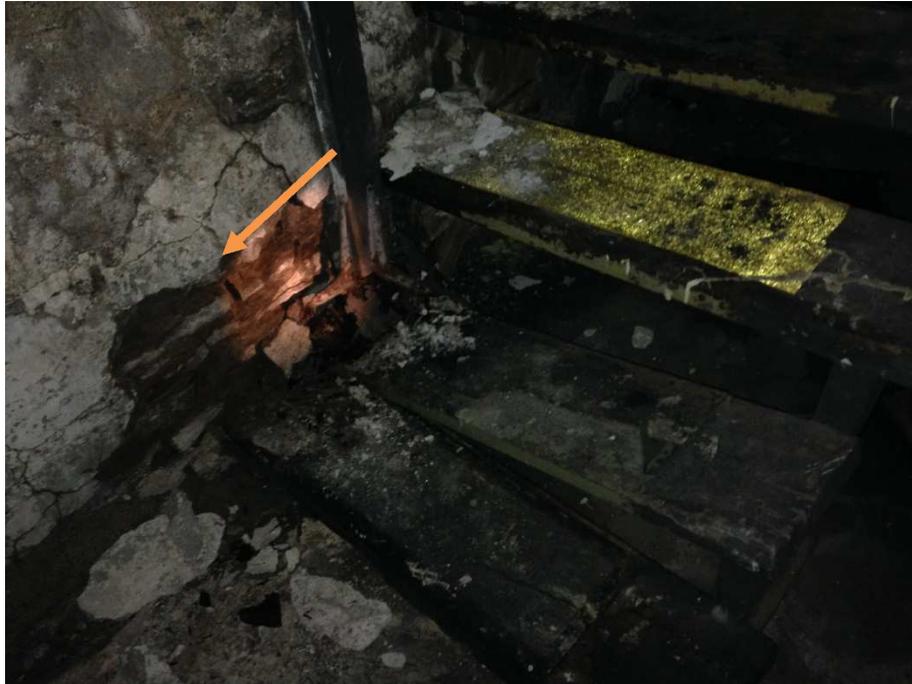
The foundation walls were observed to be crumbling, cracking, and bulging from inside the basement. Pictures 7 and 8 show portions of the walls that are deteriorating. In the basement there are a number of shoring columns that are holding up the beams of the first floor. The shoring columns are rusted and some of them are bent. Picture 9 shows two such shoring columns.

Picture 7 – Crumbling and Cracking of Foundation Walls

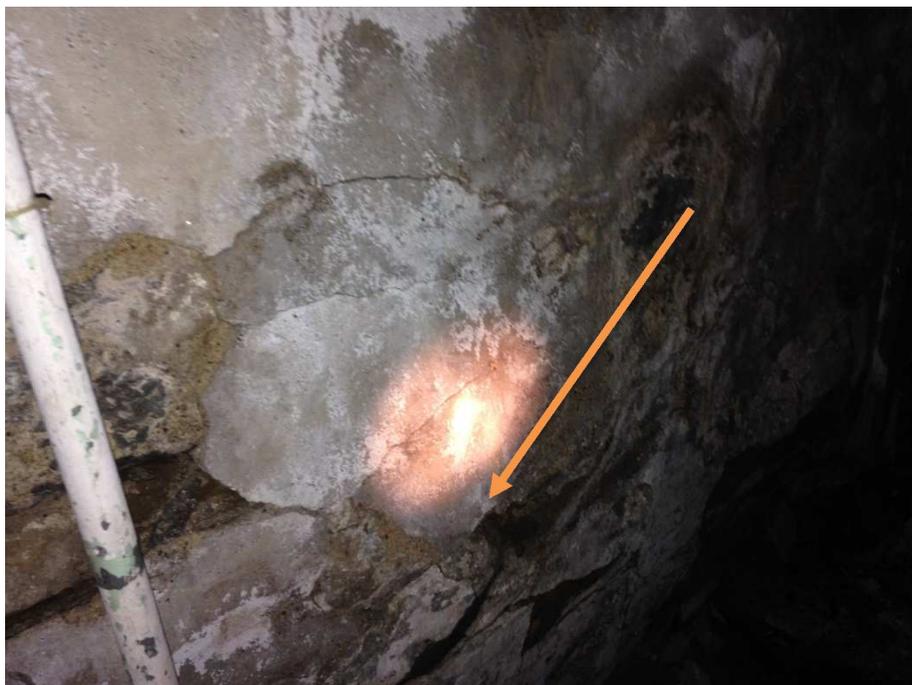
Picture 8 – Crumbling and Cracking of Foundation Walls

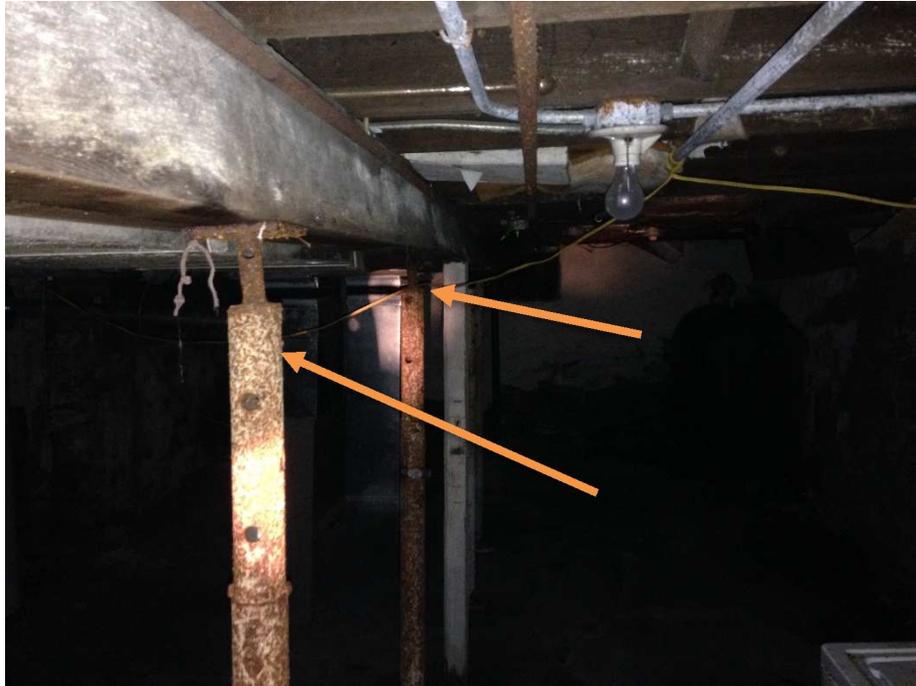
Picture 9 – Shoring Columns Supporting a Beam

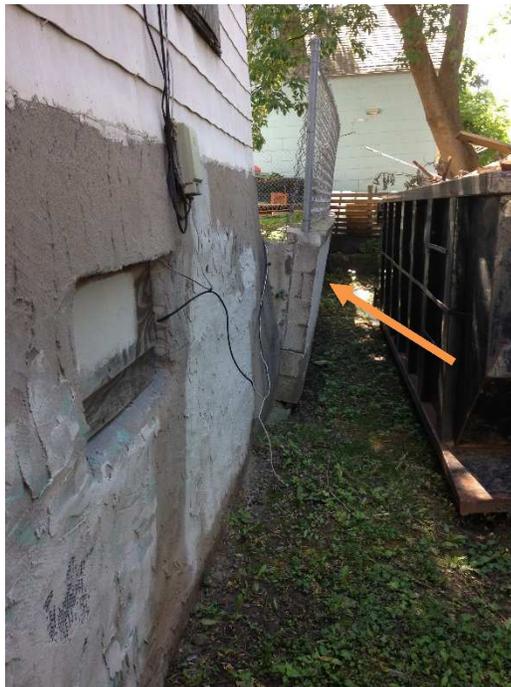
We observed the retaining wall at the exterior of the house to be out of plumb. The wall itself is sturdy, as evidenced by the lack of cracking or breaking, but its foundation has rotated. Pictures 10 and 11 show the wall out of plumb.

Picture 10 – Retaining Wall Out of Plumb

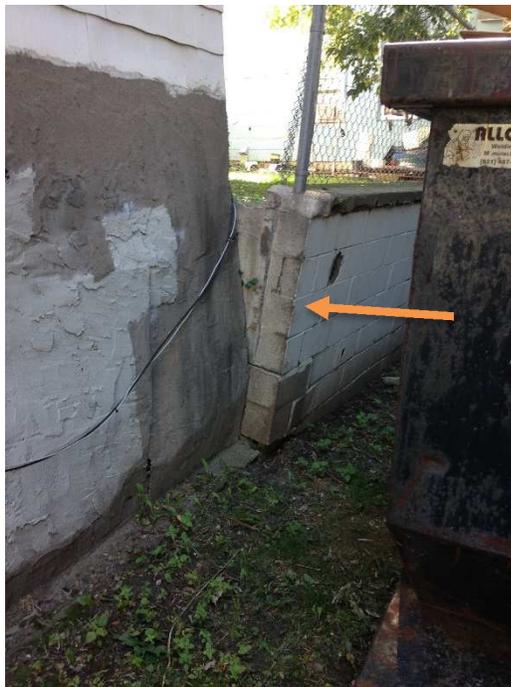
Picture 11 – Retaining Wall Out of Plumb

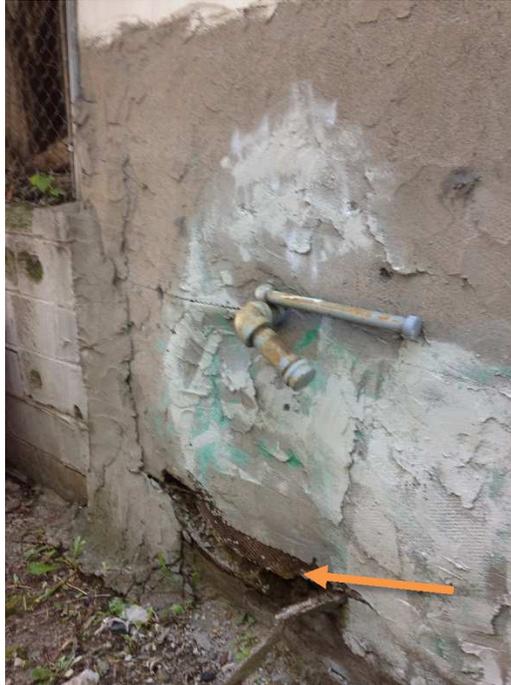
The stucco on the exterior of the house was observed to be deteriorating. Although the stucco is not critical to the structural integrity of the building, the crumbling stucco suggests that water deterioration and/or movement has occurred in the foundation. Picture 12 shows the deterioration of the stucco and Picture 13 shows the stucco bulging, likely due to water. The stucco was observed to be deteriorating in multiple places along the exterior of the house.

Picture 12 – Stucco Deterioration

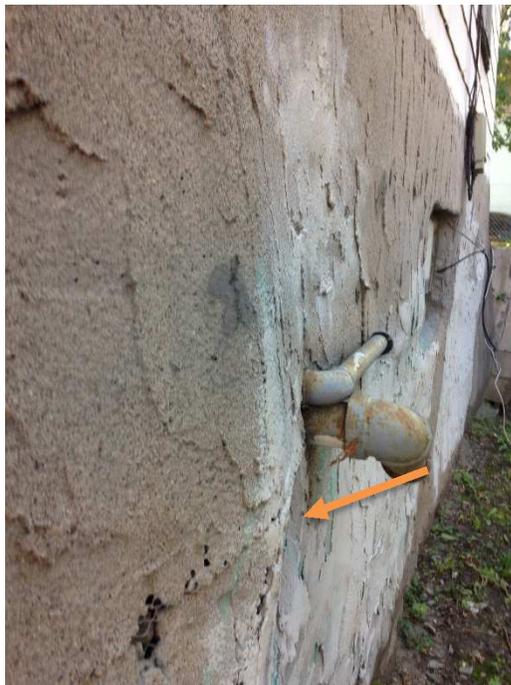
Picture 13 – Stucco Bulging Out

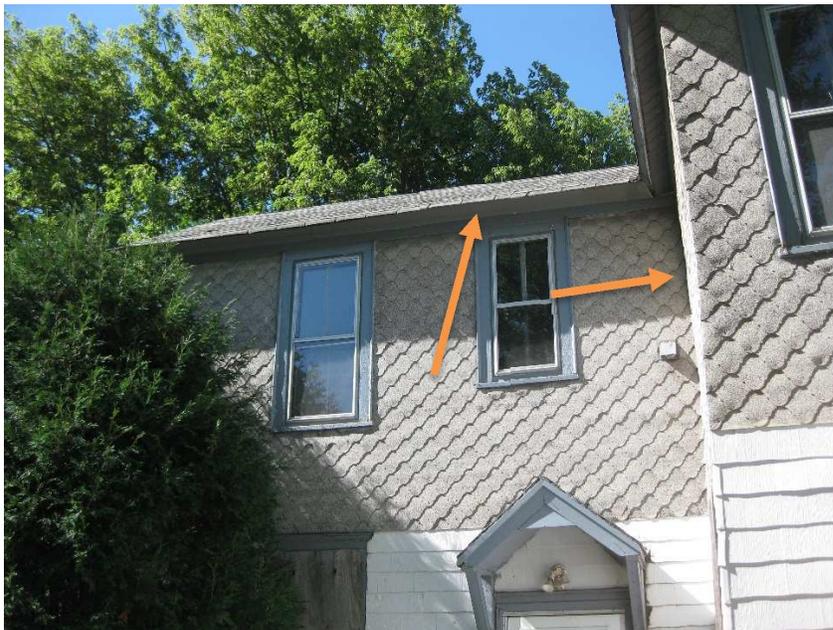
The roof and exterior walls, as observed from the outside, appeared to be in good condition. The roof was flat and there were no obvious problems. The exterior walls appeared to be plumb. Picture 14 shows one such roof and wall.

Picture 14 – House Roof and Exterior Wall
