**CITY OF SAINT PAUL  
HERITAGE PRESERVATION COMMISSION STAFF REPORT**

FILE NAME: 737 Plum Street

Project No.: 15537.00  
Re: Structural Condition Review of the building at 737 Plum St.

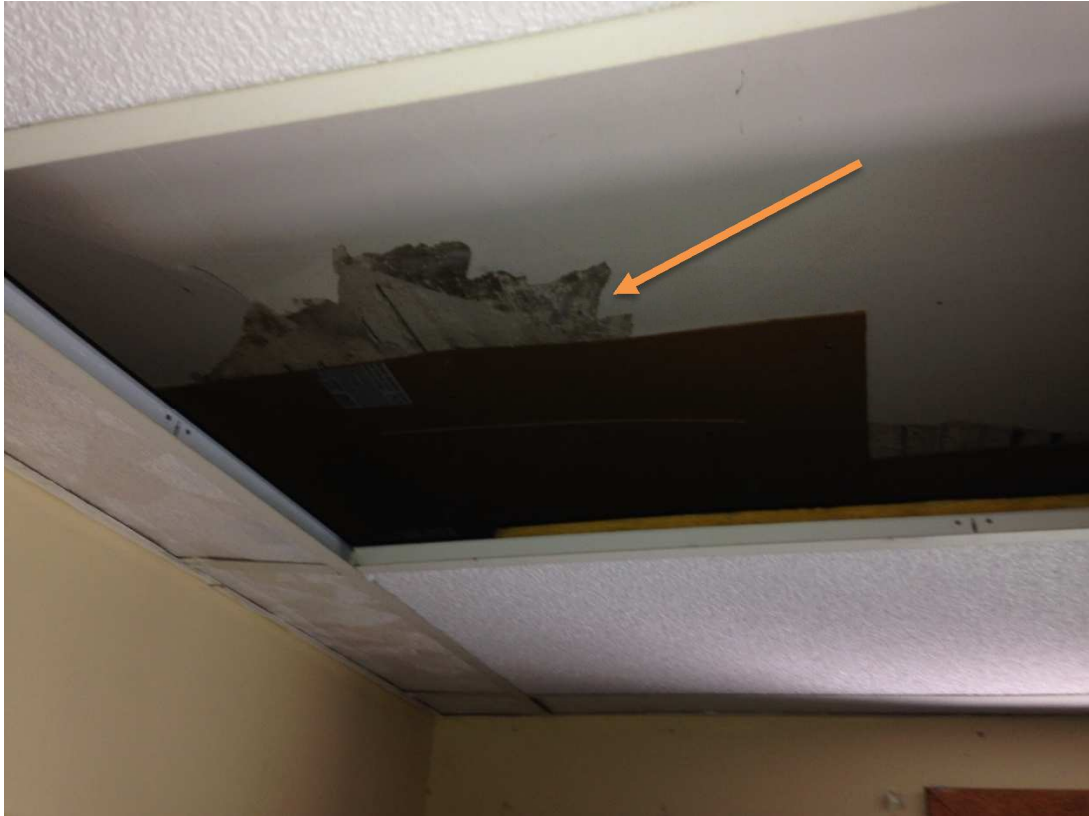
**Picture 4 – Water Damage to 2<sup>nd</sup> Floor Ceiling**

Water damage was observed in the ceiling of the 2<sup>nd</sup> floor. It is likely that the roof is damaged and allows water to get into the house. We were unable to review the roof to observe its condition. It is also likely that the water damage is more extensive than the one area that we were able to observe. There was a smell of mold present during our walkthrough suggesting that water damage and mold growth is prevalent throughout the house. Picture 4 shows the area of the 2<sup>nd</sup> floor that we were able to observe that has water damage.

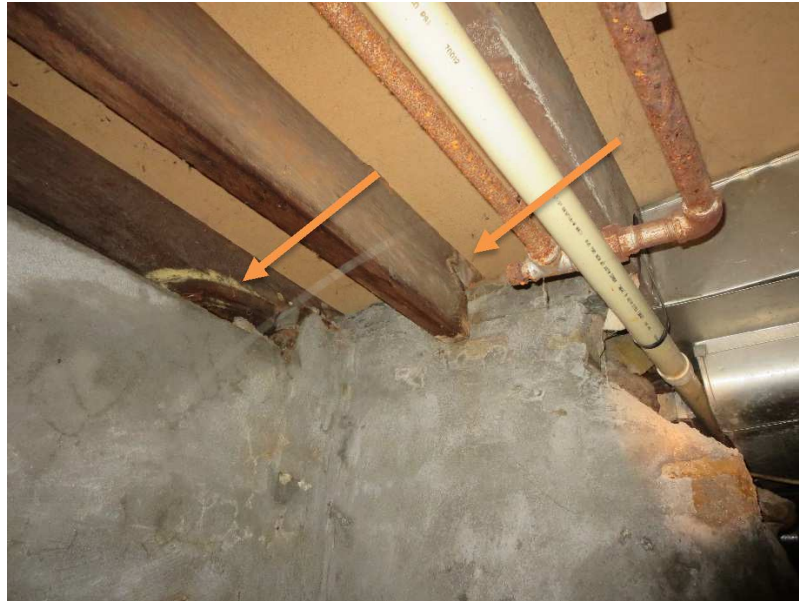
**Picture 5 – Joists Bearing on Foundation Wall**

Many of the joists are rotting in the basement. Much of the damage is located where the joists bear on the foundation wall. Picture 5 shows two such joists.

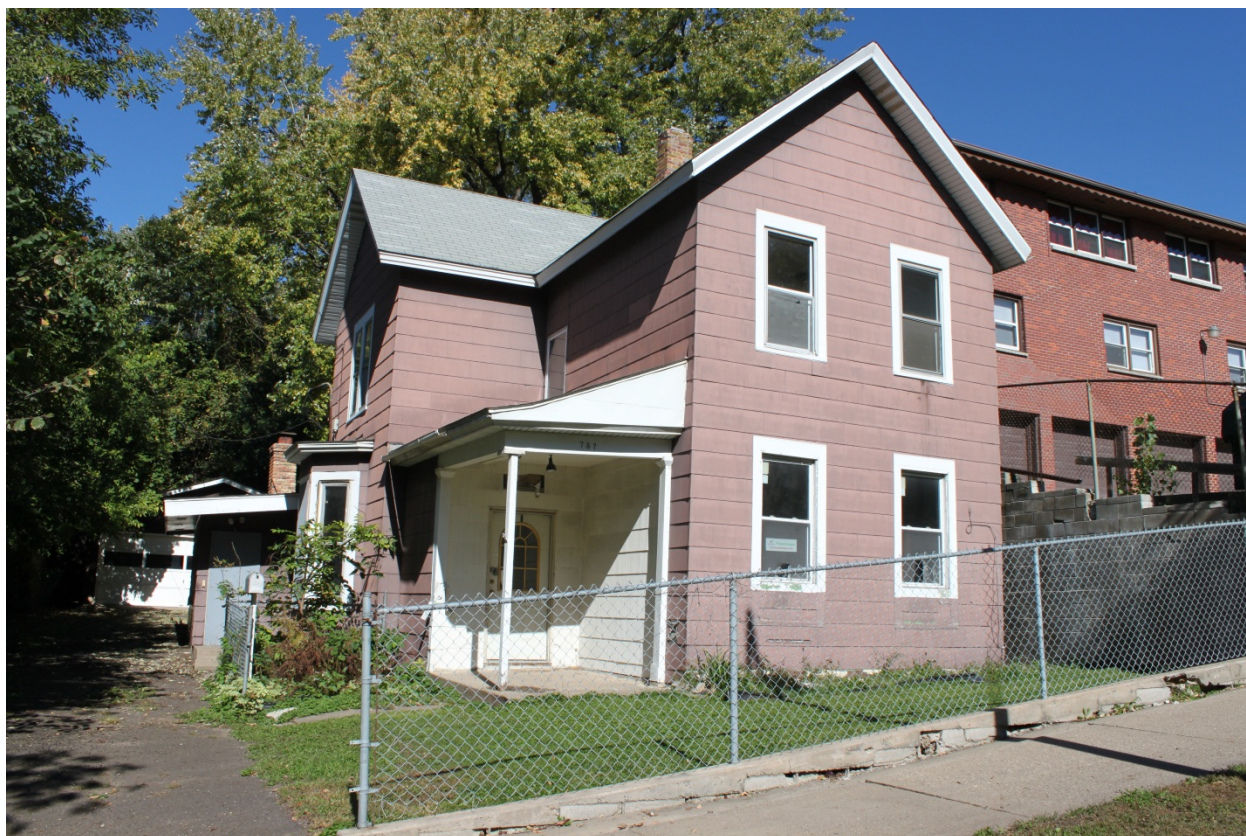
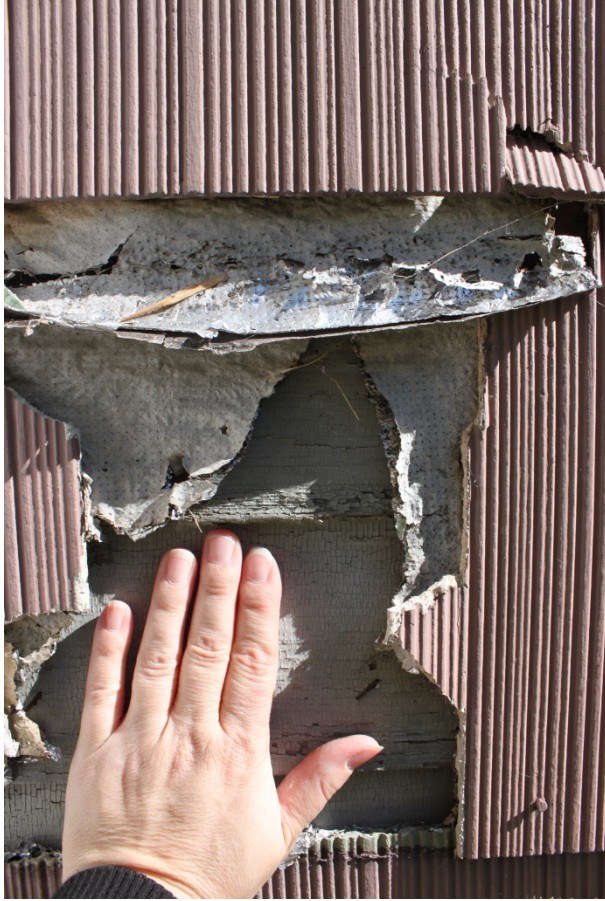
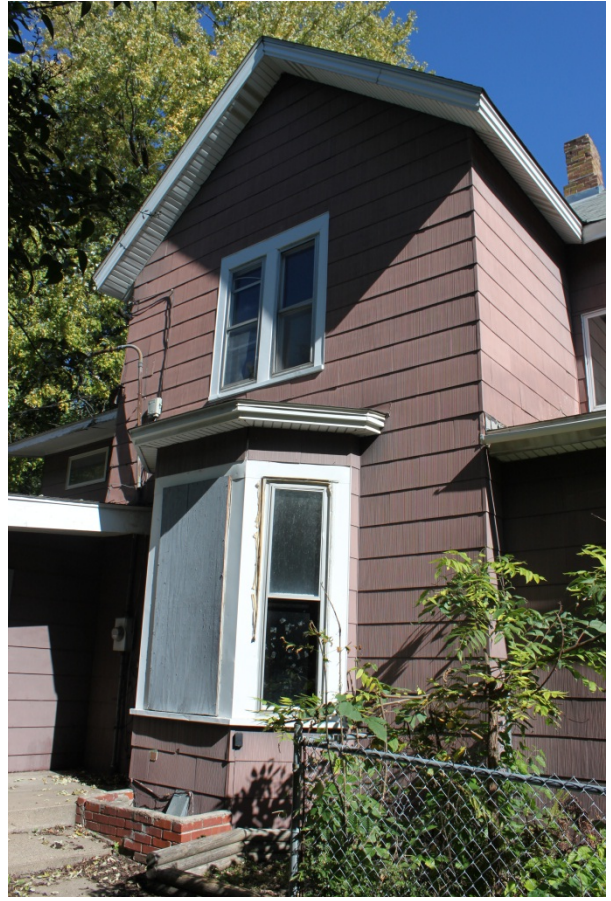
Exposed 4" clapboard beneath cement asbestos shingle (above left), west elevation with projecting bay (above right), and blocked-in windows on south elevation (below)
