**CITY OF SAINT PAUL
HERITAGE PRESERVATION COMMISSION STAFF REPORT**

FILE NAME: 700 Fourth Street East – Edward McNammee House

Project No.: 15538.00
Re: Structural Condition Review of the building at 700 4th St. E.

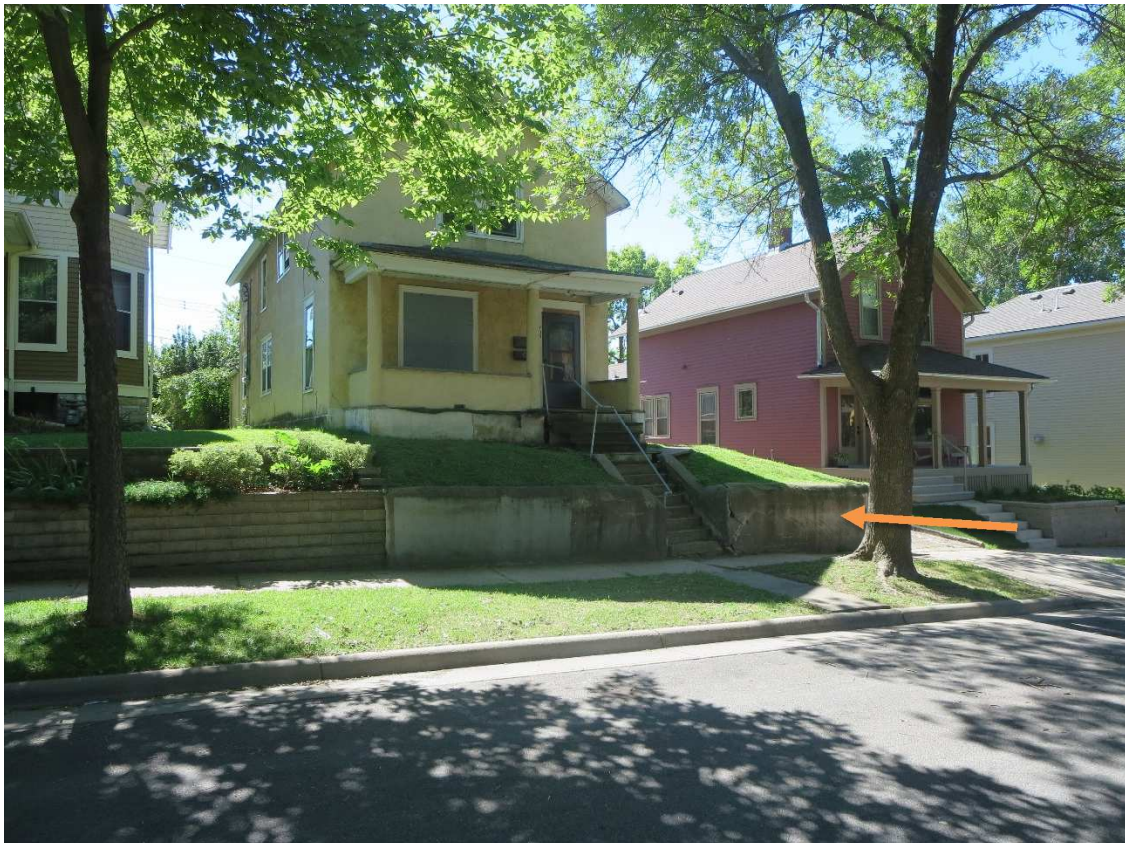
Picture 1 – Front Retaining Wall

The retaining wall at the front of the house is cracking and needs to be replaced. Picture 1 shows an overall view of the front retaining wall. Picture 2 shows the portion of the retaining wall that is showing the most cracking. A portion of the retaining wall has tipped. As the retaining wall continues along the southern side of the building its deflection increases. Picture 3 shows the wall, as seen from 4th street. There are also cracks that appear to go through the wall. Picture 4 shows one such crack.

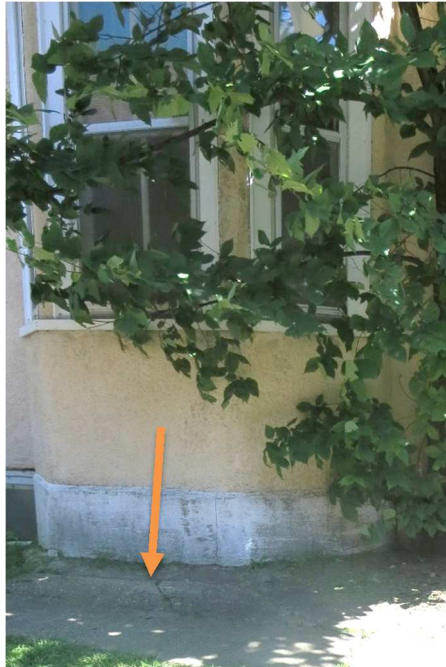
Picture 5 – Bay at South Wall

The bay along the south wall of the house appears to have settled. Picture 5 shows the bay and a crack that has occurred next to it. There is a tree that is growing just east of the bay. Its trunk is adjacent to the foundation wall. The tree is likely one cause of the settlement of the bay and could be the cause of other problems in the house. Picture 6 shows the base of the tree and the foundation wall. The background of Picture 4 shows the bay along with the tree as well.

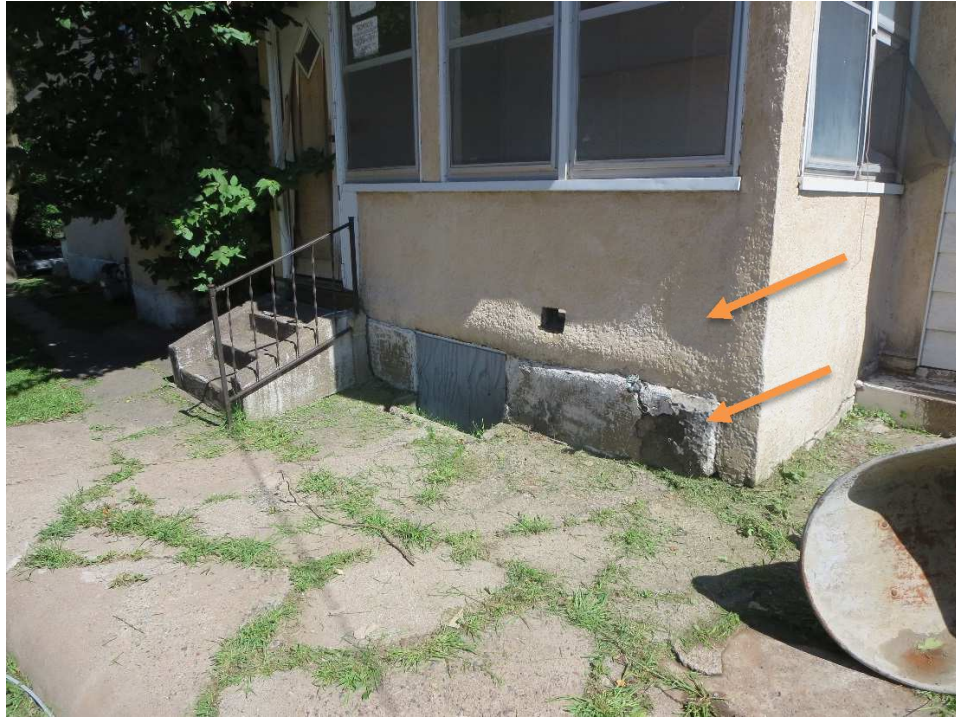
Picture 7 – Water Damage at Southern Foundation Wall

There is some water damage to the house. The eastern section of the south foundation wall showed signs of damage and rot. Picture 7 shows some of the rot that has occurred as well as spalling of the finish material along the foundation and bulging of the stucco on the wall. Water damage effects were found in the floor of the second story of the house. Picture 8 shows some of the damage. It is likely that there is damage that allows water to leak. The roof was observed from the outside to be sagging slightly (not pictured). It is likely that there is some damage to the roof, which is causing water to enter the house.

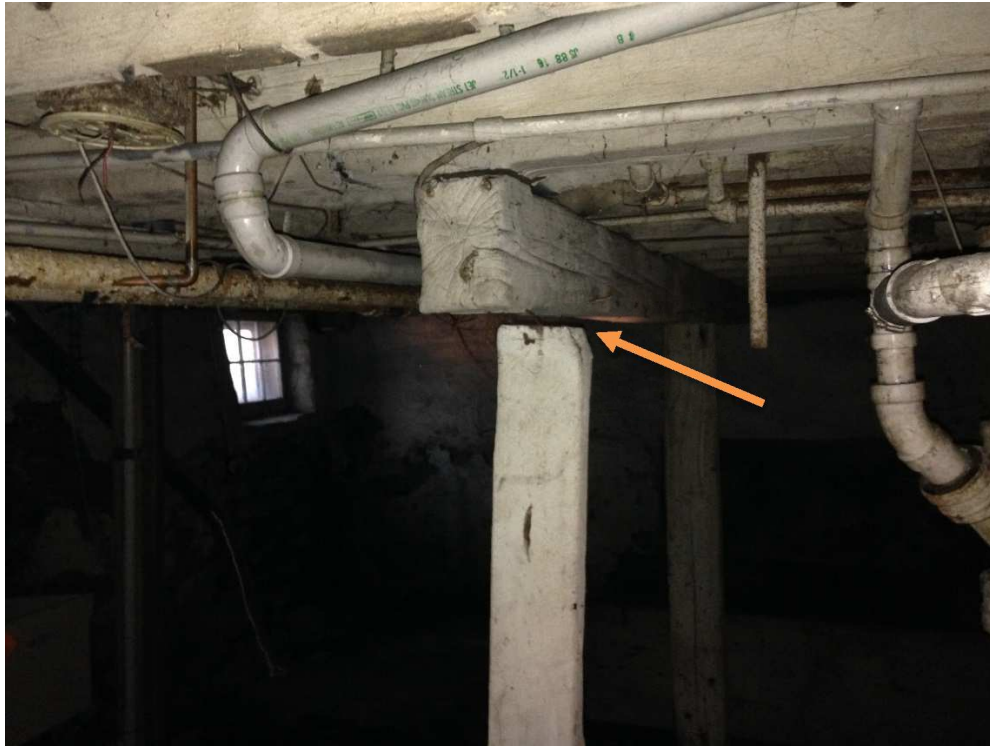
Picture 9 – Beam Above Column in Basement

There are framing issues in the basement. There is a beam that does not rest on the column as it was originally designed. Picture 9 shows the beam as well as the column. The gap between the beam and the column is approximately 1 inch. The gap between the beam and column can be seen in the picture.

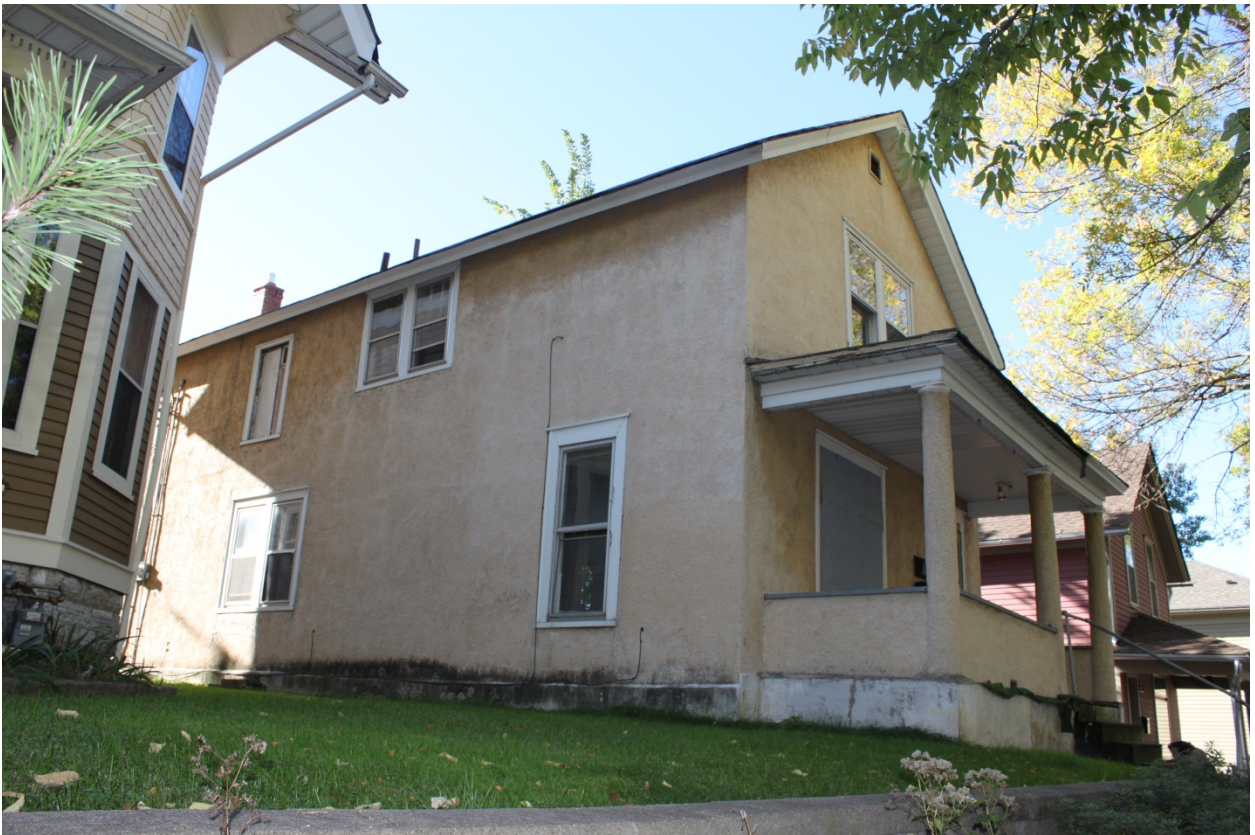
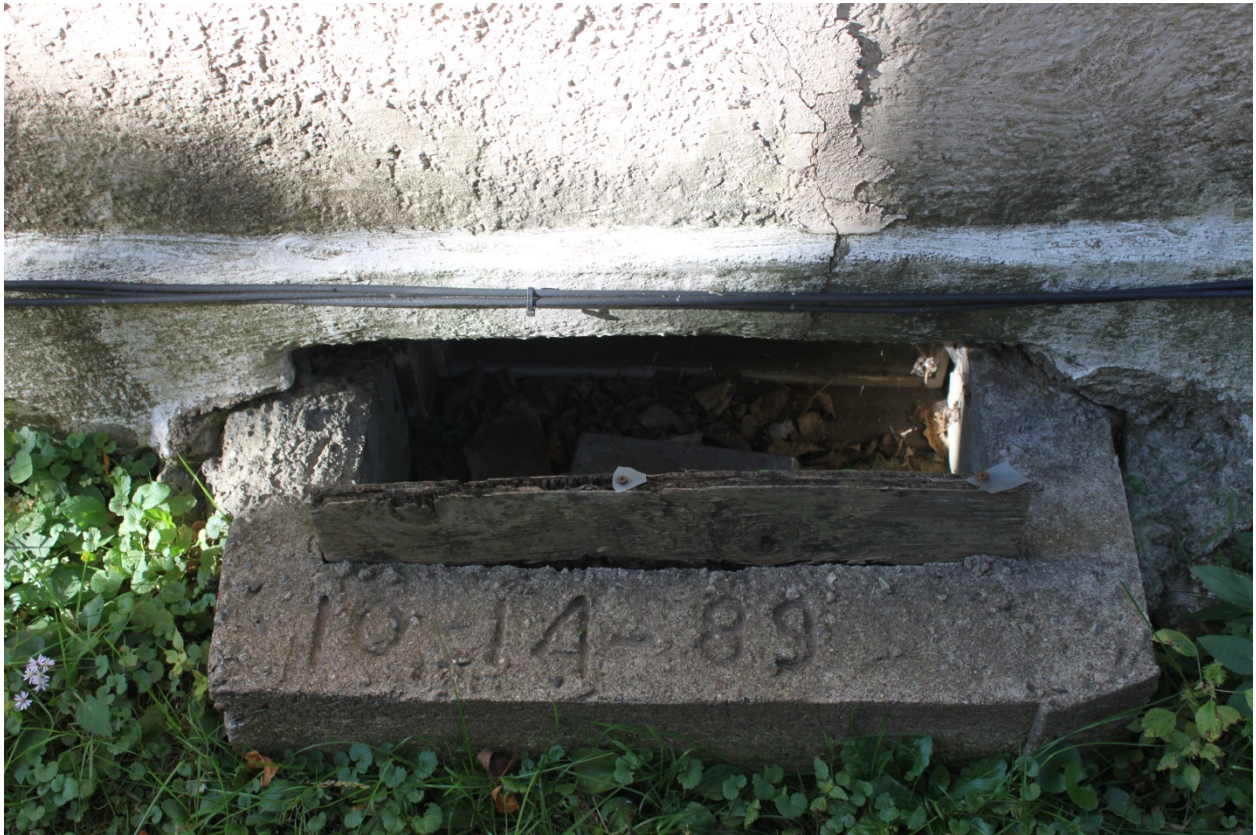
East elevation window well dated October 14, 1889 (above), with west elevation stucco fill (below left) and front door (below right)
