Atrium Office Building Window Replacement

Design Review Application to the
Heritage Preservation Commission
By Wellington Management, Inc.

Current Proposal: This application currently requests replacement of 25 third floor windows at the south wing of the building. The elevations are identified as SW2, S and SE2. Drawings from Pope Architects, in cooperation with Pella, depict a two-part metal clad replacement window with divided lights. Window replacement design for three-part windows is also presented for approval of phased replacement.

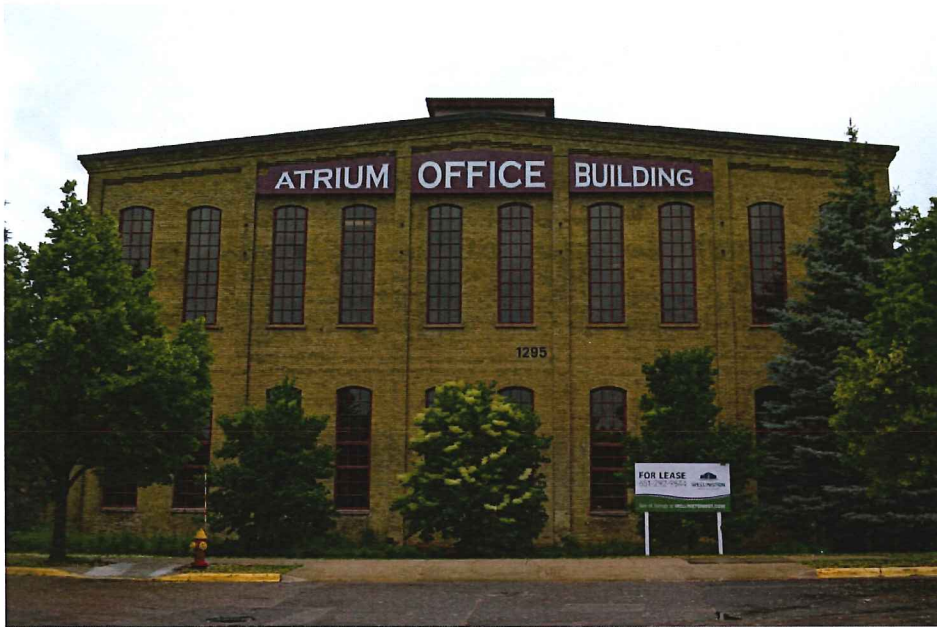
South face of the building – 2014

- The Atrium's wood frame, divided lite windows were installed in 1985 as part of the first renovation.
- There are more than 130 window units.
- Repair and maintenance of the wood framed windows cannot keep pace with deterioration.
- Fogging of glass, water infiltration and wood rot is evidenced throughout the building.

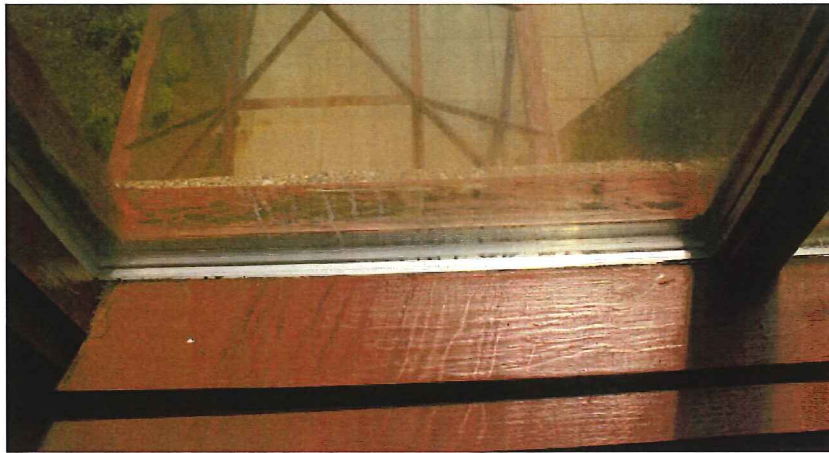
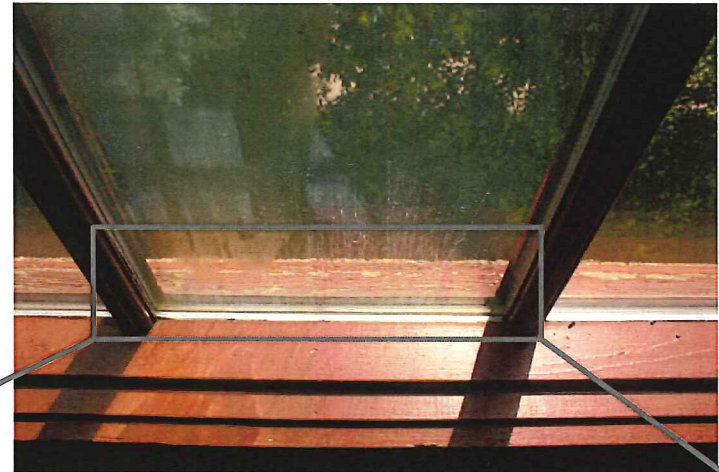
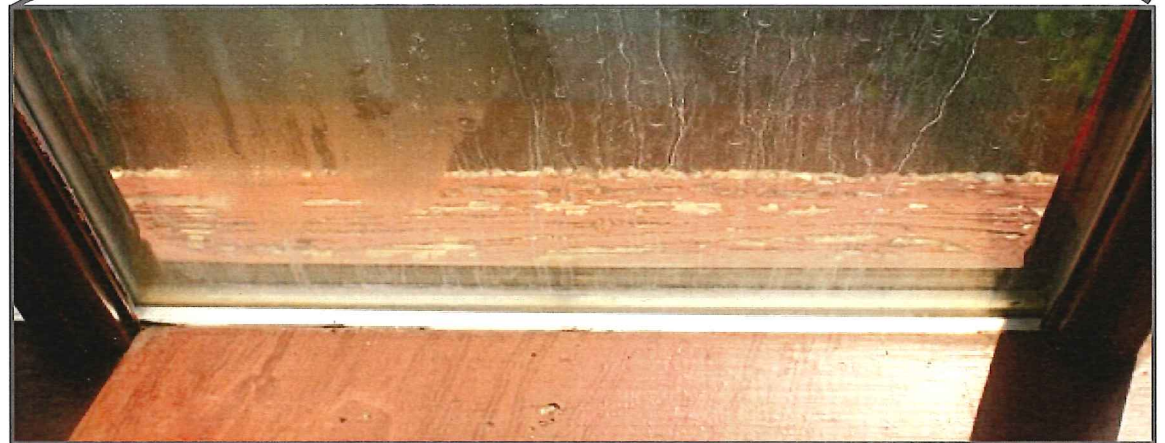
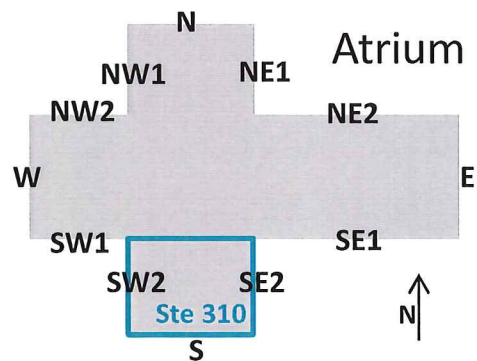
Typical Wood Condition – Suite 310

Leaking and damaged panes and deteriorated wood trim have been selectively replaced as a temporary means of stopping water infiltration and drafts.

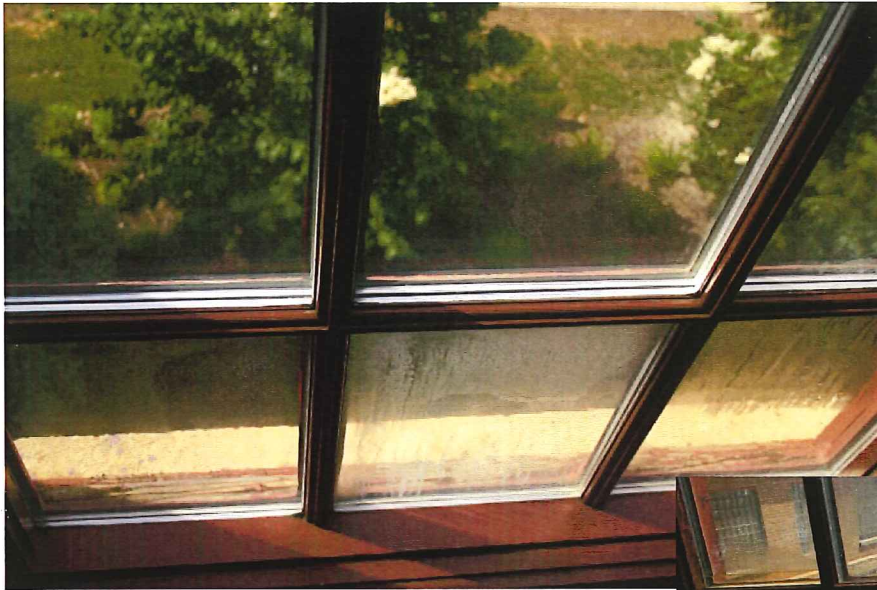
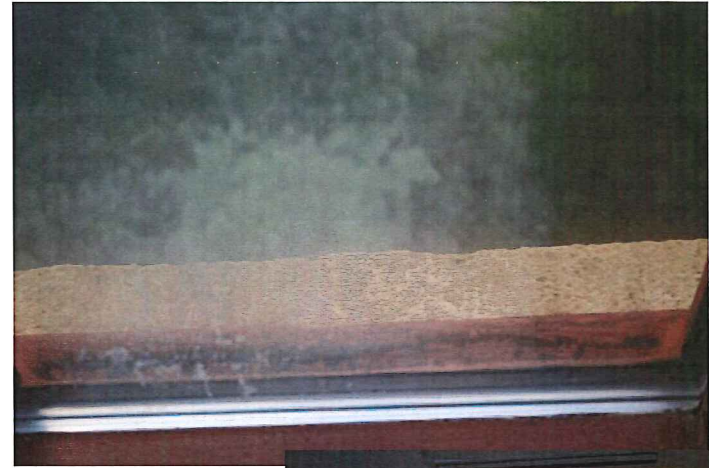
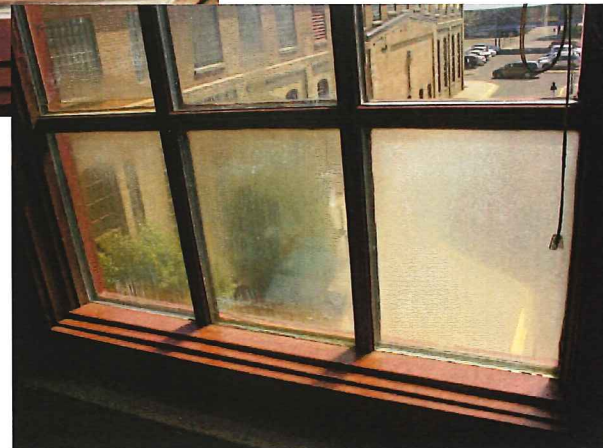
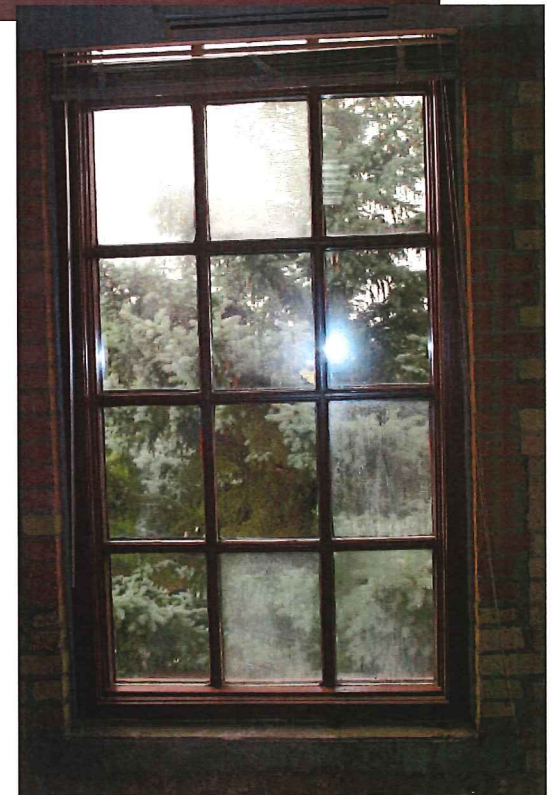
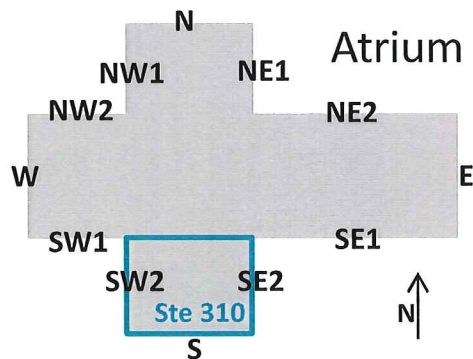
- Fogged panes and deteriorating wood frames & sills diminish the beauty of this historic building.
- Water infiltration is damaging brick, interior walls and finishes.

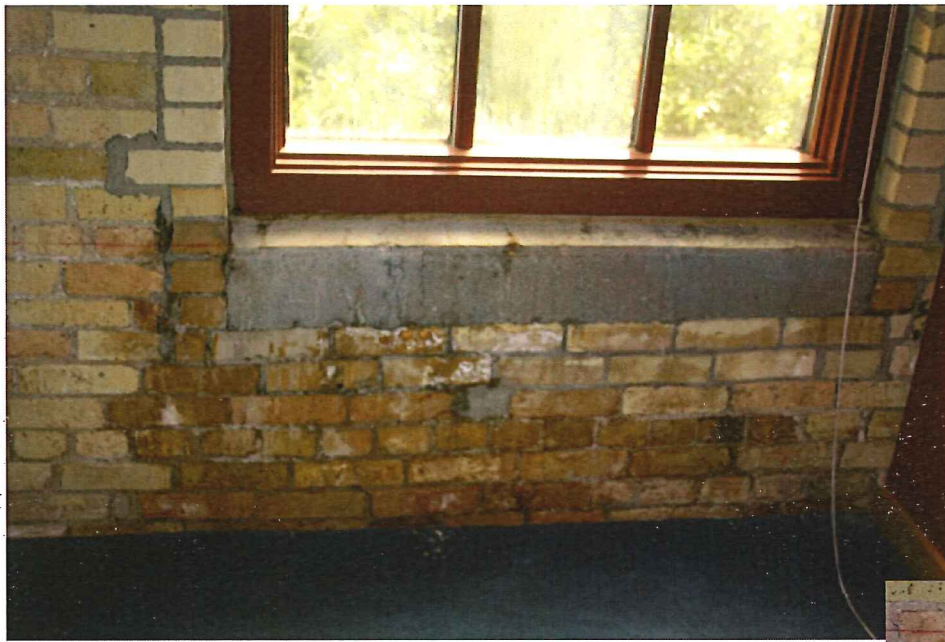
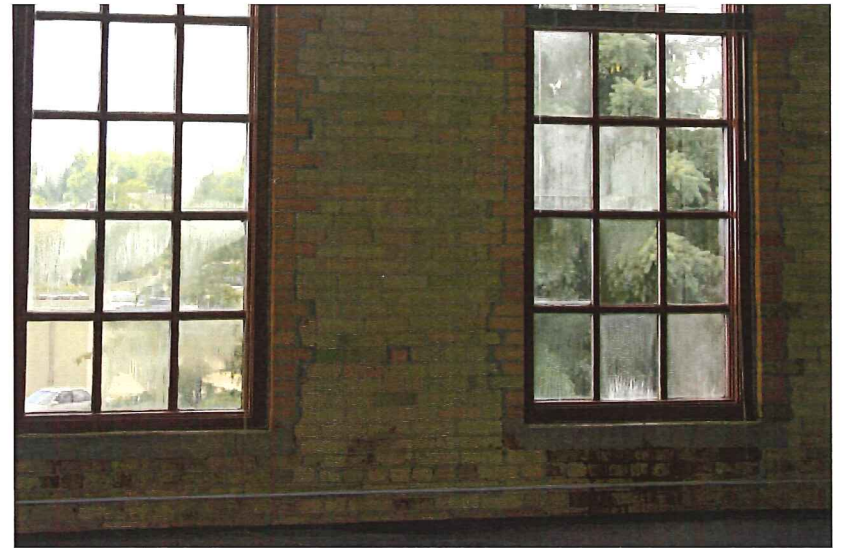
- Water infiltration has damaged the brick in suite 310 and many other locations in the building.

- Interior wall finishes and carpeting have been saturated, creating conditions conducive to mold growth and air quality concerns.

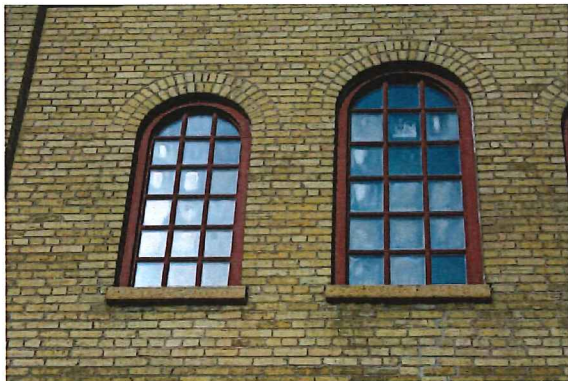
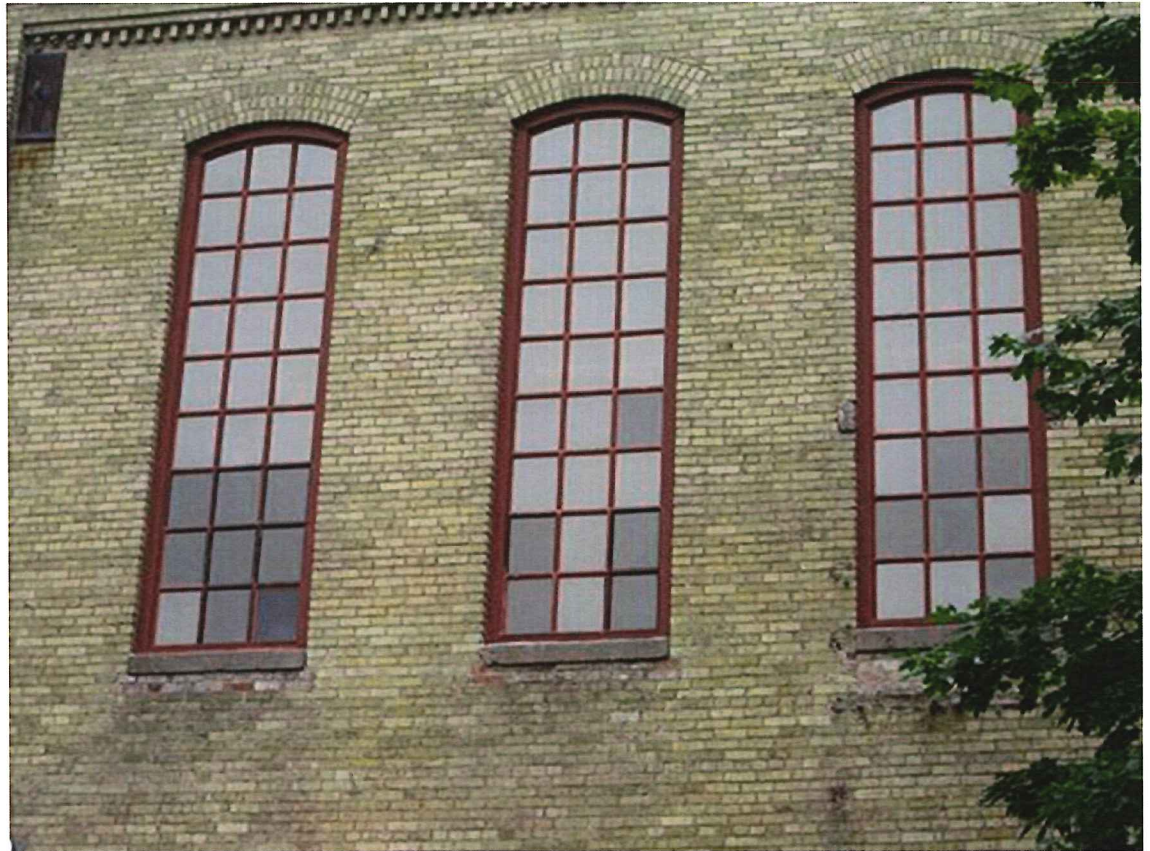
Atrium – 2014

Considerable variations in the window reflectivity/appearance are likely due to:

- Moisture within the airspace
- Glass variations
- Inconsistencies in pane installation
- Deterioration of wood mullion resulting in changes in plane

Changing the windows from multi-pane to the proposed simulated divided lite will improve this to a more uniform appearance.

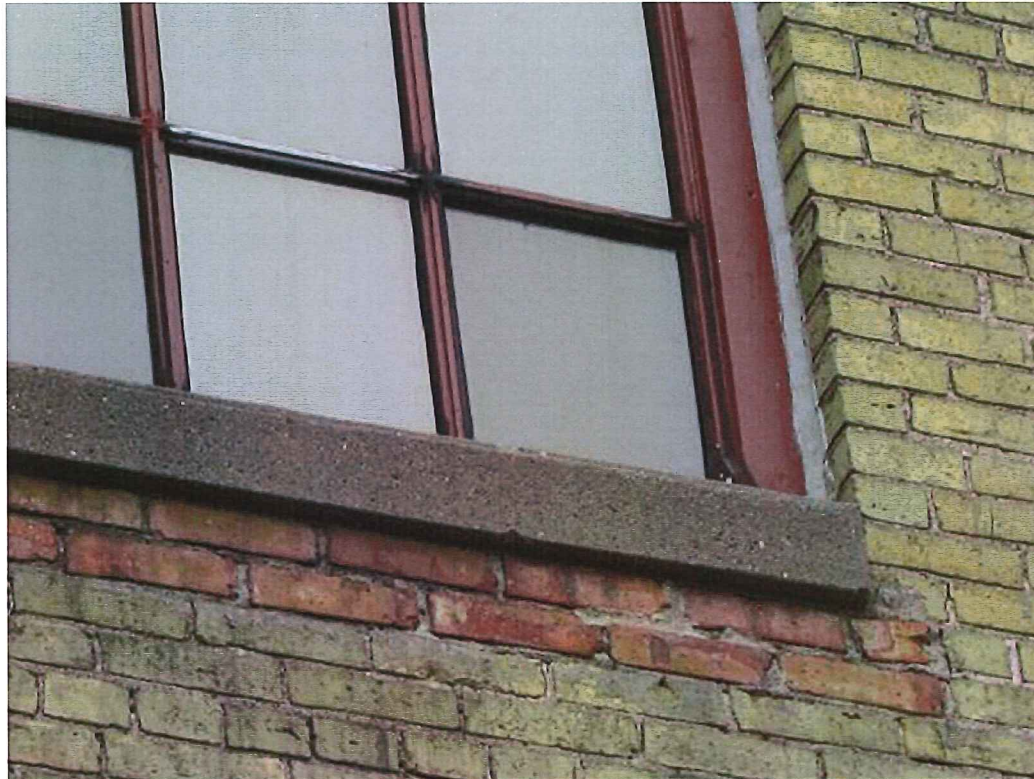
- In some locations, especially on the east side, there are large soft/sealant joints at the perimeter that are very noticeable, unsightly, and inconsistent.
- These joints may be the result of inconsistent wood jam widths – sometimes varying up to a full inch on the same window.

The details Pella is suggesting will provide an attractive and consistent appearance. Each opening will be measured to provide custom windows, rather than a “one size fits all” style that results in noticeable variation.
