**CITY OF SAINT PAUL
HERITAGE PRESERVATION COMMISSION STAFF REPORT**

FILE NAME: 500 Cedar Street, Central Presbyterian Church
DATE OF APPLICATION: August 4, 2015
APPLICANT: Fluryanne Leach, Central Presbyterian Church
OWNER: John Lee, President of the Corporation of Central Presbyterian Church
DATE OF HEARING: August 27, 2015
HPC SITE/DISTRICT: Individual Site—Central Presbyterian Church
CATEGORY: Pivotal
CLASSIFICATION: Building Permit
STAFF INVESTIGATION AND REPORT: Allison Suhan
DATE: August 21, 2015

HERITAGE PRESERVATION COMMISSION DESIGN REVIEW APPLICATION

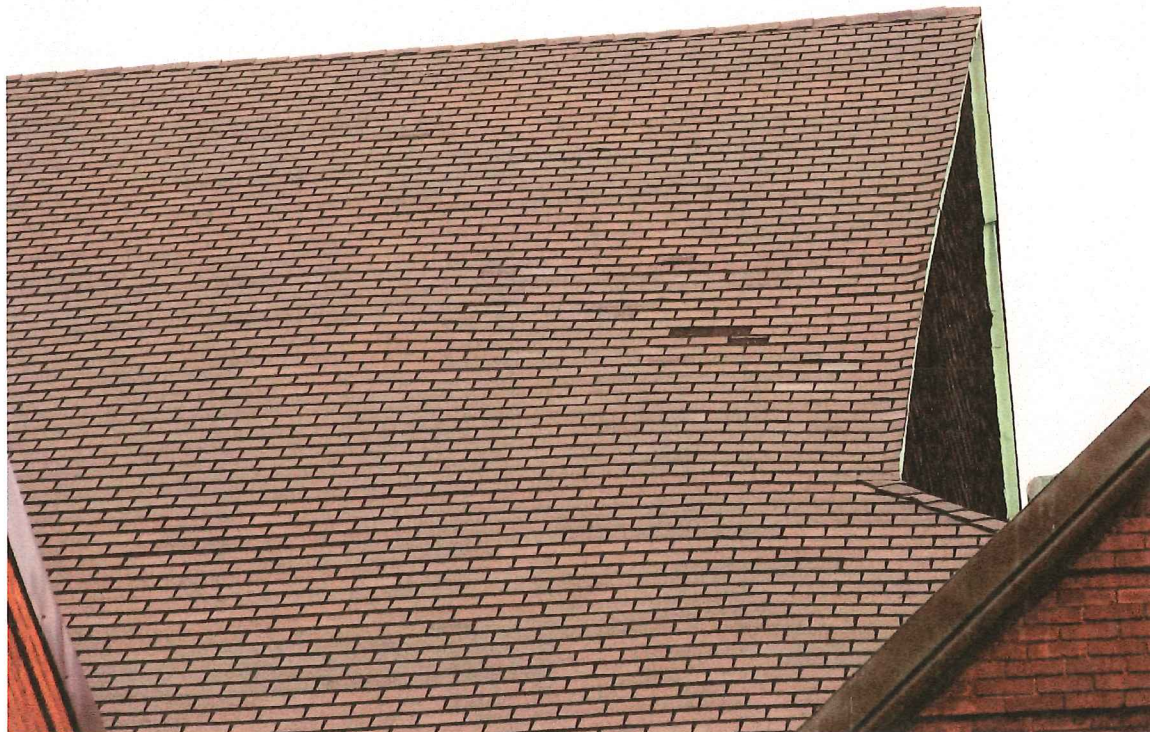
Fig. 7 Detail of south side, eastern end of main roof showing missing shingles

Figure 7 Detail of current portion of south side eastern end of main roof showing missing shingles 7/27/15

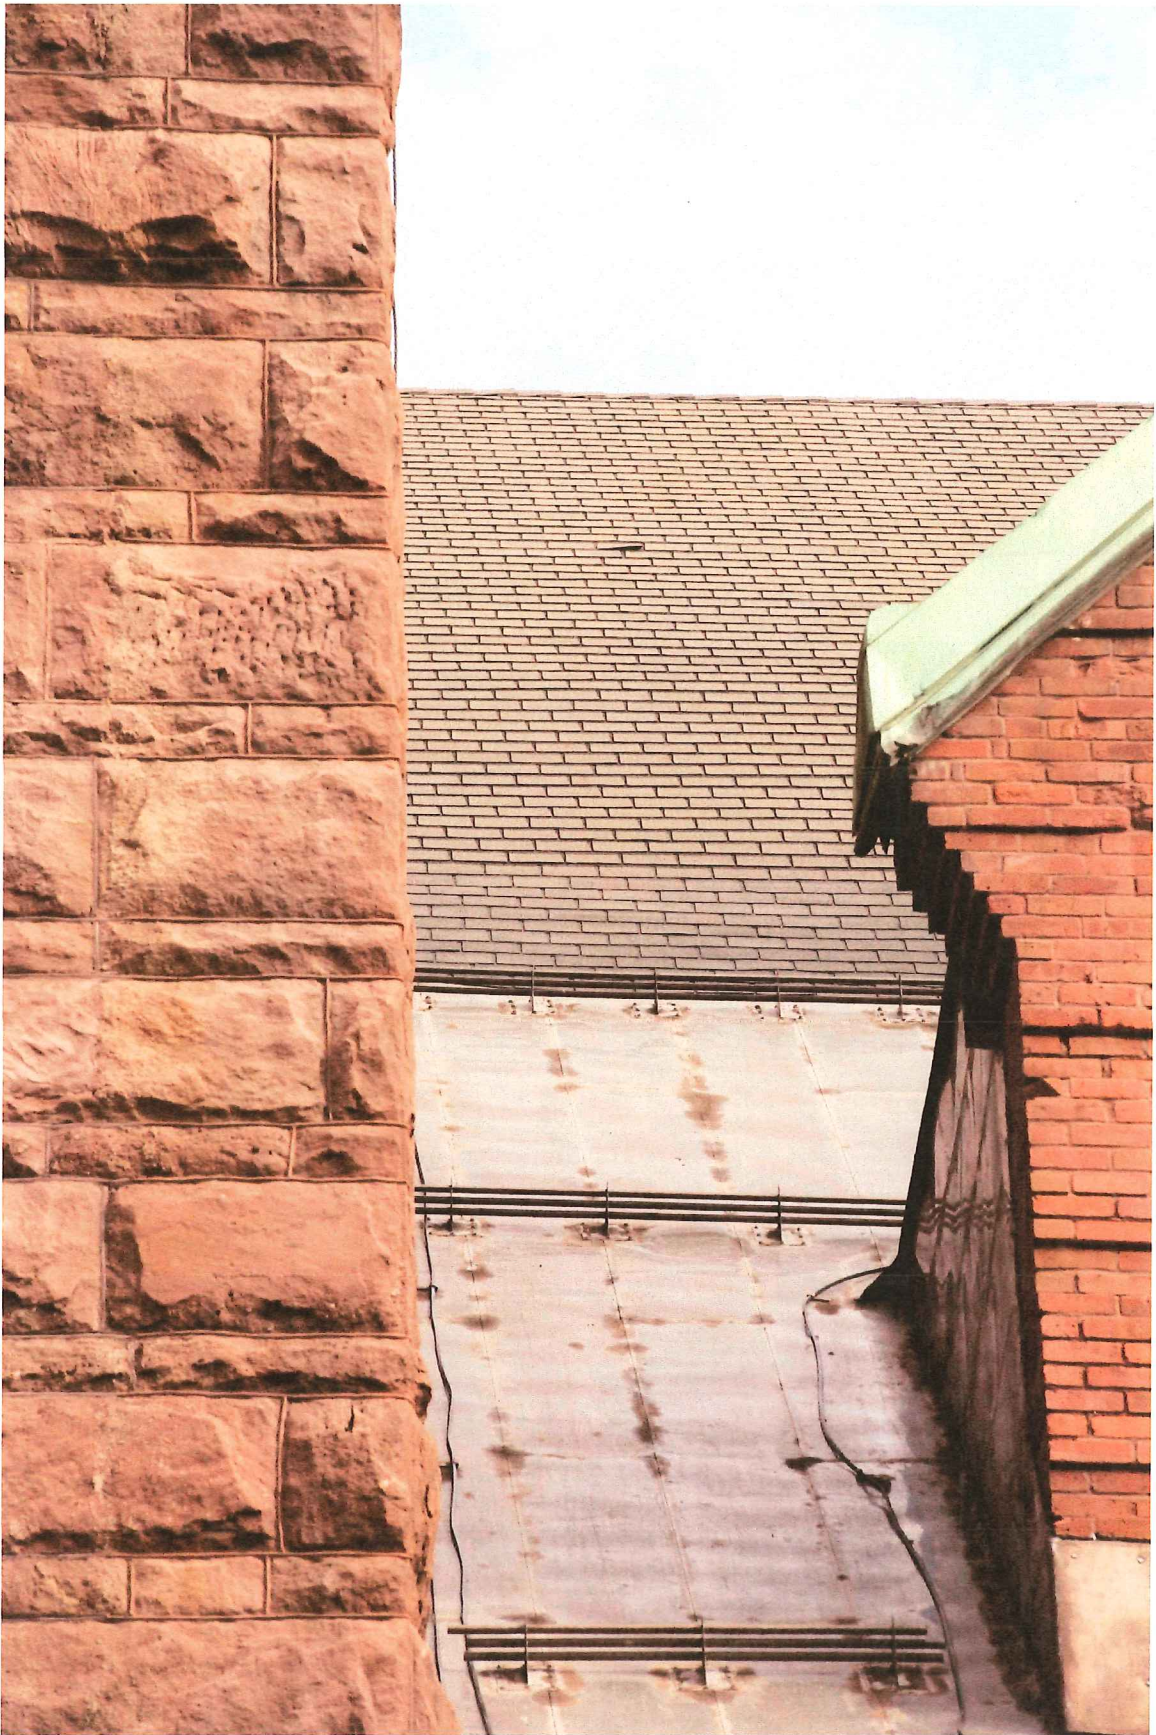
Fig. 8 Detail of south side main roof by bell tower showing missing shingles

Figure 8 Detail view of south side main roof by bell tower showing missing shingles 7/27/15

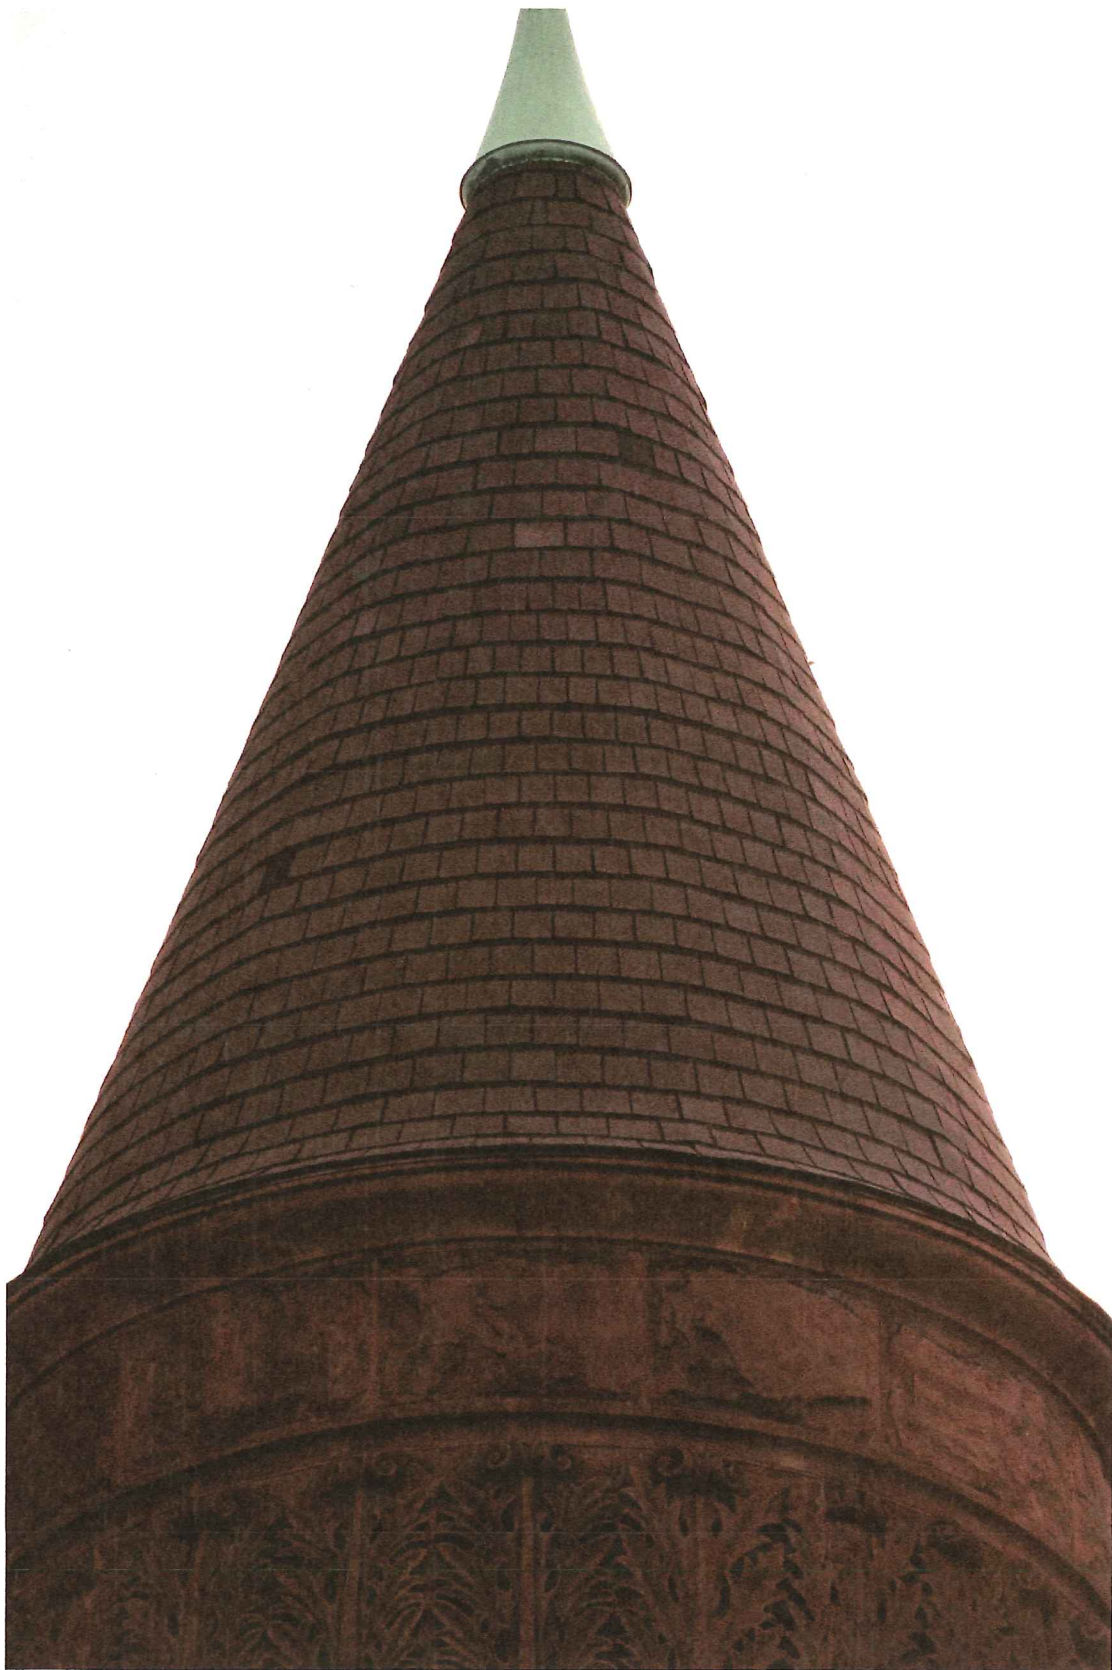
Fig. 11 Detail view of northwest corner turret roof showing missing and loose shingles

Figure 11 Detail view of turret on northwest corner showing missing shingles 7/27/15

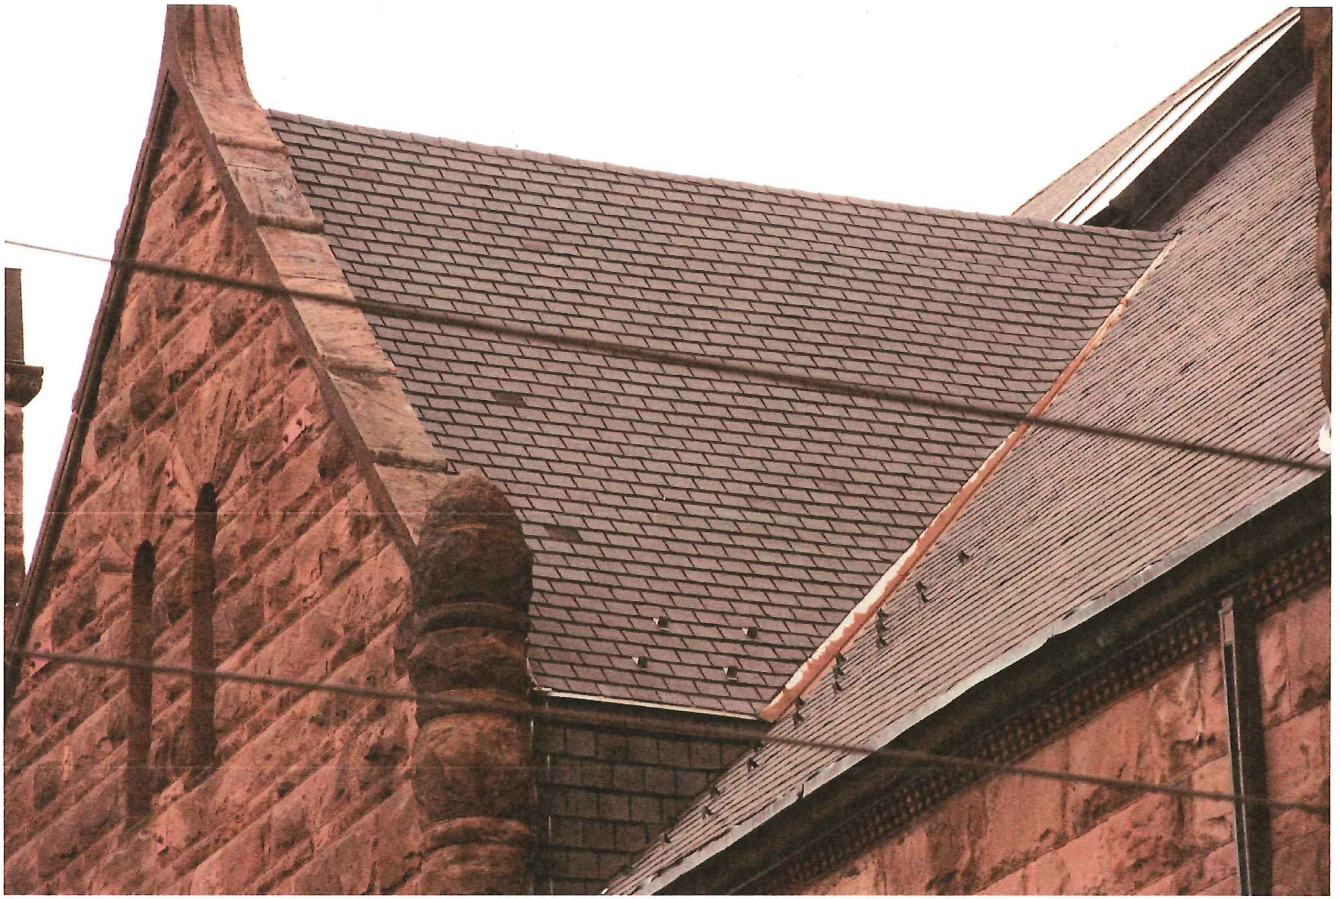
Fig. 12 Detail view of gable on northeast corner of main roof showing missing shingles

Figure 12 Detail view of gable of northeast corner showing missing shingles 7/27/15
