Response Action Implementation Report, 1A Tunnel Barrier Wall, Feature 150
Ford Twin Cities Assembly Plant, St. Paul, Minnesota
MPCA VIC Project Number VP23530
MPCA PBP Project Number PB3682

Figure 3.
Tunnel 1A – Barrier Wall
Installation
Twin Cities Assembly Plant
Ford Motor Company
St. Paul, Minnesota

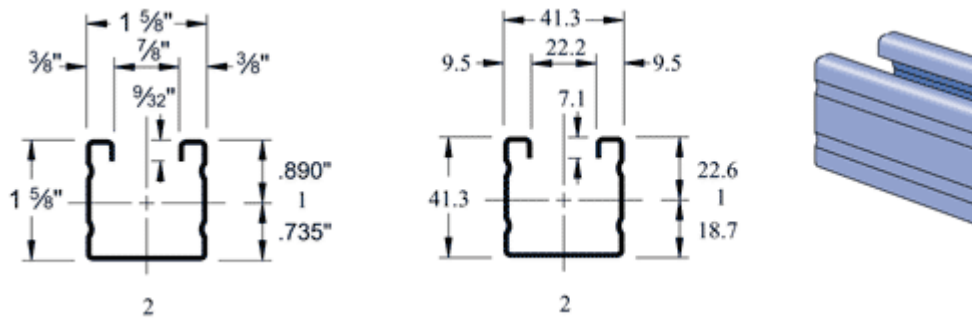
**P2000 - 1-5/8" x 1-5/8", 16
 Gauge, Solid**

The barrier was constructed at Feature 150, which is several thousand feet away from the entry portal of the tunnel. All materials were hand-carried into position via a permit-required confined space entry. Unistrut framing was utilized since it is a strong proven product, is relatively lightweight and has pre-engineered connectors. The Unistrut was used for the main skeletal framing with a chain-link fence fabric attached for additional security. The Unistrut framing was secured to the tunnel walls by drilling and anchoring into the concrete formed wall.

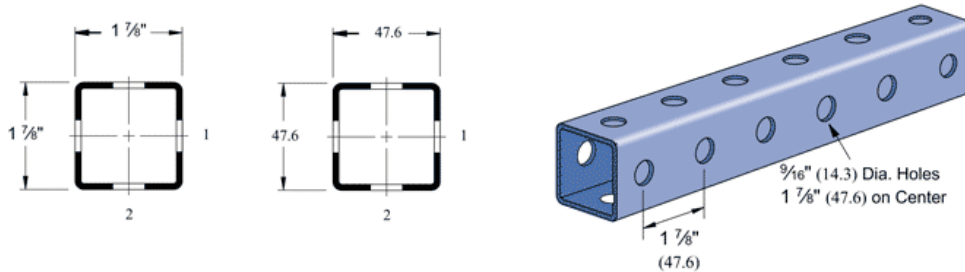
P9200 - 1 7/8" x 1 7/8" Telestrut Tubing

1. Install chain link fabric in place using existing rebar from the concrete formed wall.
2. Core into the concrete formed wall; install anchor bolts through the Unistrut and into the concrete.
3. Splice the upper and middle horizontal Unistrut sections together with the P9200 tubing and bolt in place.
4. Fasten the vertical Unistrut sections to the horizontal sections.
5. Tie the chain link fabric to the Unistrut framing.

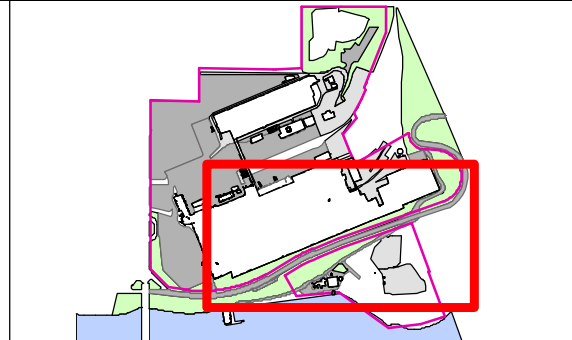
Twin Cities Assembly Plant Ford Motor Company St. Paul, Minnesota
	Tunnel Location Map
	FIGURE 2

The area referred to as Feature 150 at the Ford Twin Cities Assembly Plant is an accumulation of materials on the far southern end of the 1A Tunnel. On October 3, 6, and 7, 2008 the 1A Tunnel leading to Feature 150 was surveyed by Sunde Land Surveying (Sunde) of Bloomington, Minnesota. The tunnel location was surveyed to Ramsey County coordinate system [North American Datum of 1983 (NAD83)] and the elevation to vertical datum National Geodetic Vertical Datum of 1929 (NGVD 29). The location and extent of the tunnel are presented on Figure 2.

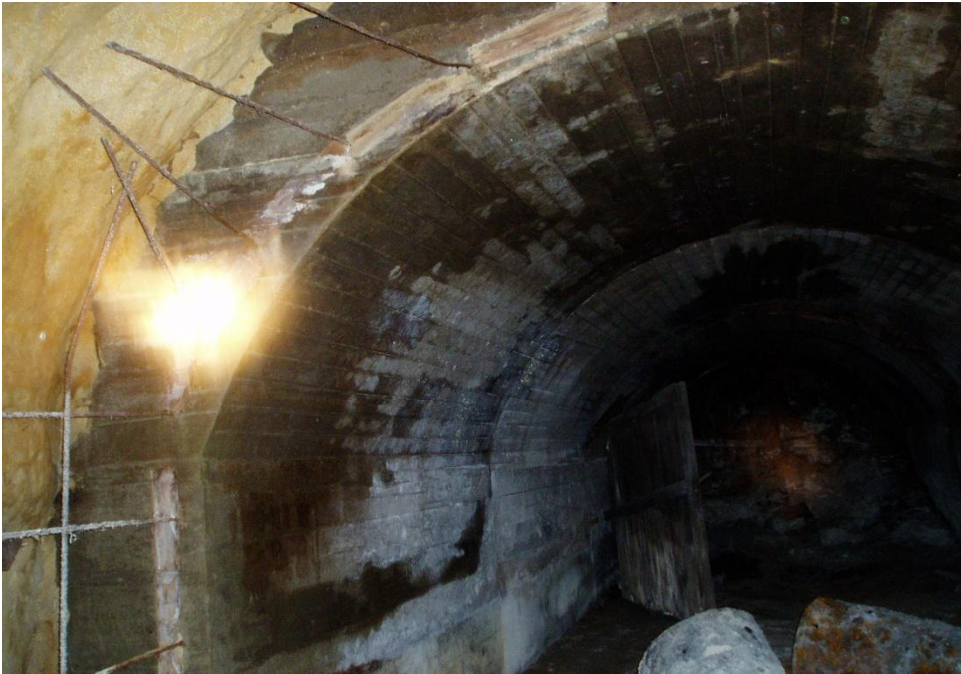
Pre-Construction Photo.

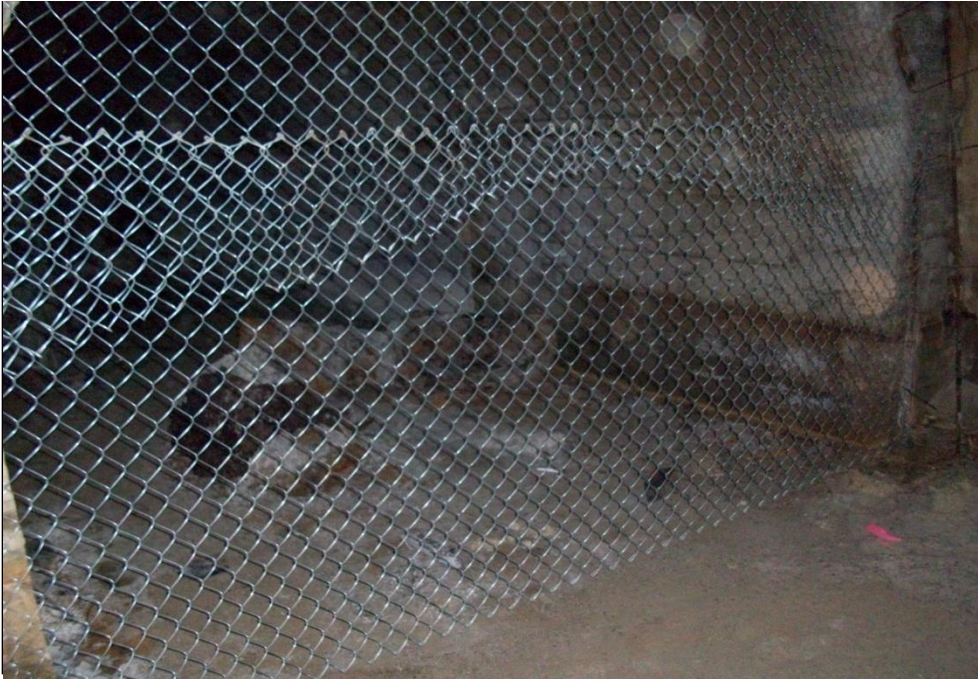
Chain Link Fencing Installation.

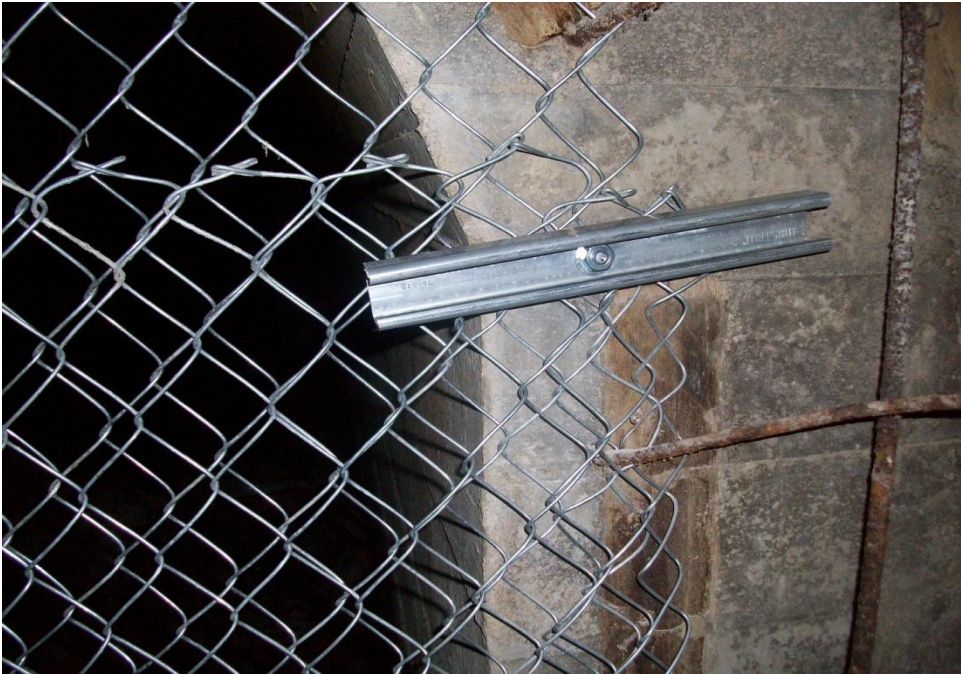
Figure 4.
Tunnel 1A – Barrier Wall
Installation
Twin Cities Assembly Plant
Ford Motor Company
St. Paul, Minnesota

Close-Up of Securing the
Chain Link Fencing to the
Concrete Wall.

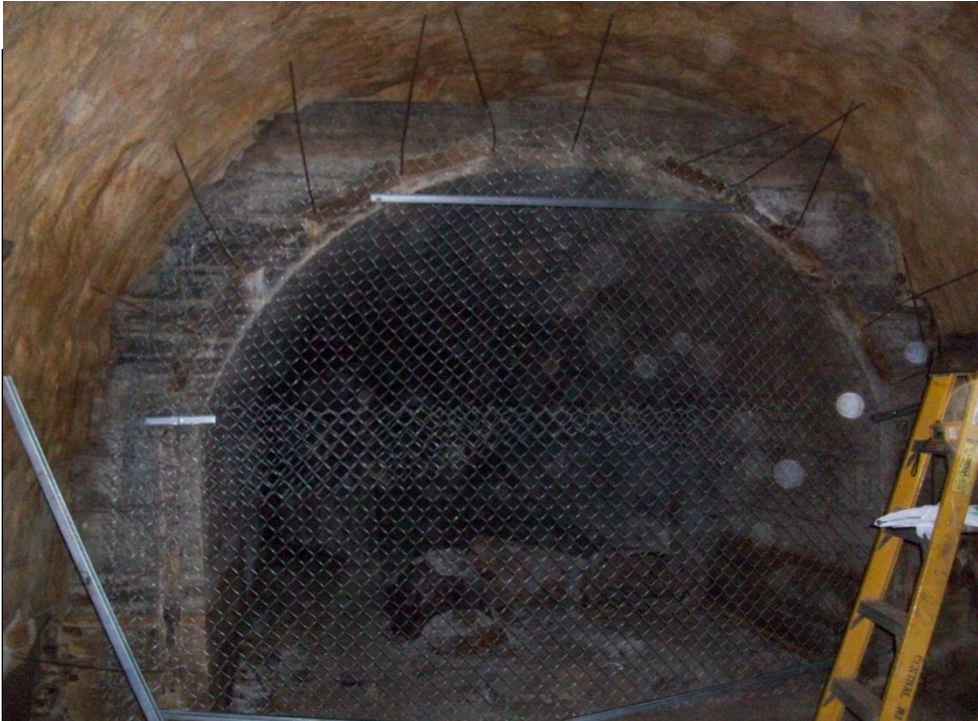
Securing the Chain Link
Fencing to the Concrete Wall.

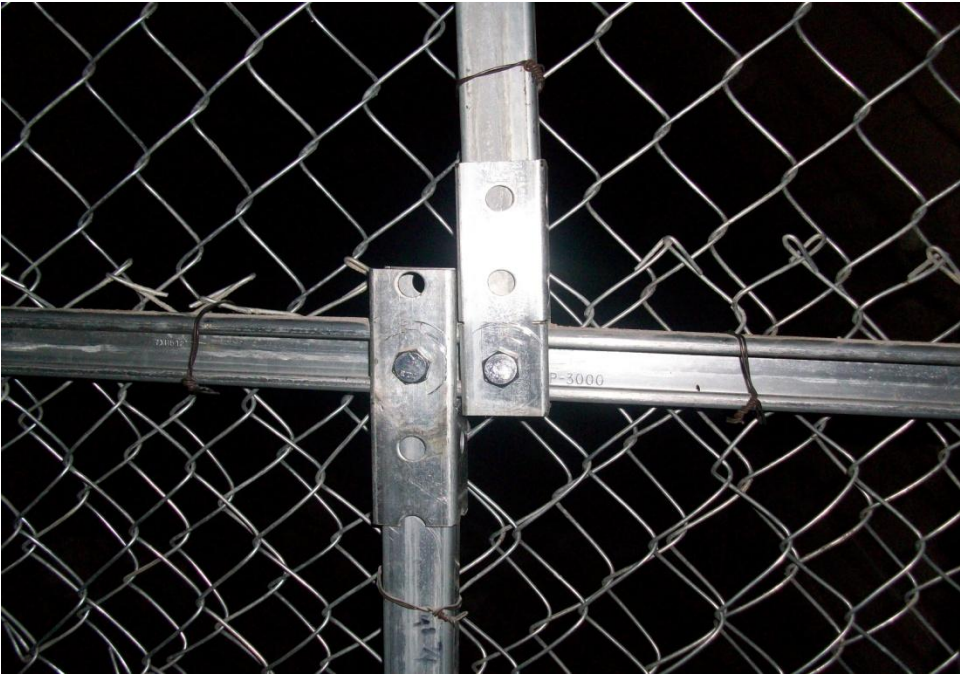
Figure 5.
Tunnel 1A – Barrier Wall
Installation
Twin Cities Assembly Plant
Ford Motor Company
St. Paul, Minnesota

Unistrut Installation.

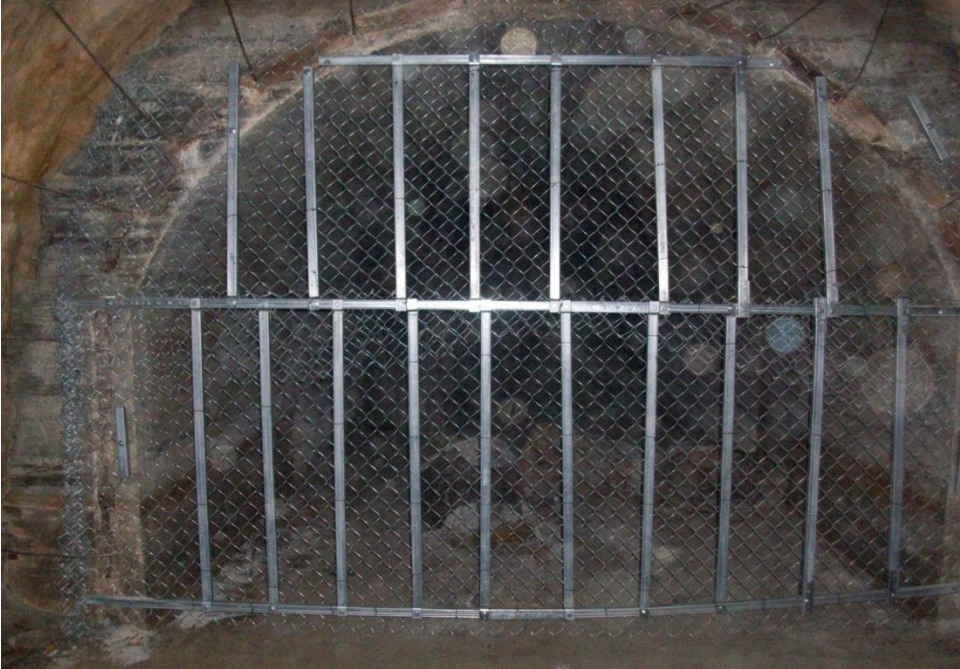
Barrier Wall Construction
Completion.

The installed barrier wall, in combination with the locks at the entrance of the tunnels is sufficient to prevent direct contact with the waste materials located at the terminal end of the 1A Tunnel and by installing the barrier wall, Ford has fulfilled is obligation of preventing direct contact with the waste materials present.
