Prepared by:
Mitch Johnson, PE and Kevin Biehn of Emmons & Olivier Resources, Inc.
for the Soil and Water Conservation District of Scott County

Crosby Farm Park: Bluff Stabilization / Restoration Feasibility Study - St. Paul, MN

Feasibility Report 08/07/2007

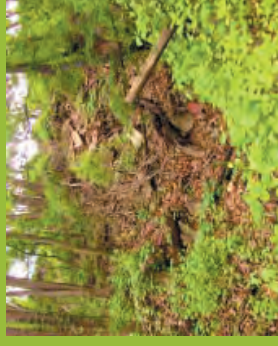
The unique bowl, filled and stabilized with rubble dumped from the top of the bluff.

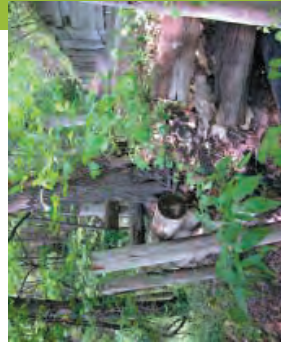
Severely eroded promontory.

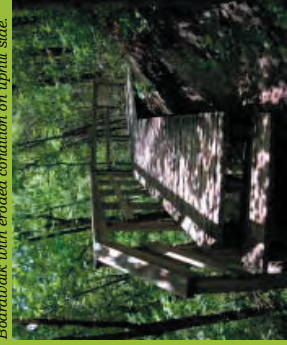
Boardwalk with eroded condition on uphill side.

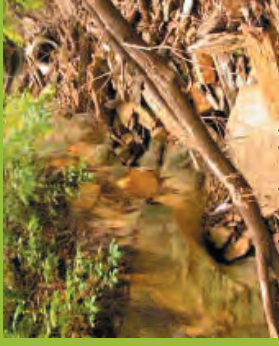
One of several severely eroded gorges, with sculpted sandstone walls and filled with rubble.

The most severely eroded areas of the bluff trail are in the ravines, where stormwater repeatedly scours out the base of the ravines and the sides collapse. Some such erosion is a naturally-occurring condition, but here it is aggravated by the presence of storm water outlets at the top of the bluff, bringing water in much larger quantities than would naturally exist. This dramatic erosion cannot be slowed or stopped without dealing with the stormwater outlets. However, we can help people navigate the ravines while still allowing water to pass through.

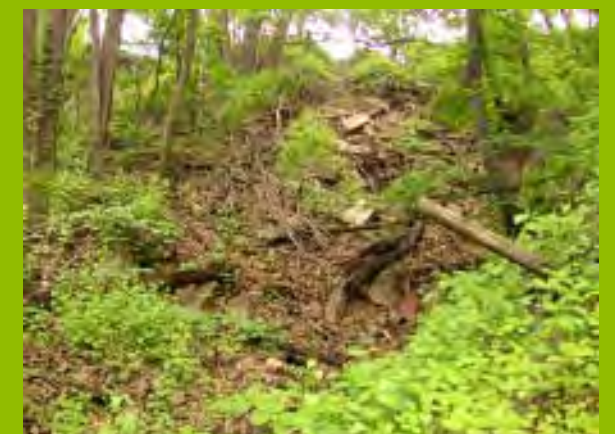
The unique bowl, filled and stabilized with rubble dumped from the top of the bluff.

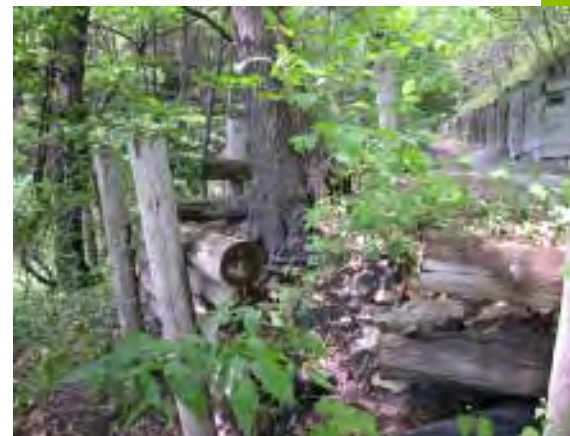
Severely eroded promontory.

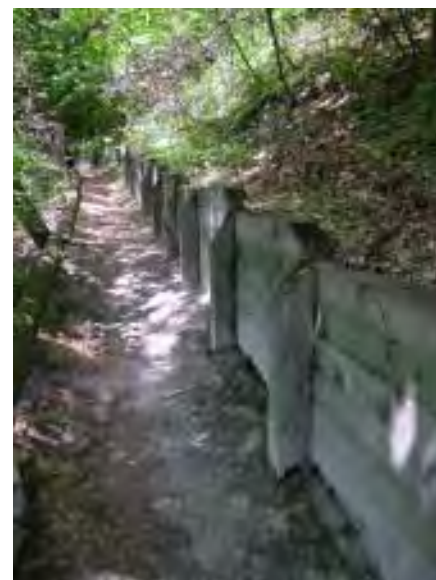
Boardwalk with eroded condition on uphill side.

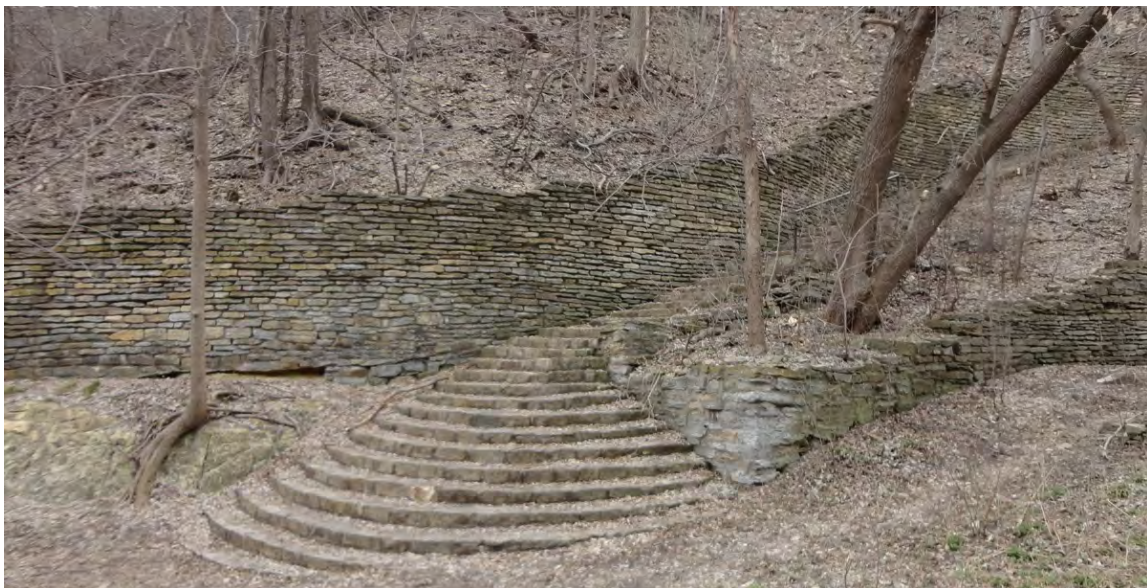
In the upper channel, the WPA project built extensive dry-stacked limestone walls to create a series of overlooks, retaining walls, a grand staircase and large council rings along the western side of the ravine (Figure 8). It is possible that at least a portion of the stone used may have been salvaged from the site.

Figure 8: WPA era walls and grand staircase along the eastern edge of Hidden Falls Ravine

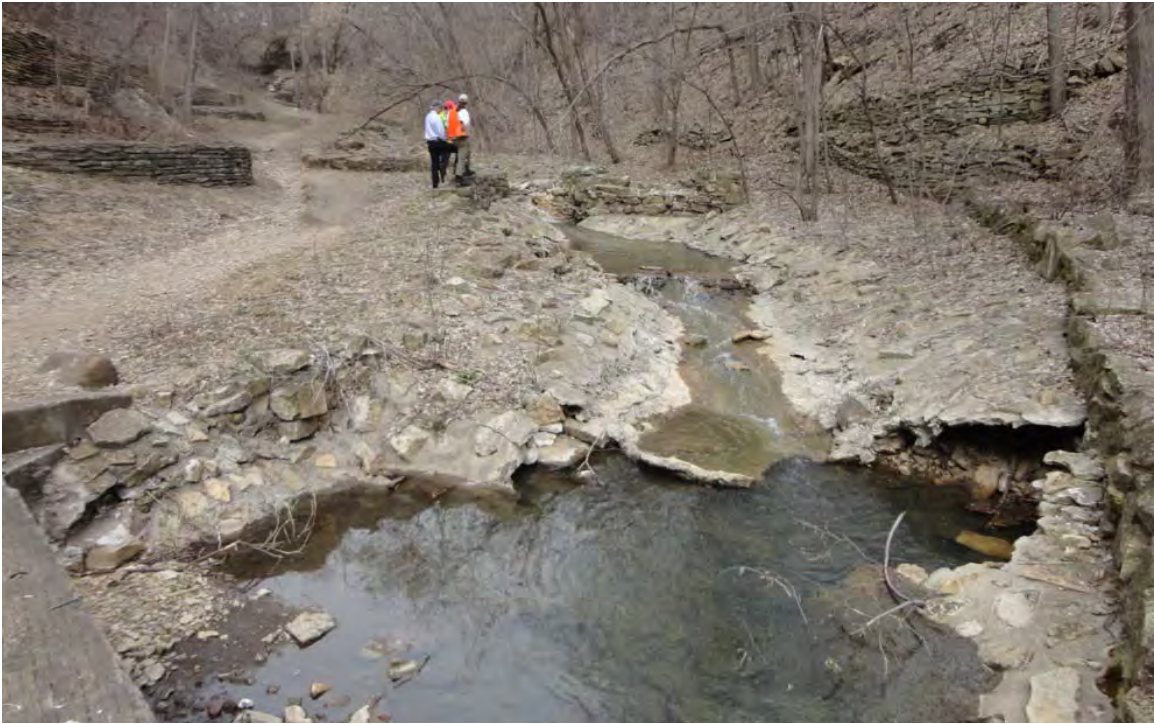
Figure 20: Looking upstream from bridge #3 at Station 12+85 at the Lower Step Pool Reach

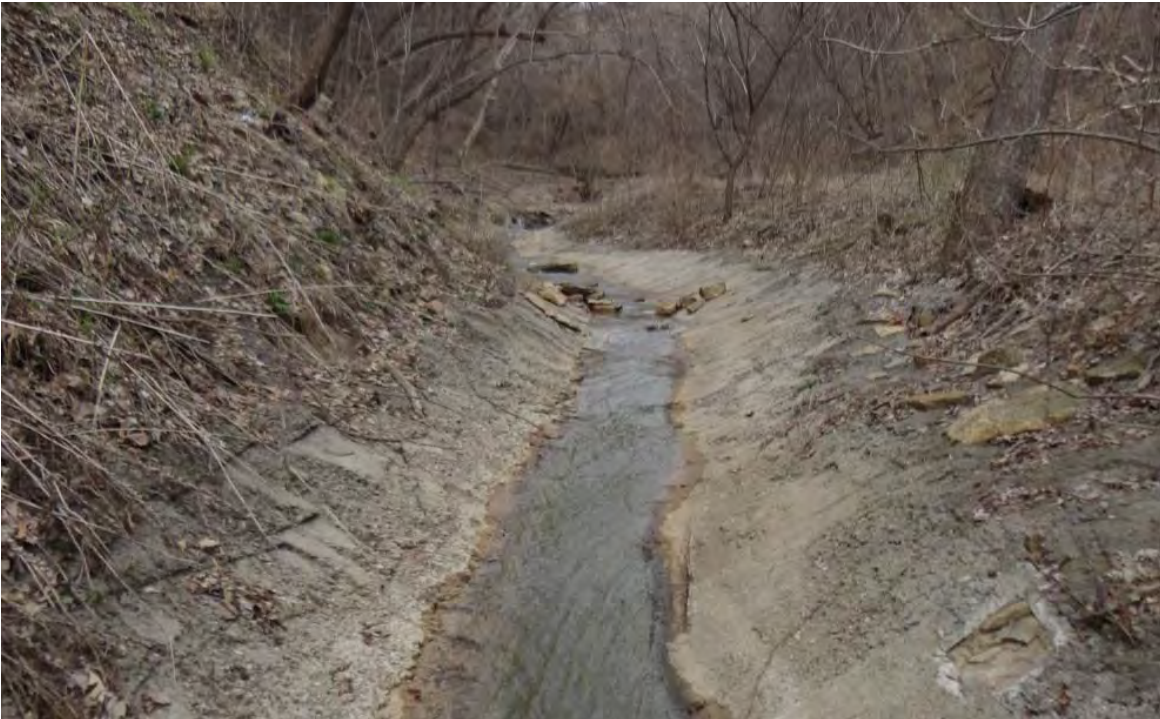
Figure 21: Looking upstream at The Chute along the base of bluff near Station 11+00 – 12+50

The immobility of the concrete chute has precluded development of any step pool form in that reach. The slope in this reach suggests that continuation of a step pool channel in this reach is appropriate.

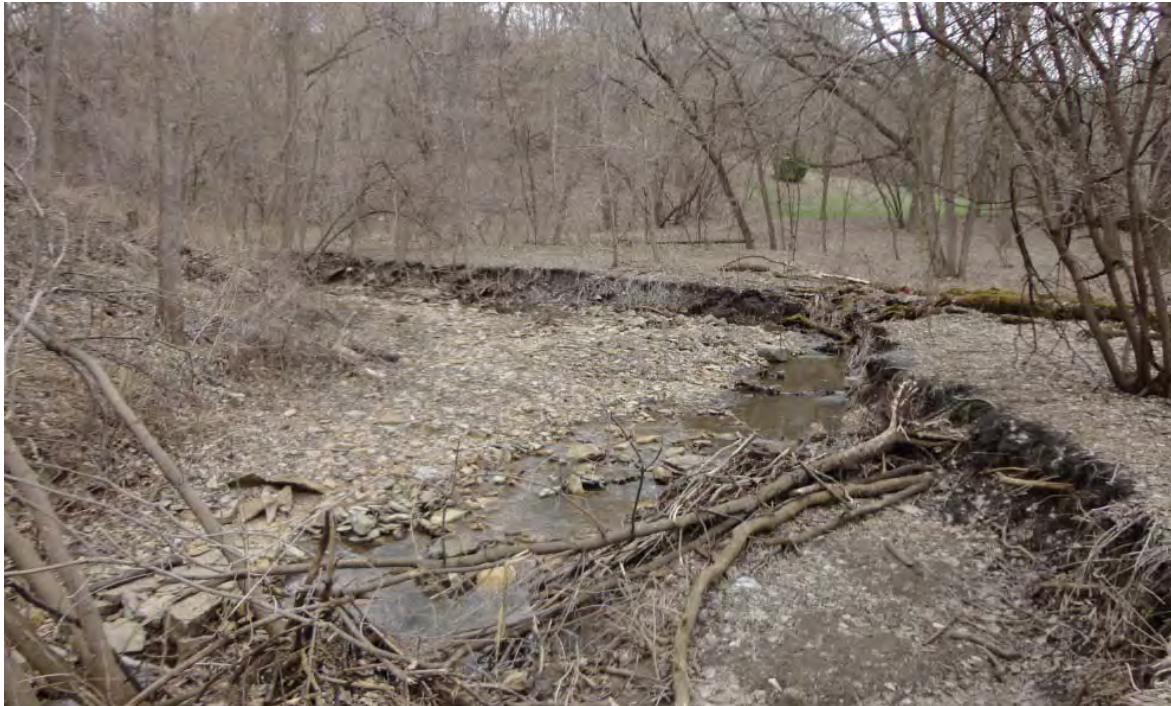
Figure 22: Alluvial Fan Reach - Bar development at toe of bluff upstream from Station 9+00

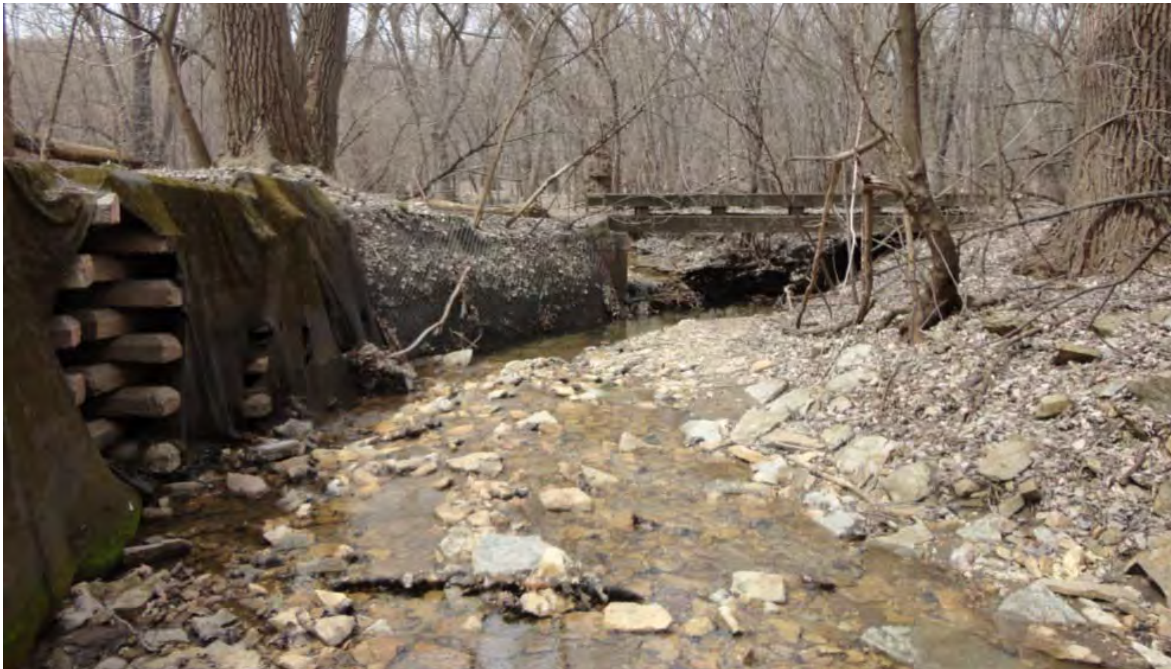
Figure 23: Alluvial Fan Reach - Bank erosion project on channel left looking downstream at Station 6+00 to bridge #2 crossing
