Atrium Office Building Window Replacement

Design Review Application to the
Heritage Preservation Commission
By Wellington Management, Inc.

Current Proposal: This application currently requests replacement of 25 third floor windows at the south wing of the building. The elevations are identified as SW2, S and SE2. Drawings from Pope Architects, in cooperation with Pella, depict a two-part metal clad replacement window with divided lights. Window replacement design for three-part windows is also presented for approval of phased replacement.

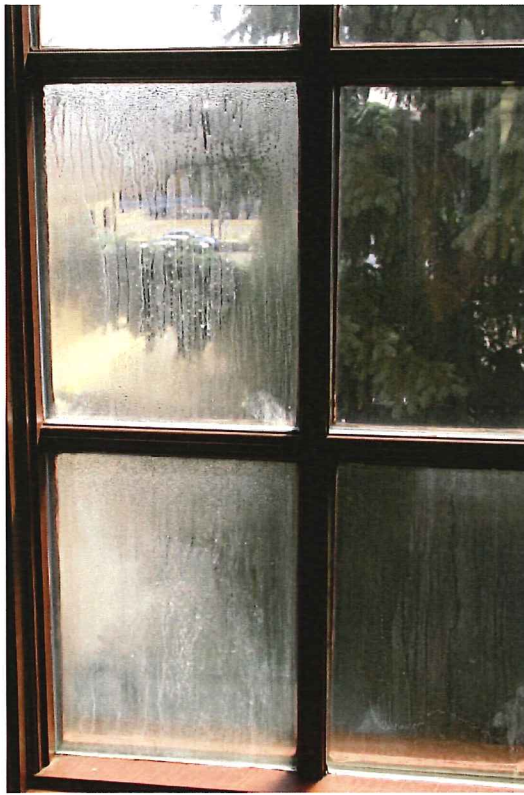
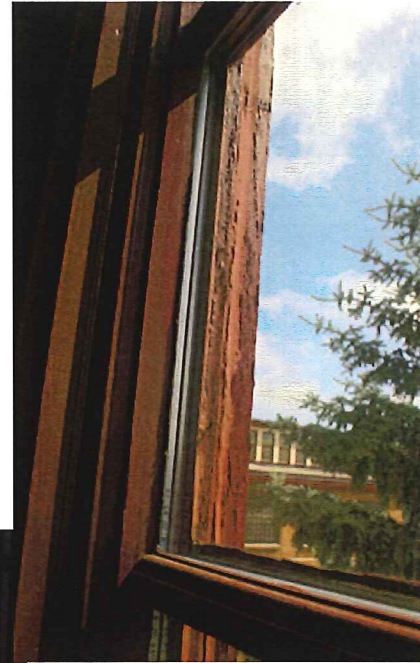
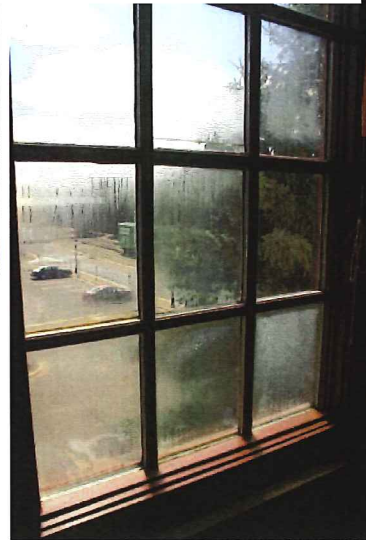
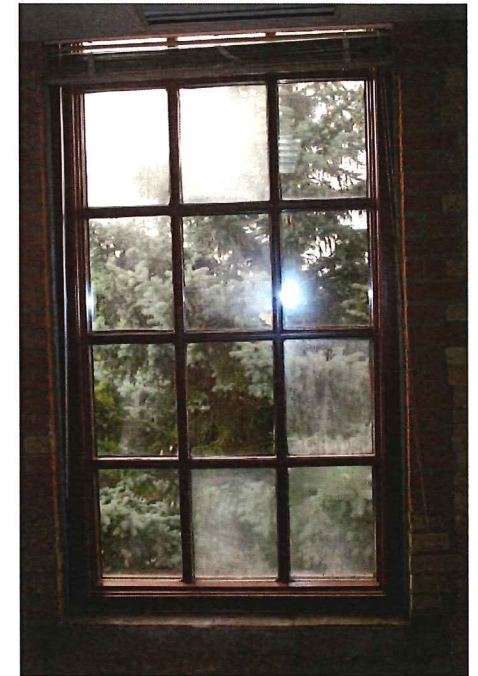
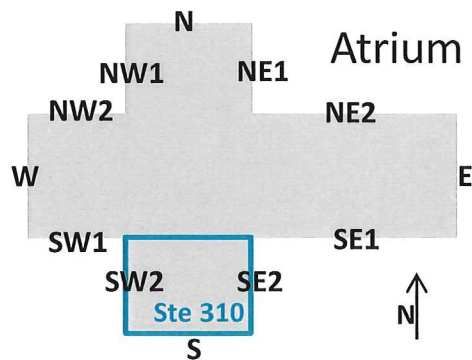
Leaking and damaged panes and deteriorated wood trim have been selectively replaced as a temporary means of stopping water infiltration and drafts.

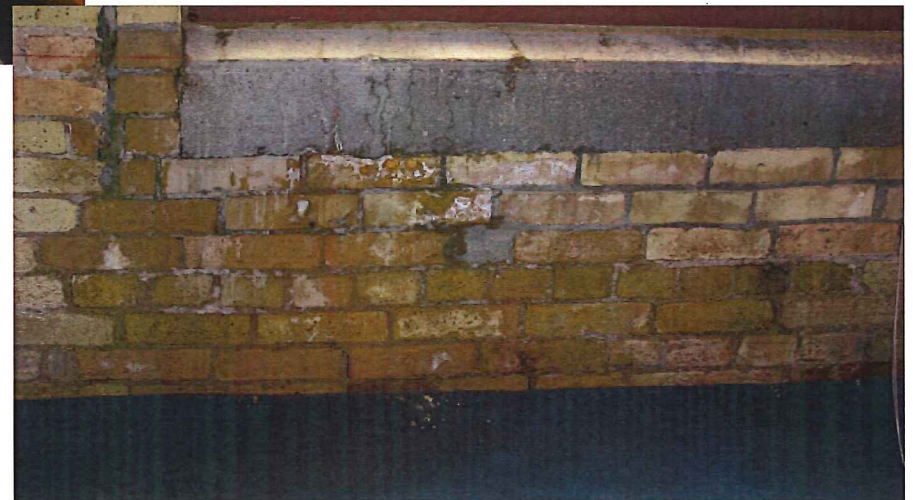
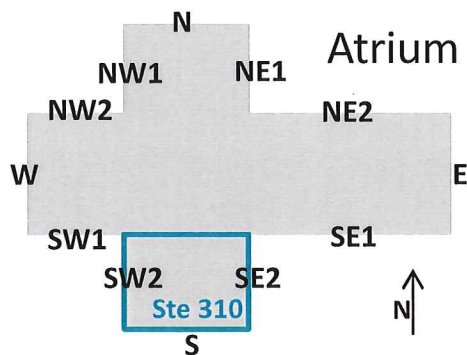
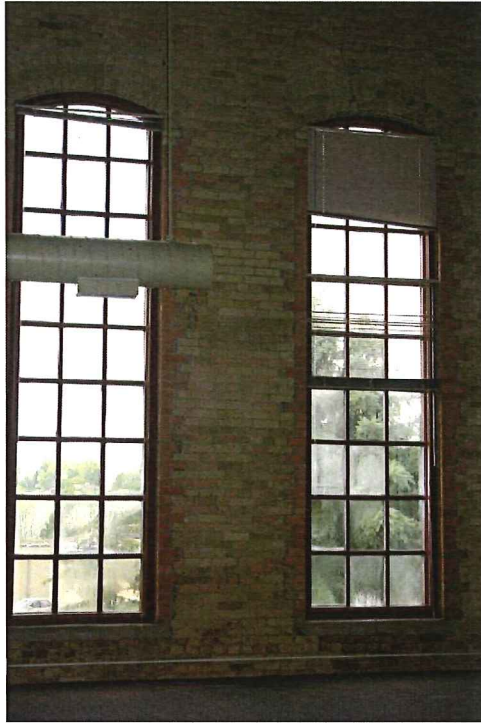
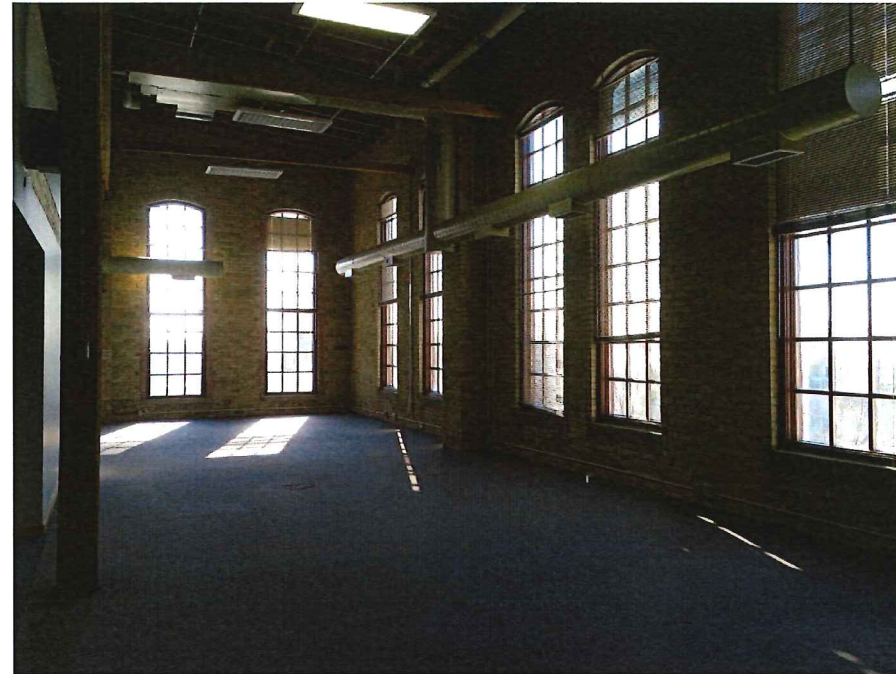
- Water infiltration has damaged the brick in suite 310 and many other locations in the building.

- Interior wall finishes and carpeting have been saturated, creating conditions conducive to mold growth and air quality concerns.

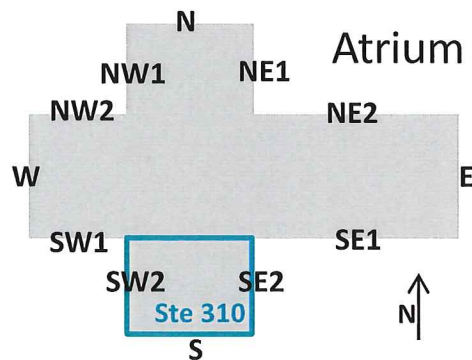
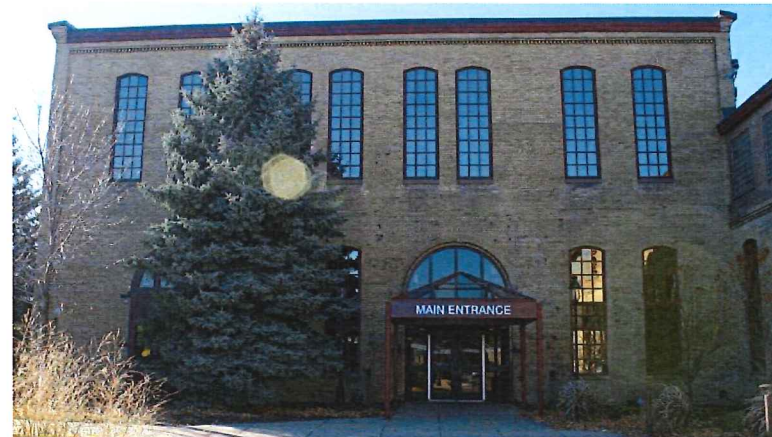
SE2 – 3rd floor is part of suite 310

- Suite 310 contains twenty-five 13 foot high window units that require replacement.

- Each unit has 27 individual panes of glass.

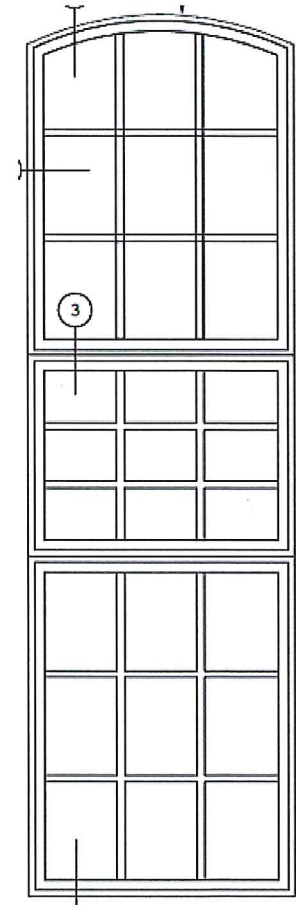
- In some locations, especially on the east side, there are large soft/sealant joints at the perimeter that are very noticeable, unsightly, and inconsistent.
- These joints may be the result of inconsistent wood jam widths – sometimes varying up to a full inch on the same window.

The details Pella is suggesting will provide an attractive and consistent appearance. Each opening will be measured to provide custom windows, rather than a “one size fits all” style that results in noticeable variation.
