**CITY OF SAINT PAUL
HERITAGE PRESERVATION COMMISSION STAFF REPORT**

FILE NAME: 500 Cedar Street, Central Presbyterian Church
DATE OF APPLICATION: August 4, 2015
APPLICANT: Fluryanne Leach, Central Presbyterian Church
OWNER: John Lee, President of the Corporation of Central Presbyterian Church
DATE OF HEARING: August 27, 2015
HPC SITE/DISTRICT: Individual Site—Central Presbyterian Church
CATEGORY: Pivotal
CLASSIFICATION: Building Permit
STAFF INVESTIGATION AND REPORT: Allison Suhan
DATE: August 21, 2015

HERITAGE PRESERVATION COMMISSION DESIGN REVIEW APPLICATION

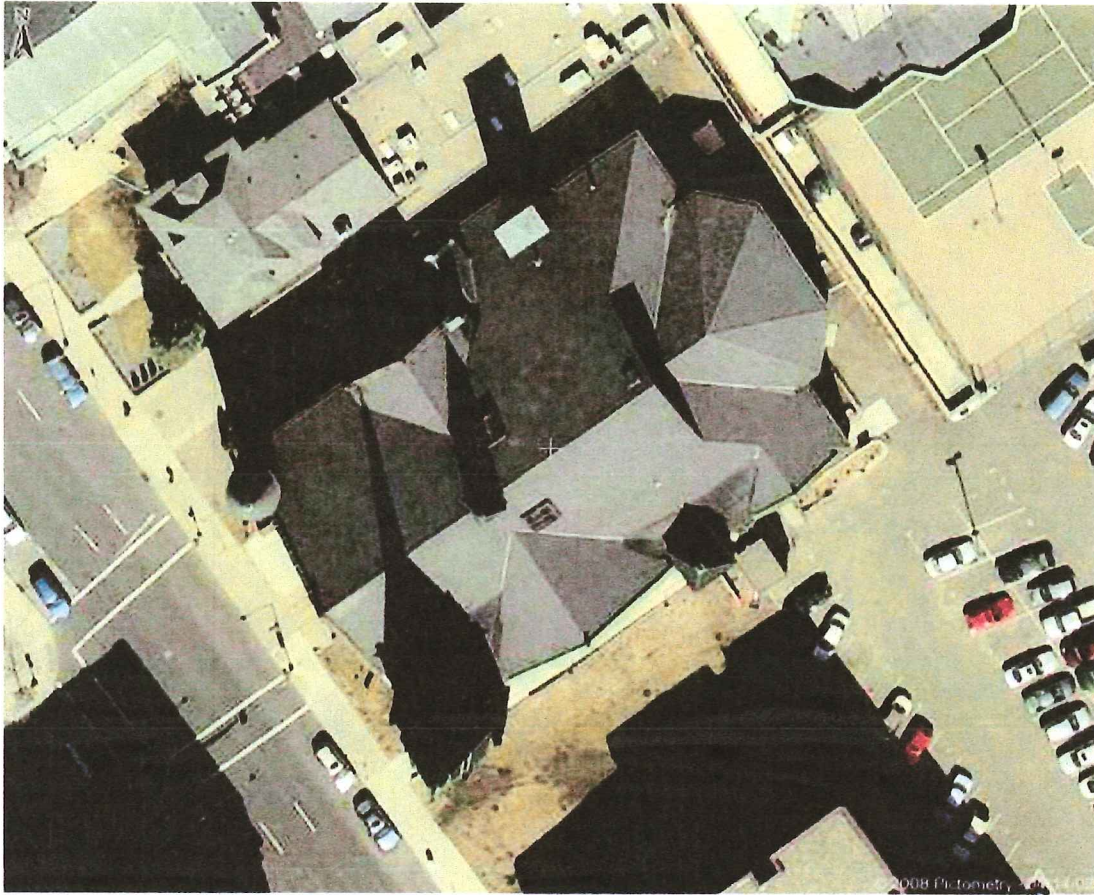
Fig. 1 Top view of church roof, front of church faces Cedar on left side of building in this photo

Figure 1 - Top View, Cedar Street is on the left 2/12/15

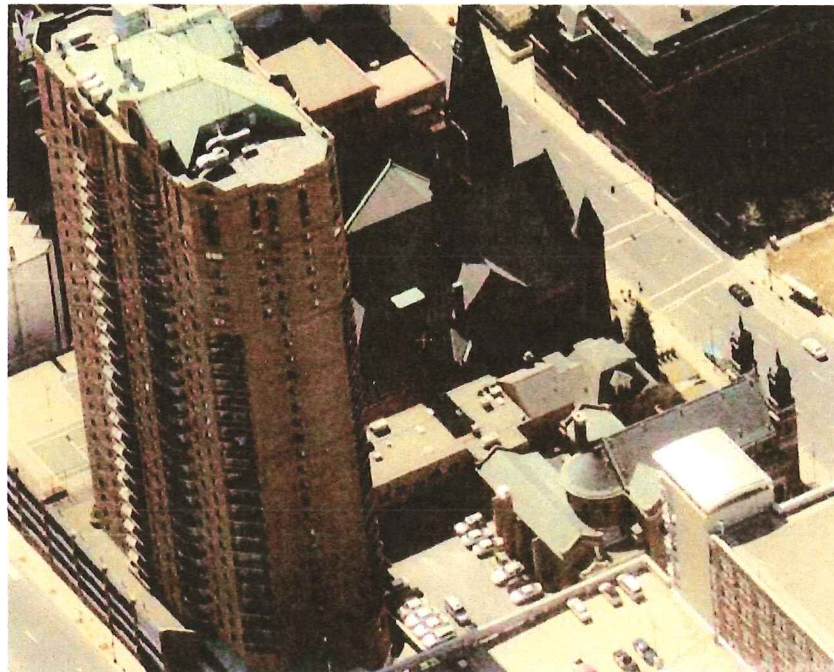
Fig. 2 View from north side, St. Louis King of France church buildings on north side of building, City Walk apartments and parking garage behind building

Figure 2 View of North side which faces the St. Louis King of France church buildings 2/12/15

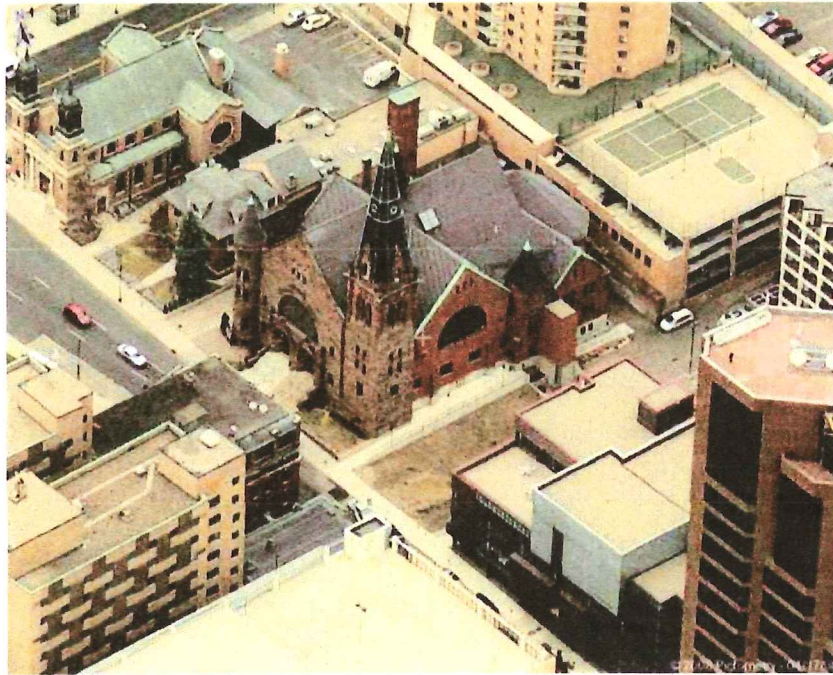
Fig.3 View from south side, MPR building and parking lot to south of church

Figure 3 View of South side which faces the MPR parking lot and building 2/12/15

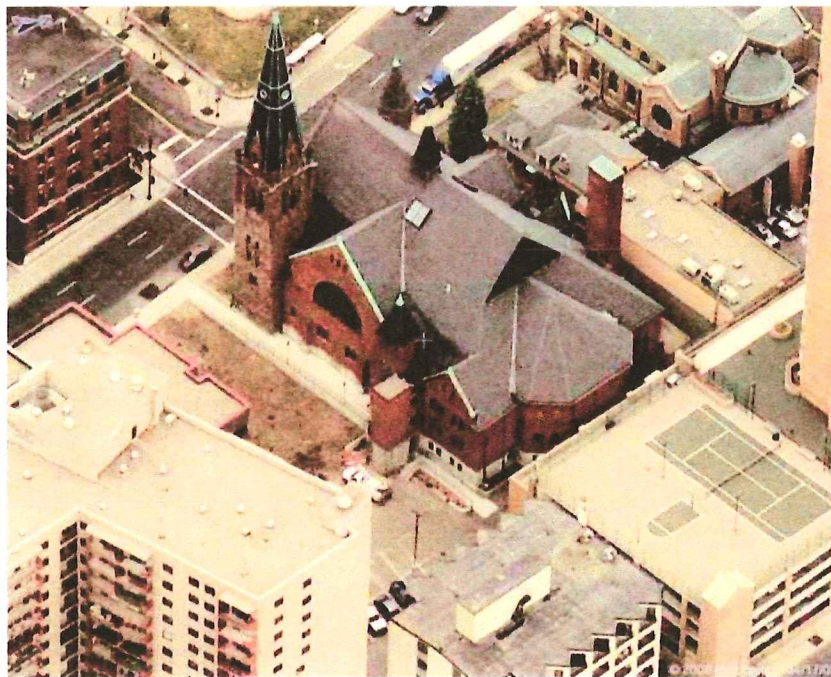
Fig. 4 View from east side showing hipped roof at rear of church with apartment parking garage immediately behind

Figure 4 View of East side showing hipped roof of rear of church and apartment buildings parking garage immediately behind church 2/12/15

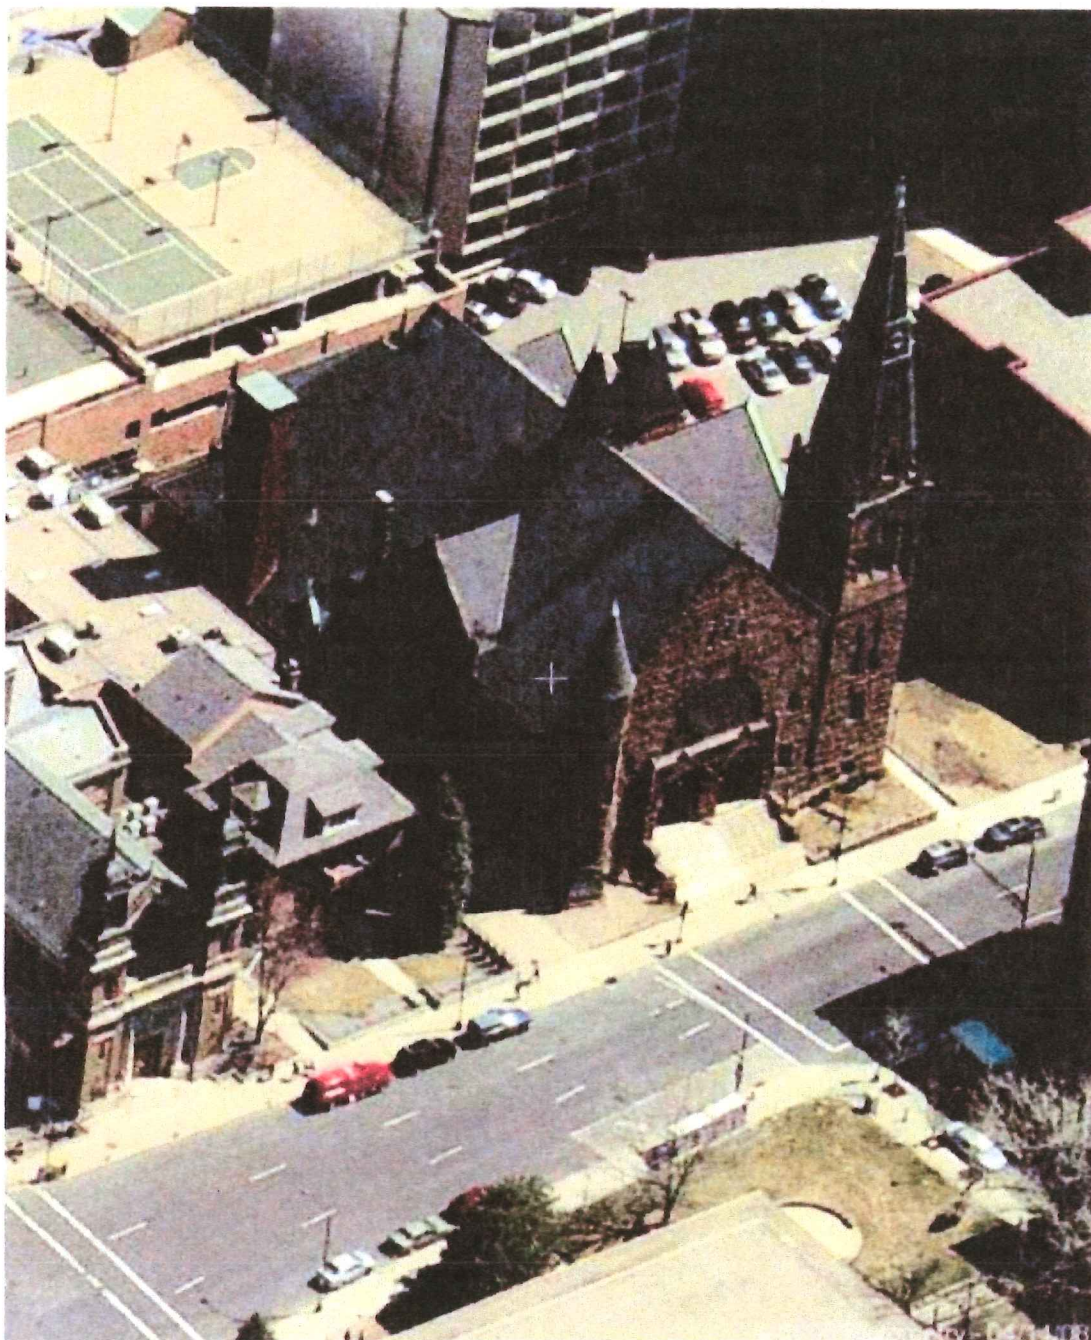
Fig. 5 View from west side showing St. Louis King of France Church buildings separated from church by narrow drive

Figure 5 View of West side, facing Cedar St. with MPR building on far right and St. Louis King of France Church buildings on left 2/12/15

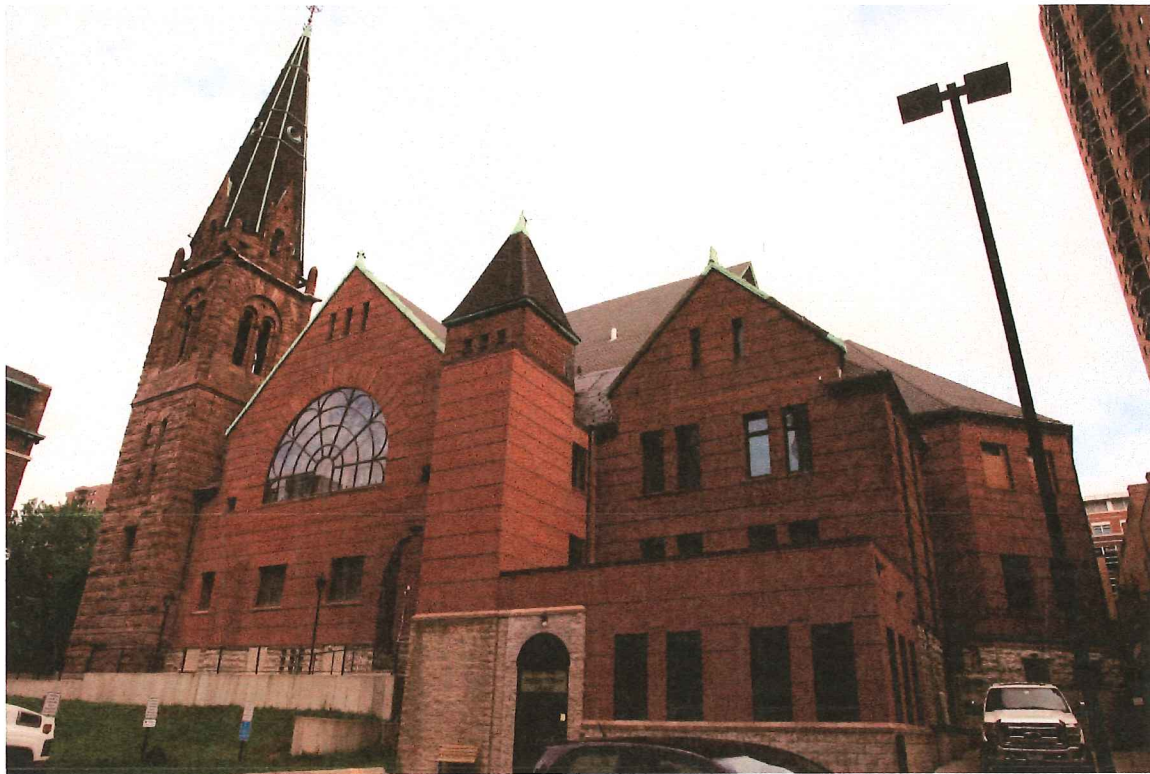
Fig. 6 South side of church taken from adjacent parking lot, showing bell tower, south turret and side of hipped roof

Figure 6 View from South side showing bell tower at left and hipped roof at right 7/27/15

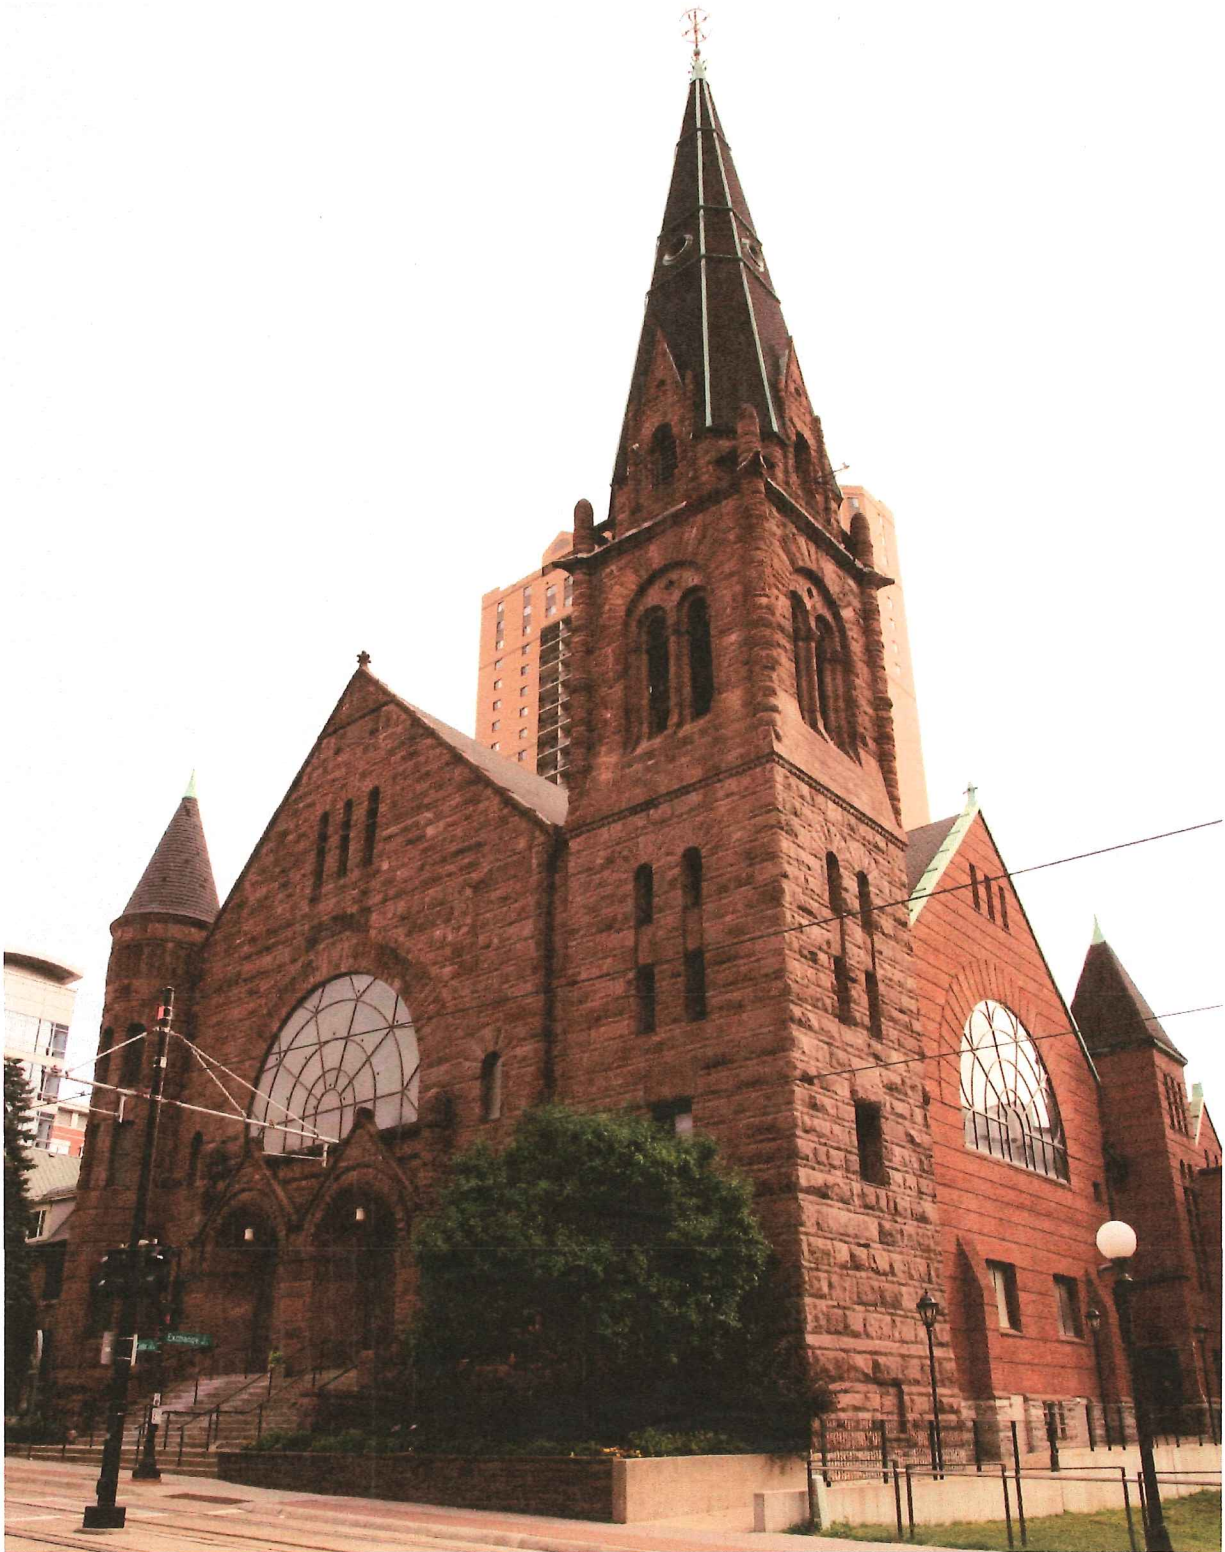
Fig. 9 View of church taken from southwest corner showing bell tower and west front

Figure 9 View taken from southwest side 7/27/15

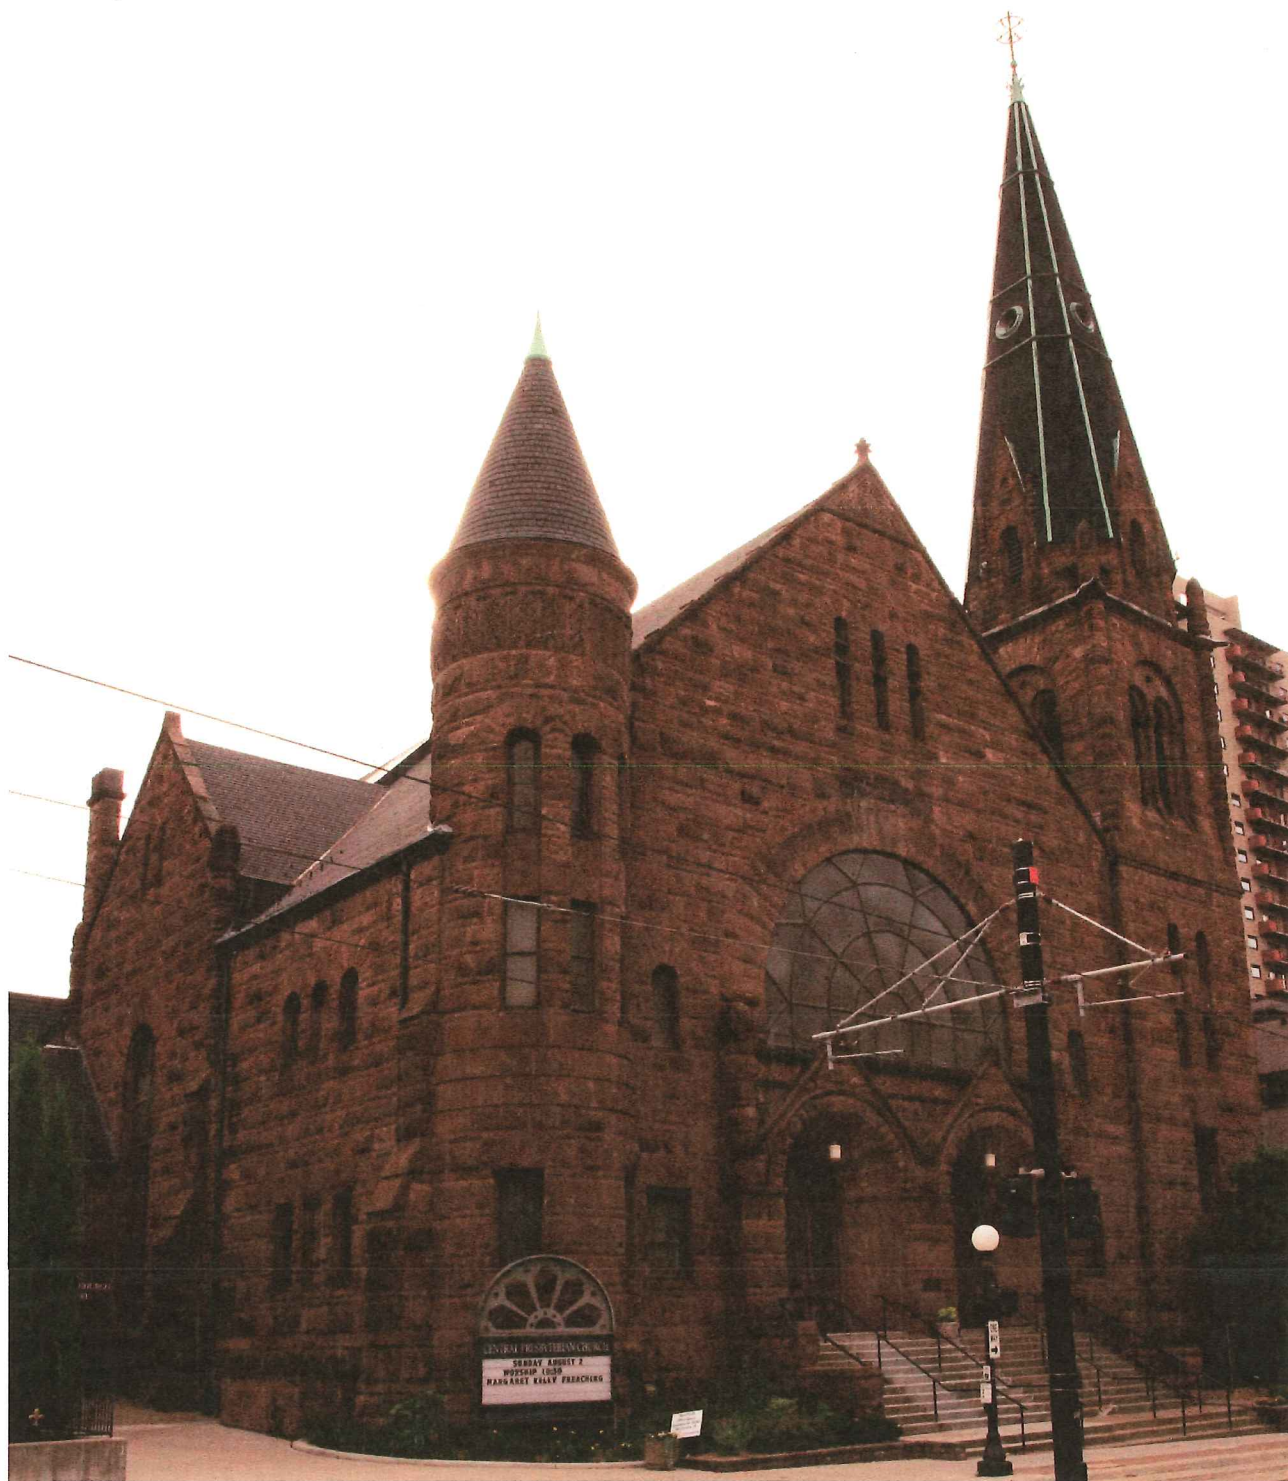
Fig. 10 View of church taken from northwest corner showing west front with bell tower on right and northwest turret on left

Figure 10 View taken from northwest side 7/27/15

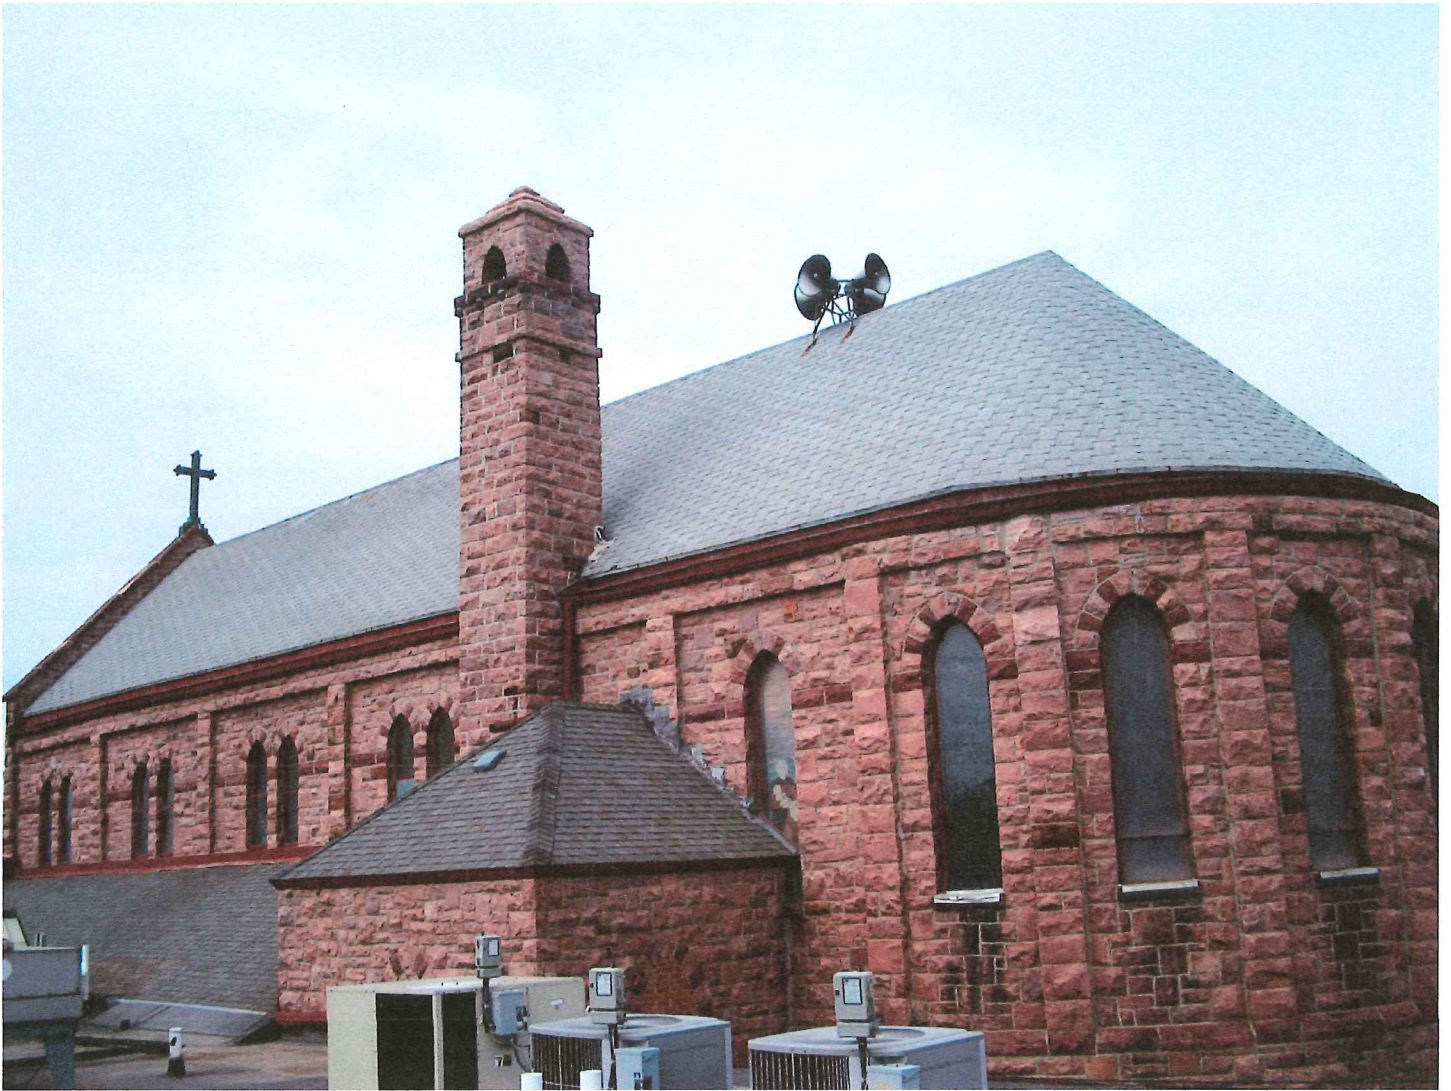
Fig. 13 View of a different church with DECRA stone coated steel shingle XD in natural slate installed by same contractor

Figure 137 DECRA stone coated steel shingle XD in natural slate on a different church 6/20/15
