Prepared by:
Mitch Johnson, PE and Kevin Biehn of Emmons & Olivier Resources, Inc.
for the Soil and Water Conservation District of Scott County

Crosby Farm Park: Bluff Stabilization / Restoration Feasibility Study - St. Paul, MN

Feasibility Report 08/07/2007

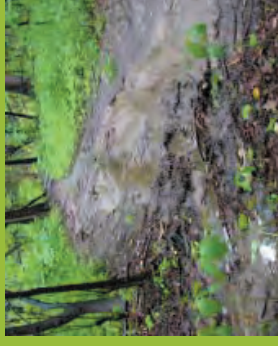
Water running through the trail after rain.

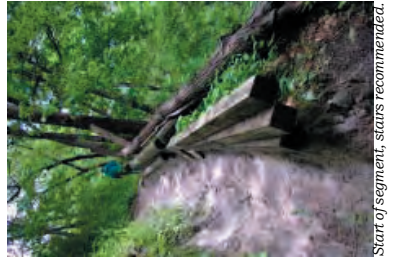
Start of segment, stairs recommended.

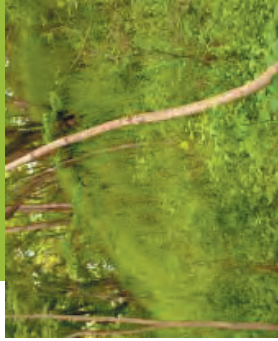
A particularly severe infestation of garlic mustard.

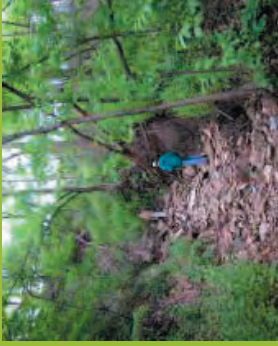
Another severely eroded gorge, above, with the cause of its erosion, a storm water pipe, below.

The most severely eroded areas of the bluff trail are in the ravines, where stormwater repeatedly scours out the base of the ravines and the sides collapse. Some such erosion is a naturally-occurring condition, but here it is aggravated by the presence of storm water outlets at the top of the bluff, bringing water in much larger quantities than would naturally exist. This dramatic erosion cannot be slowed or stopped without dealing with the stormwater outlets. However, we can help people navigate the ravines while still allowing water to pass through.

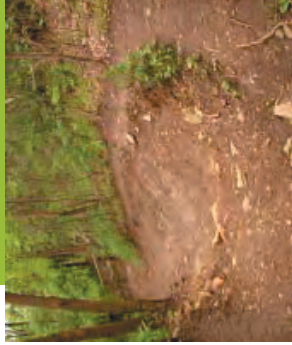
Sloped and eroded trail, where wide stairs are recommended.

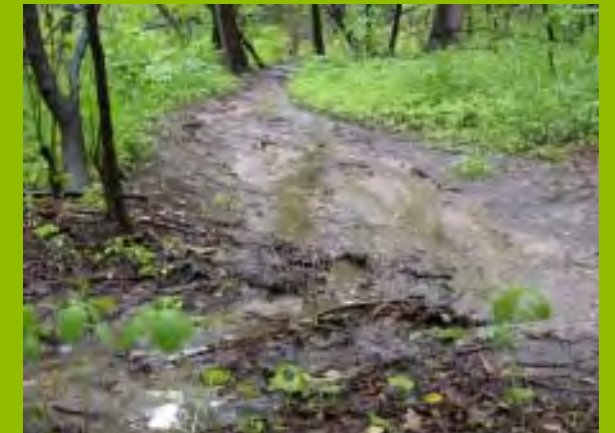
Water running through the trail after rain.

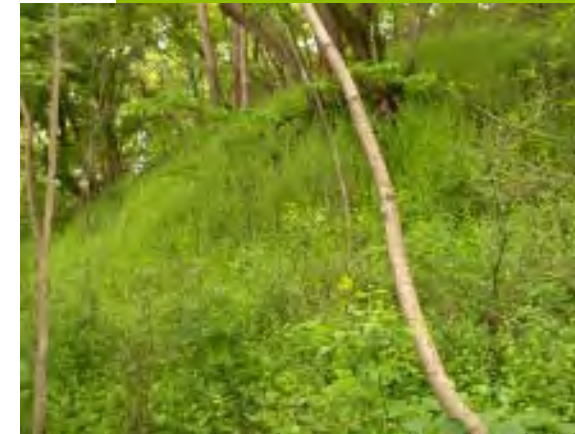
A particularly severe infestation of garlic mustard.

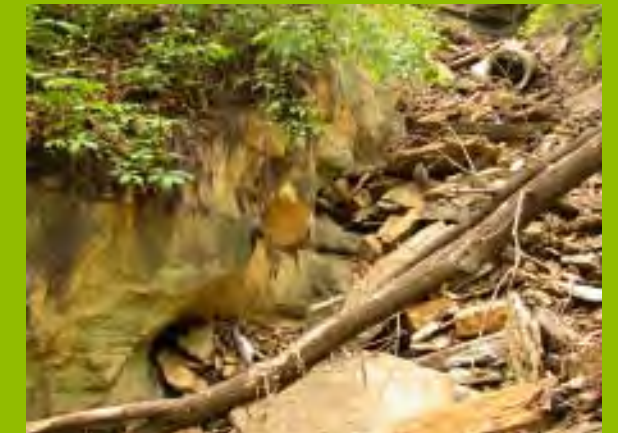
One of several severely eroded gorges, with sculpted sandstone walls and filled with rubble.

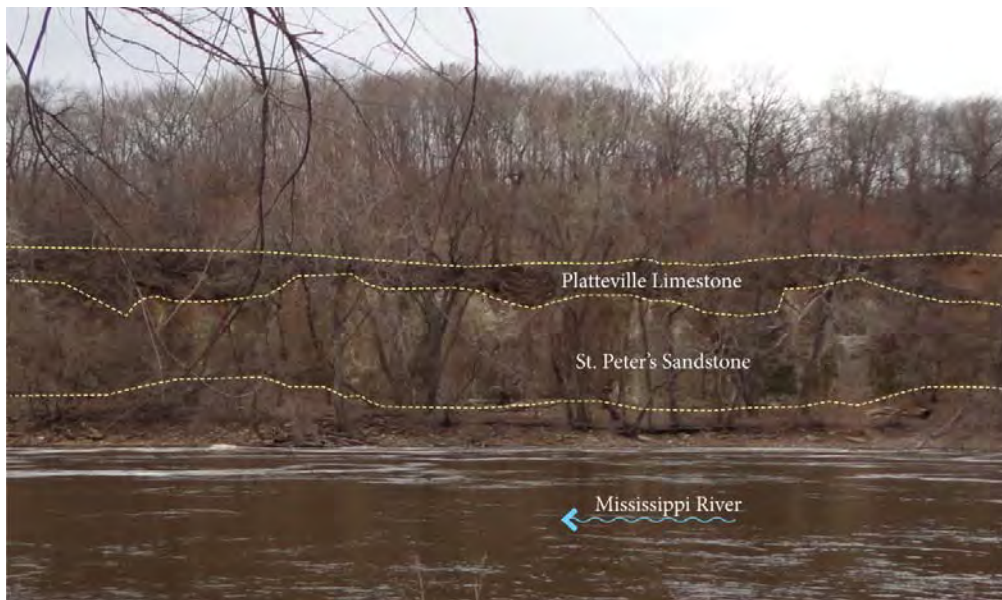
Figure 4: The sandstone and limestone bluffs on the right Mississippi River bank as visible from Hidden Falls

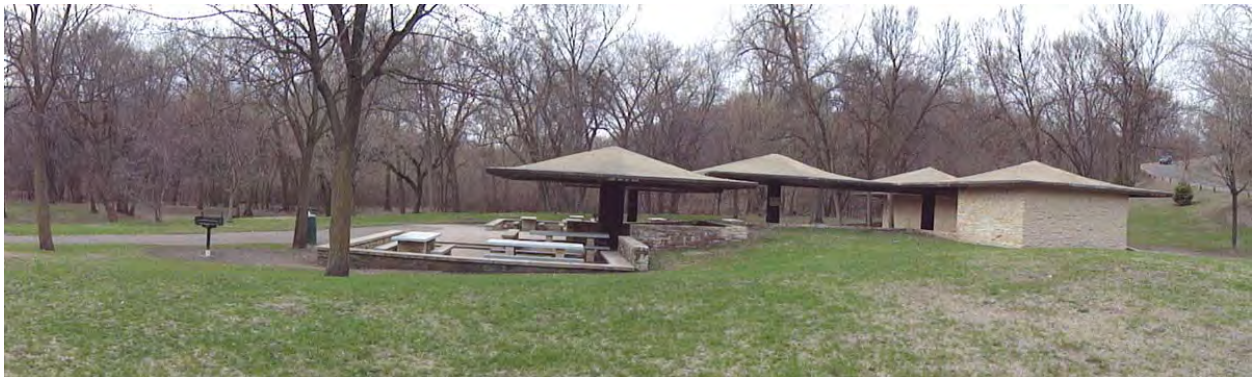
The Picnic Pavilion is an architecturally interesting example of early 70s park architecture, centrally sited mid-distance between Hidden Falls and the Mississippi River (Figure 9). Construction documents for the pavilion, dated 1973, are archived in the Northwest Architectural Archives. Drawings illustrate construction plans and details for the pavilion as well as the boat launch and parking areas along the Mississippi River. Soil boring reports at the location of the pavilion provide further geotechnical information about soils in the alluvial fan (see Soils Section). Stone building materials and sources are also referenced (Lannon Stone quarried by Halquist Stone Company in Sussex, WI).

Figure 9: Picnic Pavilion, Looking north towards bluff

The Picnic Pavilion is still a relevant piece of architecture and part of the park plan. Its use can be reactivated through landscape design and trail planning to create better connections and visibility to the park water features, including the bluff, stream, and falls.

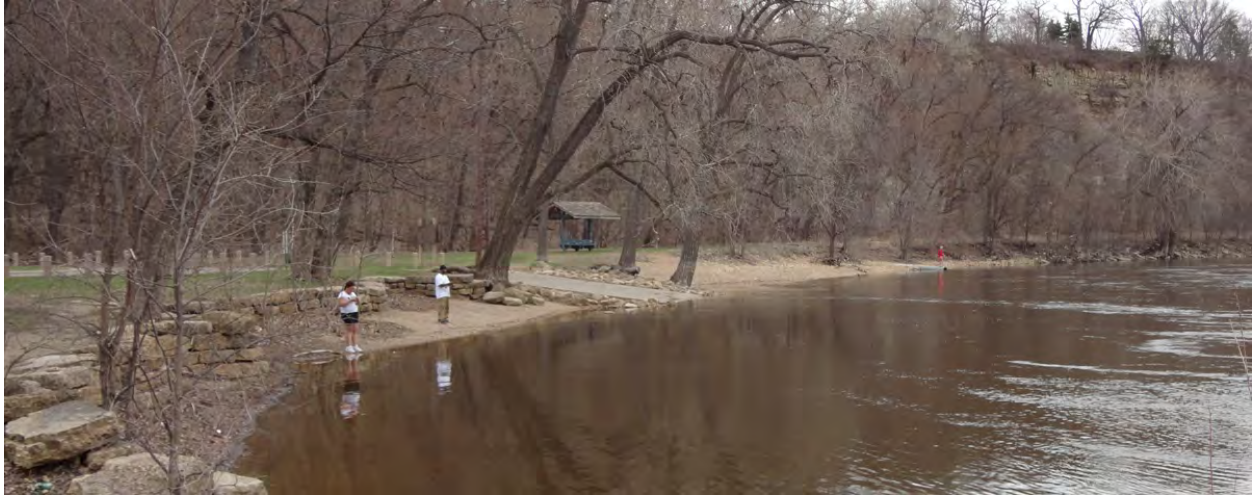
lot for boaters, anglers and other park users. Grading and filling has eliminated any backwater or relic channel features that may have existed in this area.

Figure 10: Boat Launch area with limestone walls and fishing access

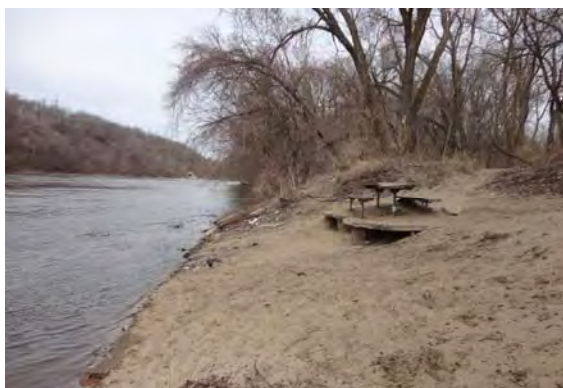
Manicured turf landscape surrounds the picnic pavilion and boat launch areas, but the remainder of Hidden Falls Park is passively managed and is dominated by native vegetation. An asphalt pathway, southwest of the picnic pavilion, takes visitors to the levee along the Mississippi River and terminates at a laminated wood bridge which crosses the mouth of the Hidden Falls Creek. The trail along the cascade and falls portion of the creek is the only pathway along the stream. Bridges cross the stream at three locations – near the downstream end of the cascade reach, near the transition from alluvial fan to floodplain, and near the mouth of the stream. Primitive pathways have been forged by park goers. Circulation through the site could be improved by connecting pathways. Various site furnishings (picnic tables, benches and pedestrian structures) are decades old and many are in poor condition.

Figure 11: Mississippi R bank with picnic table

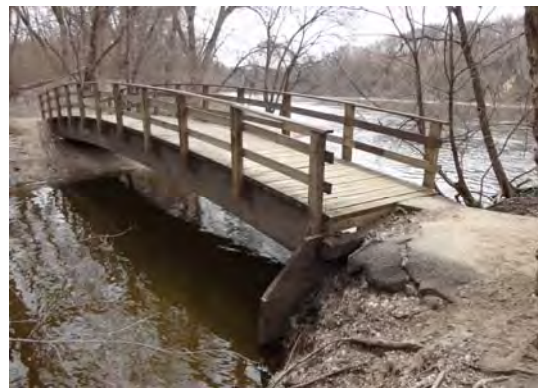
Figure 12: Bridge across Hidden Falls Creek at the Mississippi River

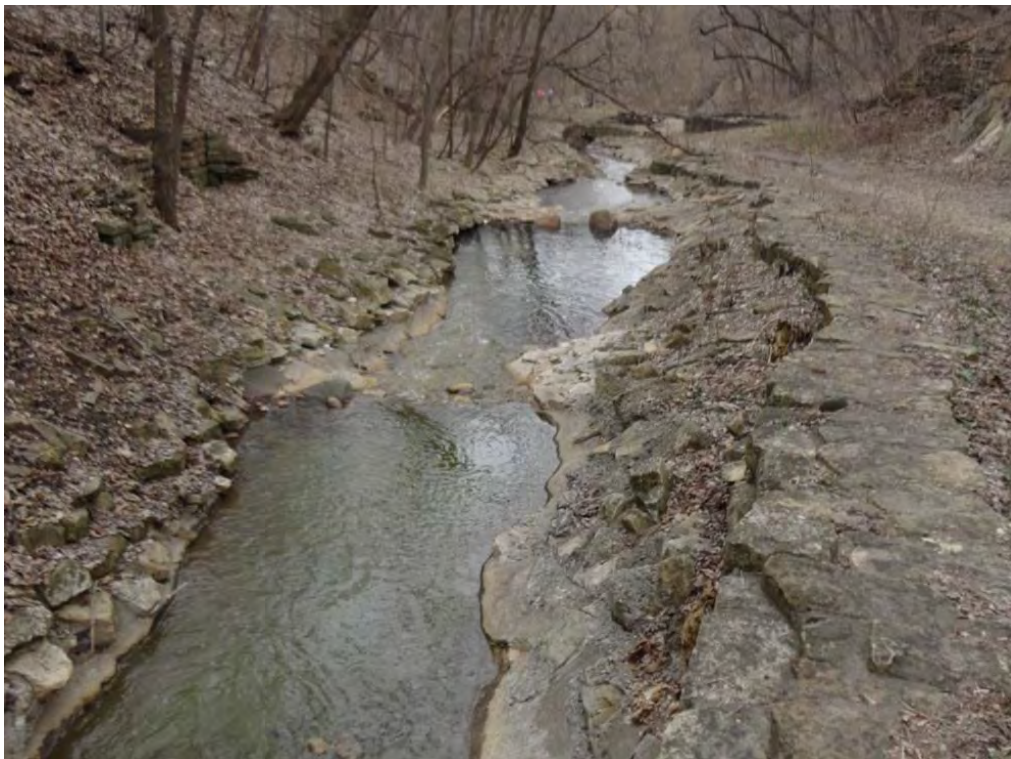
Figure 19: Looking downstream from approximately Station 15+00 at the Lower Step Pool channel

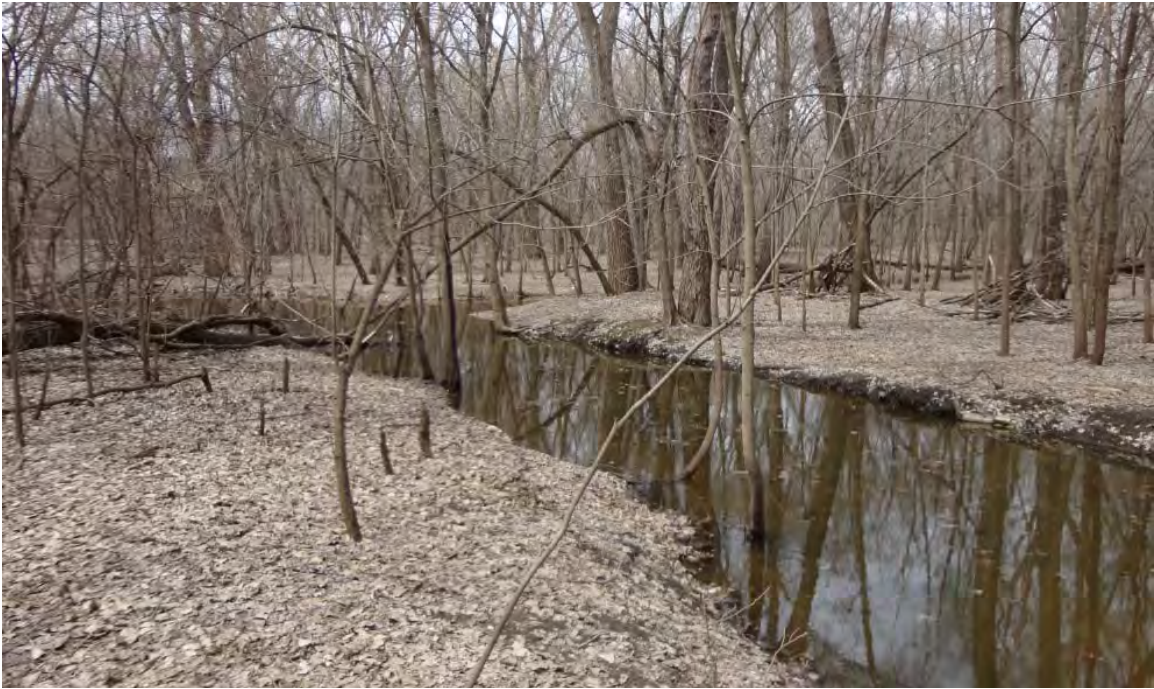
Figure 24: Floodplain Reach, near Station 4+00

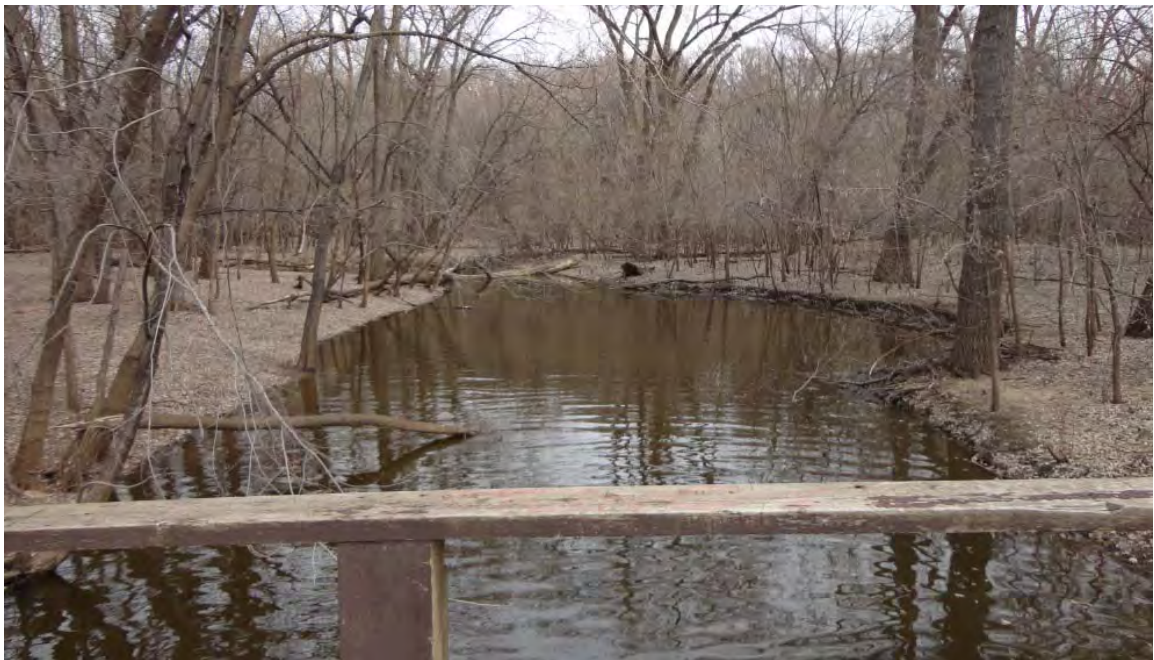
Figure 25: Floodplain Reach upstream from pedestrian bridge #1

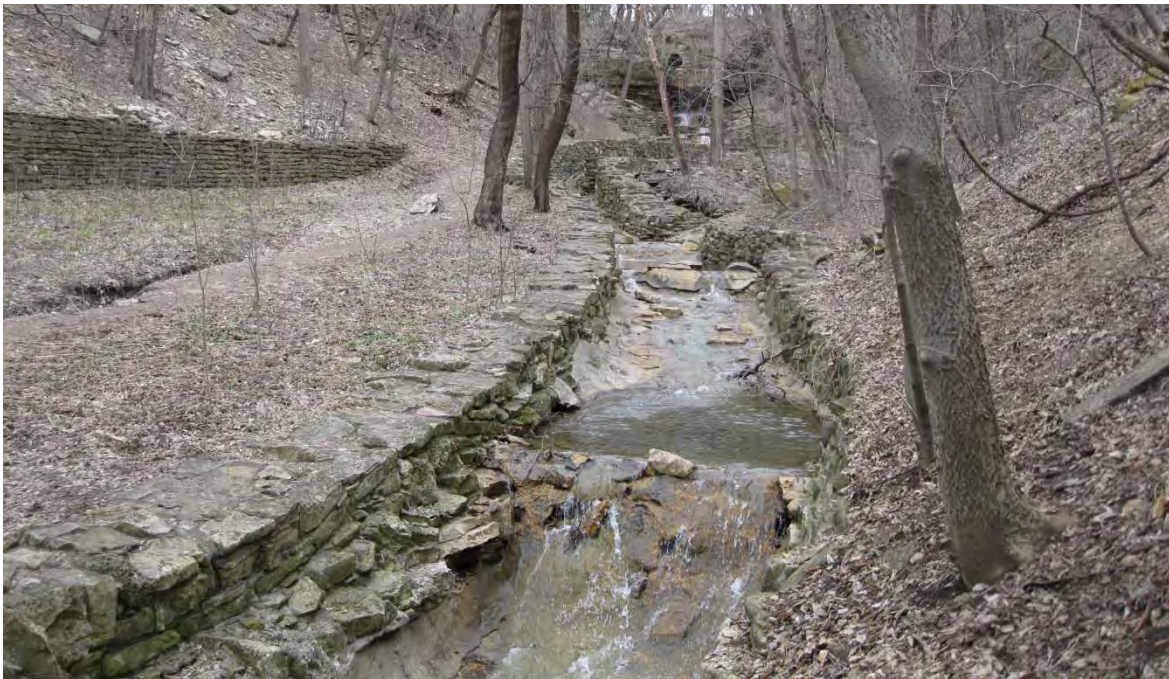
The channel width was most likely reduced in the areas where stone walls are now creating vertical banks, so the L/W was probably originally smaller than it is now. Regardless, the current values are within a typical range for natural step pool channels. The (Hs/L)/S ratio is lower than expected for the upper reach. The value near 1 suggests little to no pool depth below

the drops, which is consistent with field observations. However, it is likely that pools were deeper before the concrete was placed in them. The presence of concrete currently eliminates scour potential in the pools.

Figure 28: Existing step pool reach at Hidden Falls Creek

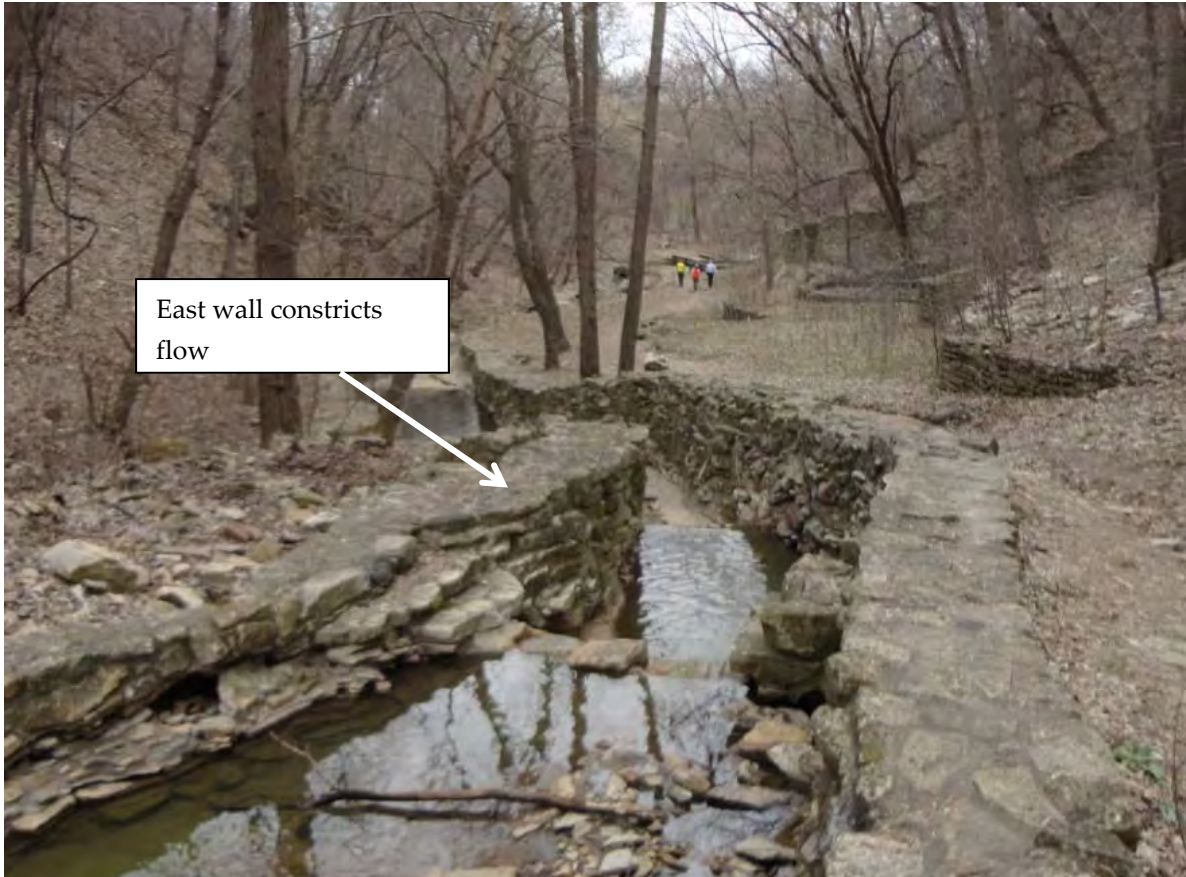
Figure 29: Upper step pool reach showing 1980's era walls considered for removal

A few alternatives are feasible for enhancing the step pool reaches. Given the value of increasing the width of the channel, removing the concrete lining from the channel bed, and using natural material that matches the surrounding environment, all of the alternatives include these features. For all alternatives, access to the channel may be improved by incorporating steps down from the trail to the channel, if desired. The key variables distinguishing the alternatives are (1) whether the mortared stone 1980's era walls are removed entirely on one side of the channel to achieve the greater width or simply moved and rebuilt (Figure 29); and (2) whether the channel is lined with clay to restrict infiltration. The value of these alternatives is summarized in Table 6 together with a no action alternative for comparison.

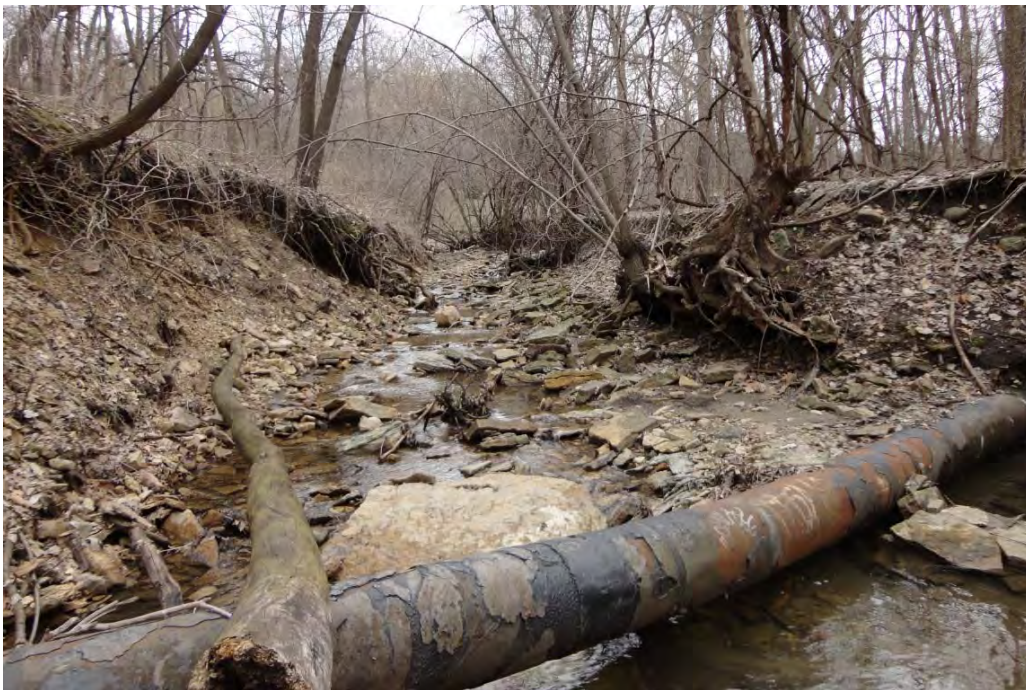
Soil borings further from this channel do not show similar large rock in the upper soil layers. This suggests that this channel aggraded through deposition of rock material that washed down the ravine. The existing ground elevation in the abandoned channel further suggests that the channels evolved as expected in alluvial fan development. The elevation of the bed of the abandoned channel is approximately 2 feet higher than the bed elevation of the current channel. This is evidence that aggradation occurred in the historic channel to the point that a flood flow spilled out and was able to cut through finer material into a lower, steeper sloped channel.

Figure 30: Incised alluvial fan channel with abandoned pipe

Imposed on the geologic evolution of the alluvial fan are the shorter term impacts of human modifications to the watershed and the stream. Continued erosion of the ravine has been halted through the concrete stabilization and the stormsewer pipe within the watershed. Even if a portion of the stream is daylighted upstream of the Mississippi River Blvd crossing, development adjacent to the stream will probably necessitate incorporation of stabilizing features that will continue to limit sediment supply to this reach. At the same time, increased
